BUILDING SURVEY

BUILDING SURVEY FOR *****

Date of Survey: *****

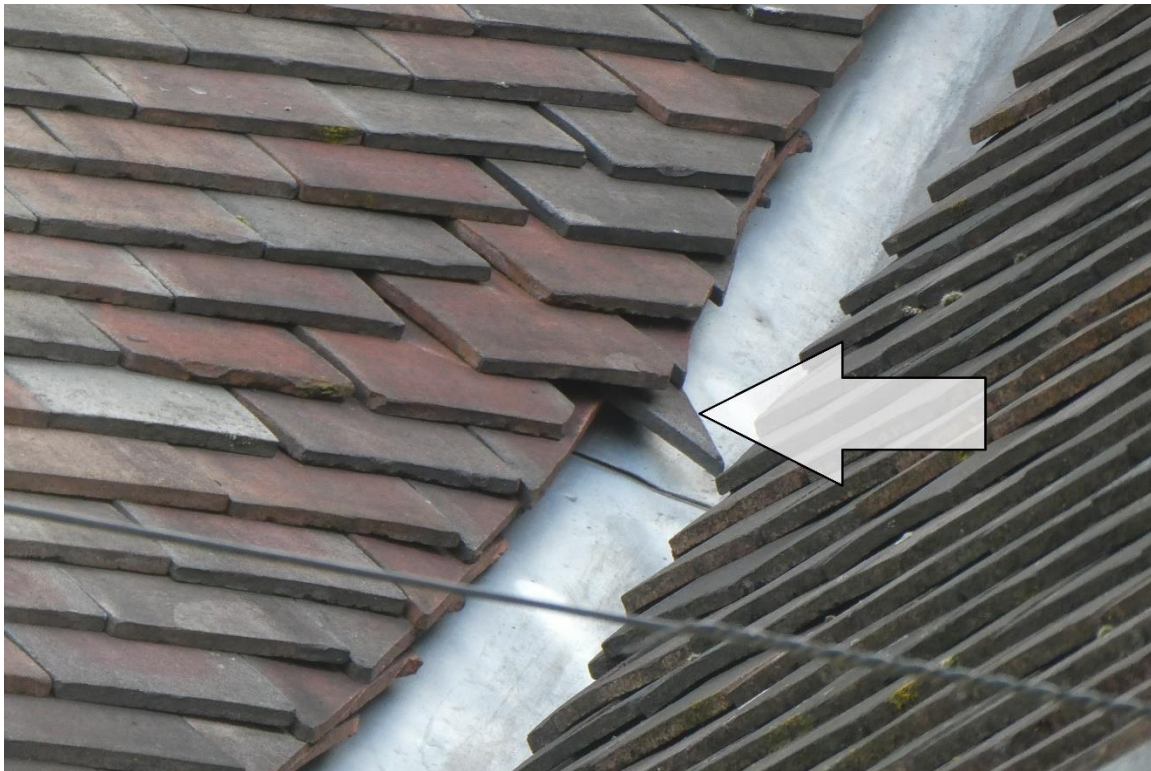
1. One cut valley tile looks like it has slipped to the front valley.
2. We could not see mortar to the valleys. Traditionally, mortar is used to the edge of the lead lined valleys to weather-proof them although other means to can be used to stop rainwater getting into the valley edges. The valleys should be inspected.
3. One tile is missing to the front of the extension.
4. Three broken tiles and one slipped tile to the right-hand side of the lower and second-storey extension.
5. To the rear eaves, the tiles look uneven, and this can be caused by the lower of the double-laid tiles deteriorating.
6. The lead flashing has been missed to the front return above the porch. This needs to be installed.

SLIPPED CUT VALLEY TILE. NOTE THAT YOU CANNOT SEE MORTAR TO THE EDGE OF THE VALLEYS.

3.06 We recommend that the roof is inspected by a roofing contractor, and they replace all of the missing or broken tiles and the missing lead flashing. They should also check the condition of the mortar to hips, ridges, and valleys. They can also give you a quotation to lift and refix all ridge and hip tiles in a ventilated dry-fix system. They should also allow for a ventilated eaves system:

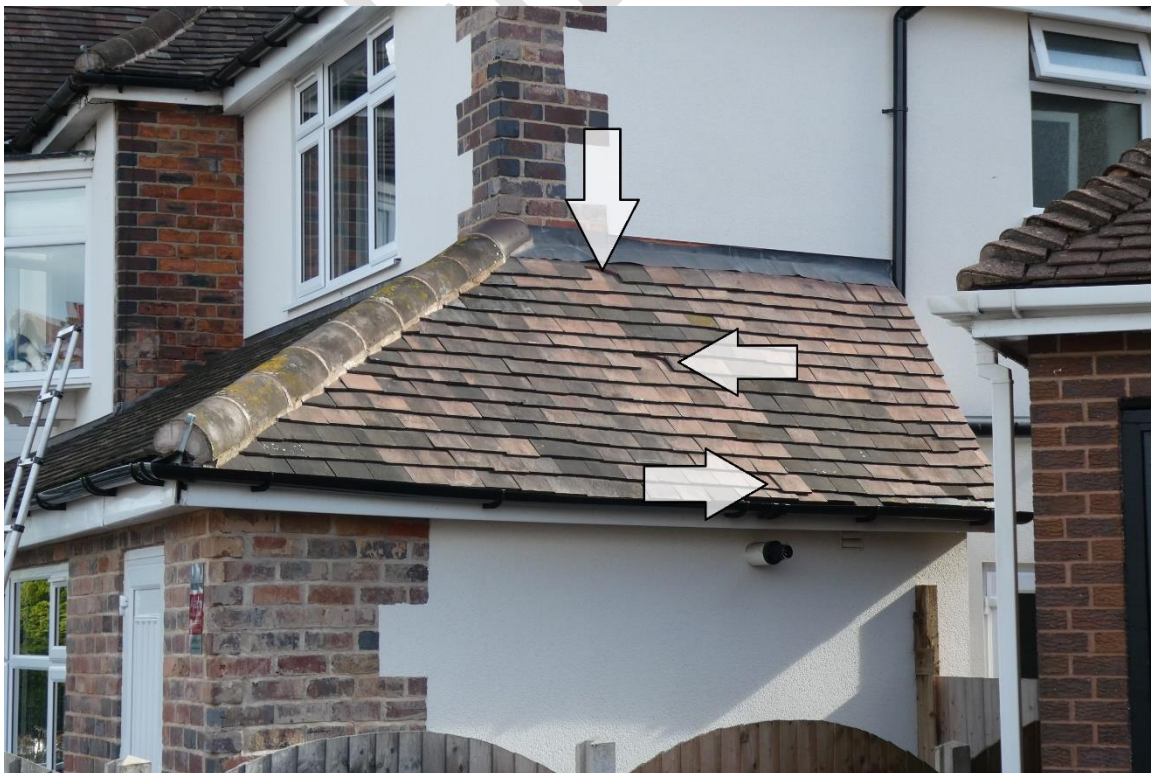
BROKEN AND SLIPPED TILES.

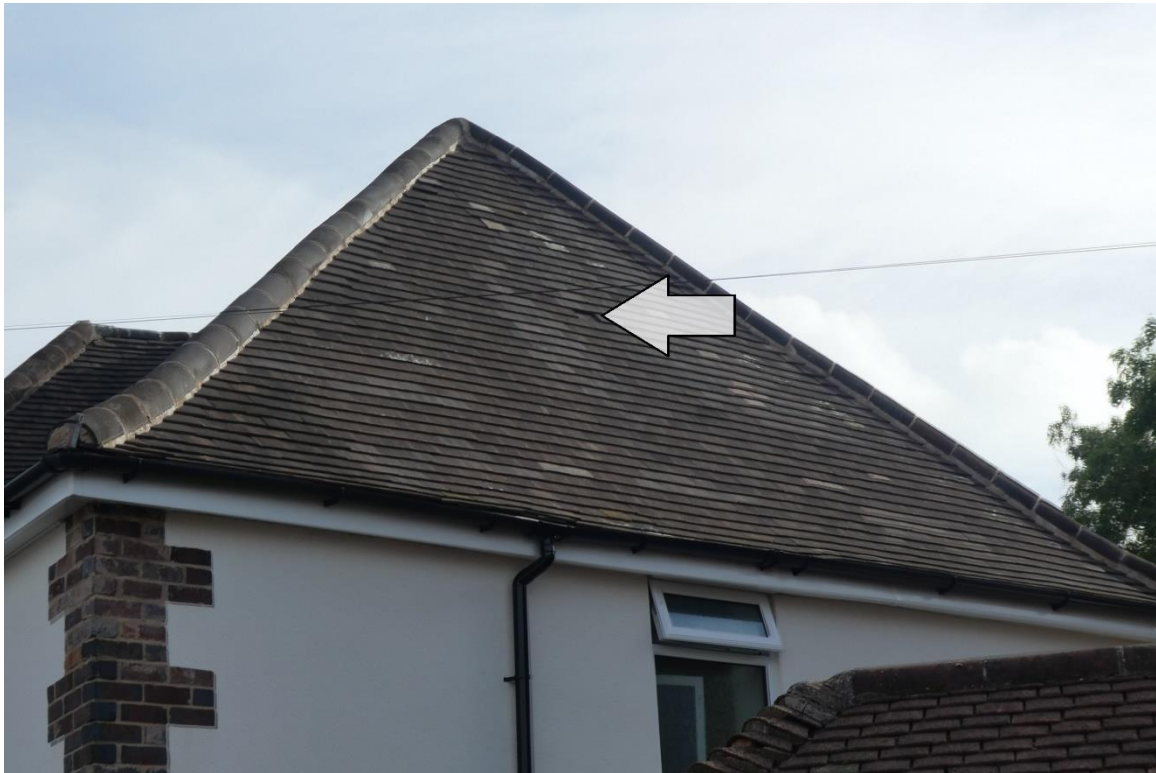
BROKEN TILE.

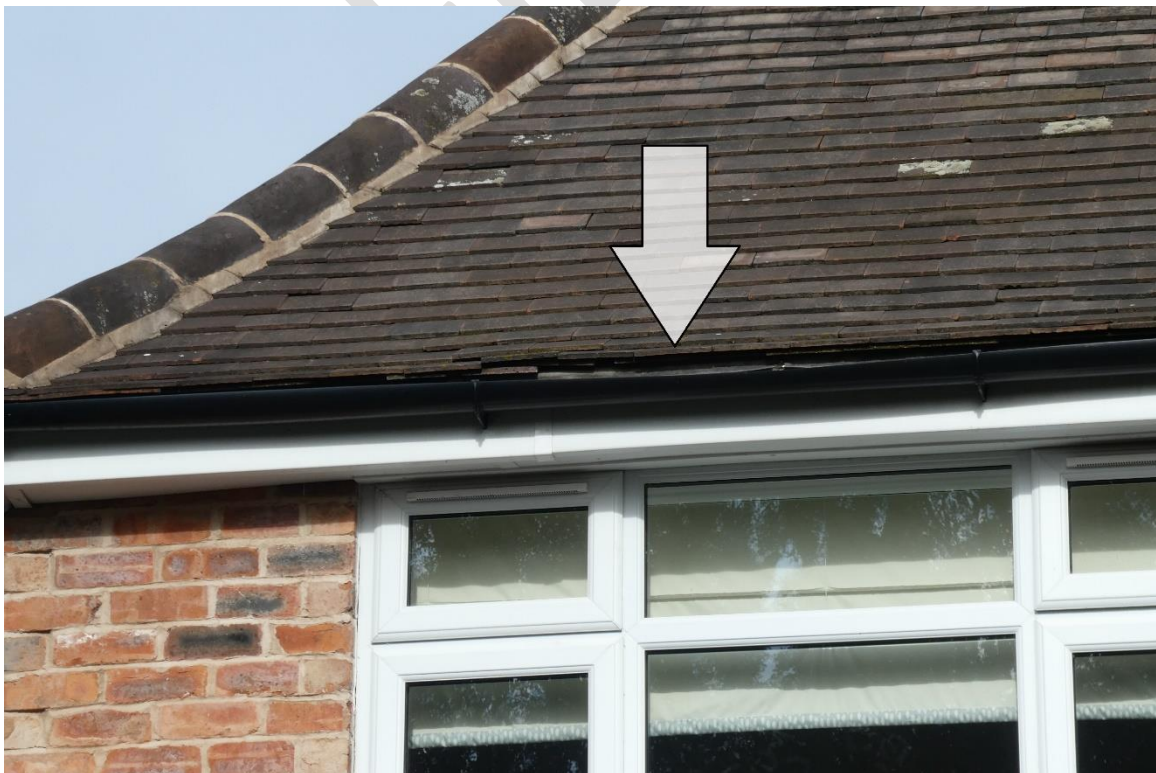
UNEVEN EAVES NEEDS TO BE CHECKED.

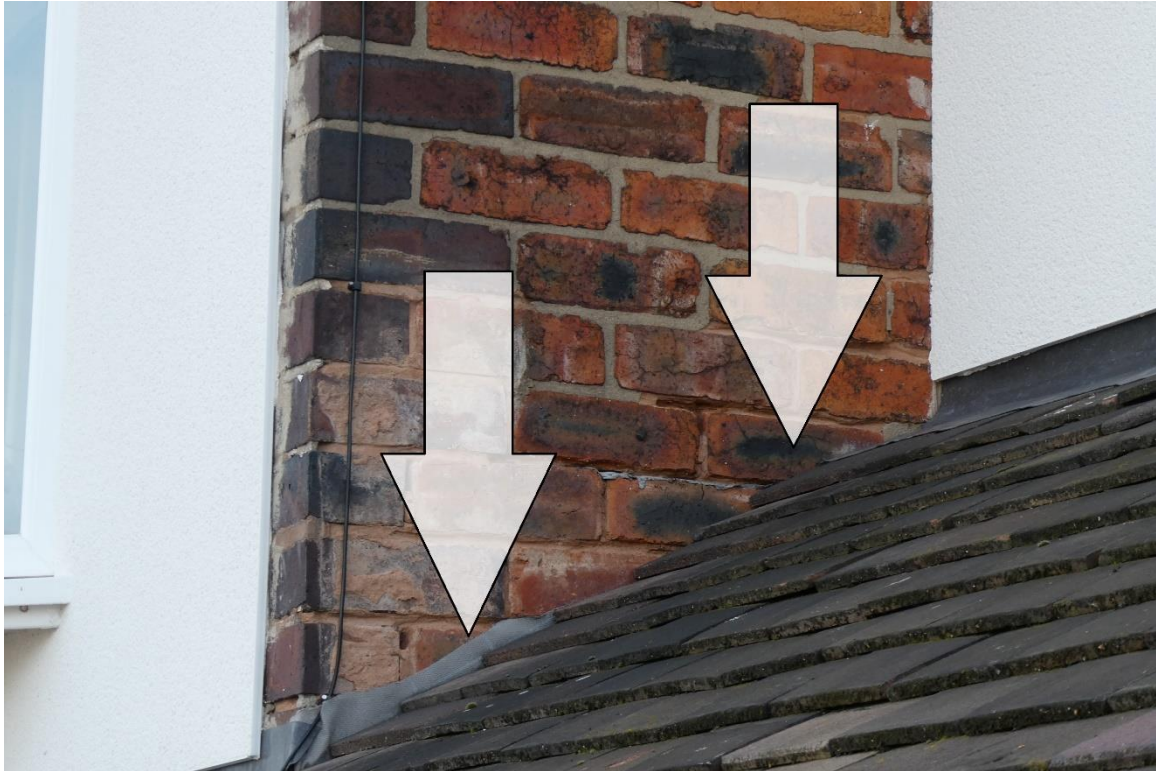
LEAD FLASHING IS MISSING.

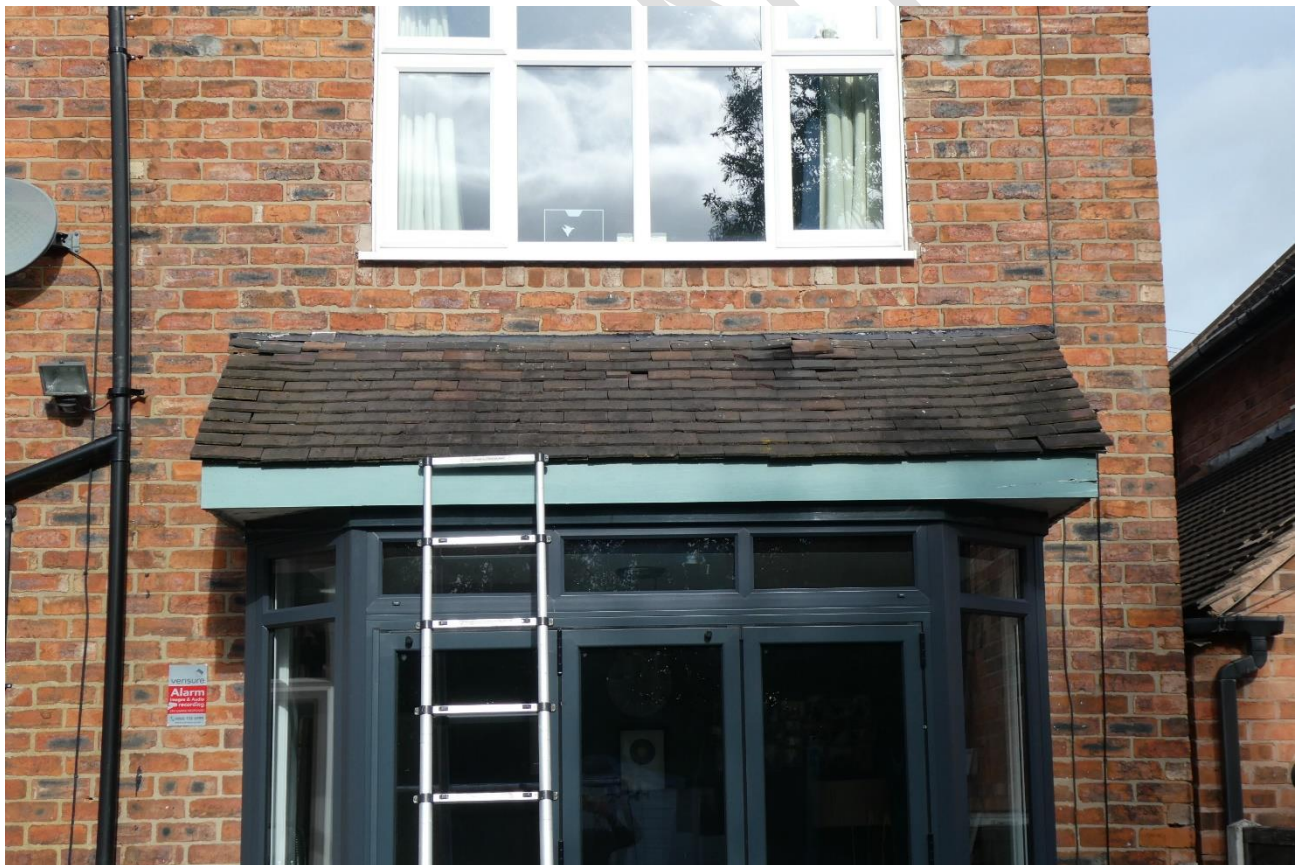
Rear reception roof finish.

3.09 This small roof is covered in original clay plain tiles. The tiles look older than those used to the other roofs and there are broken tiles.

THIS ROOF REQUIRES RENEWAL.

3.11 The roof finish should be replaced with new membrane, battens, and tiles to BS5534. The flashing to the house wall should also be replaced with lead roll.

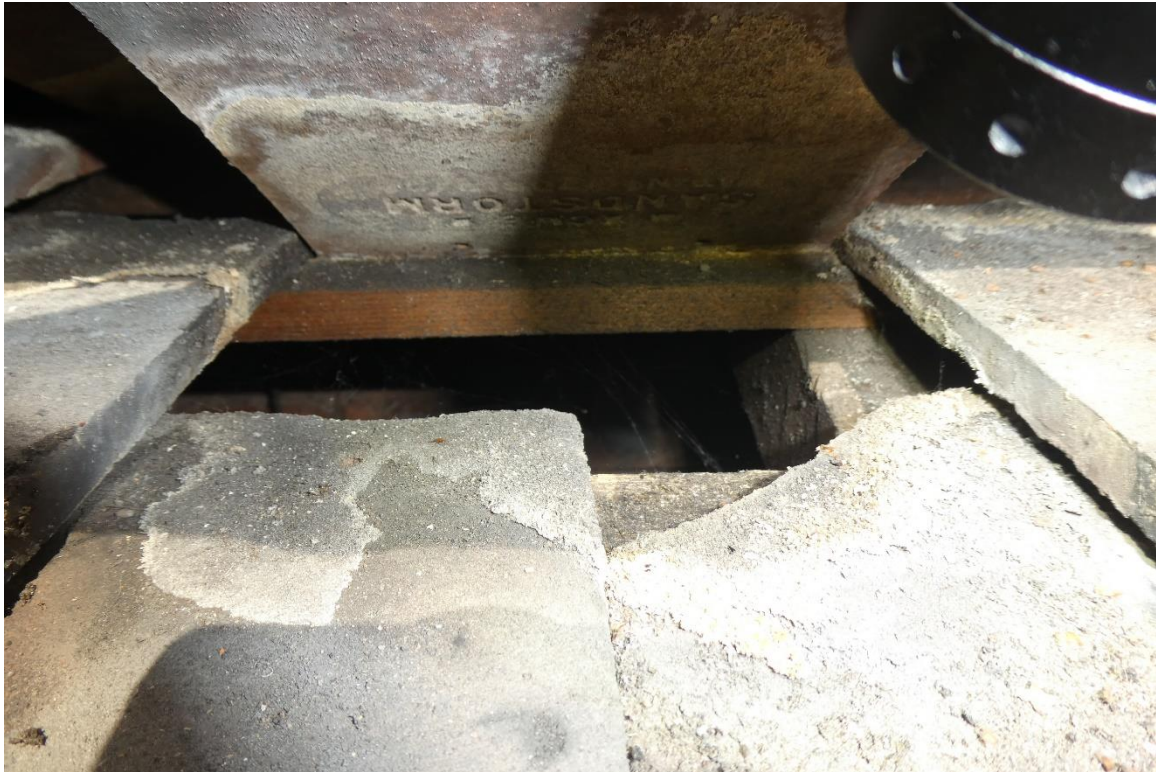
LOOKING UNDER THE TILES. THE ROOF IS UNLINED.

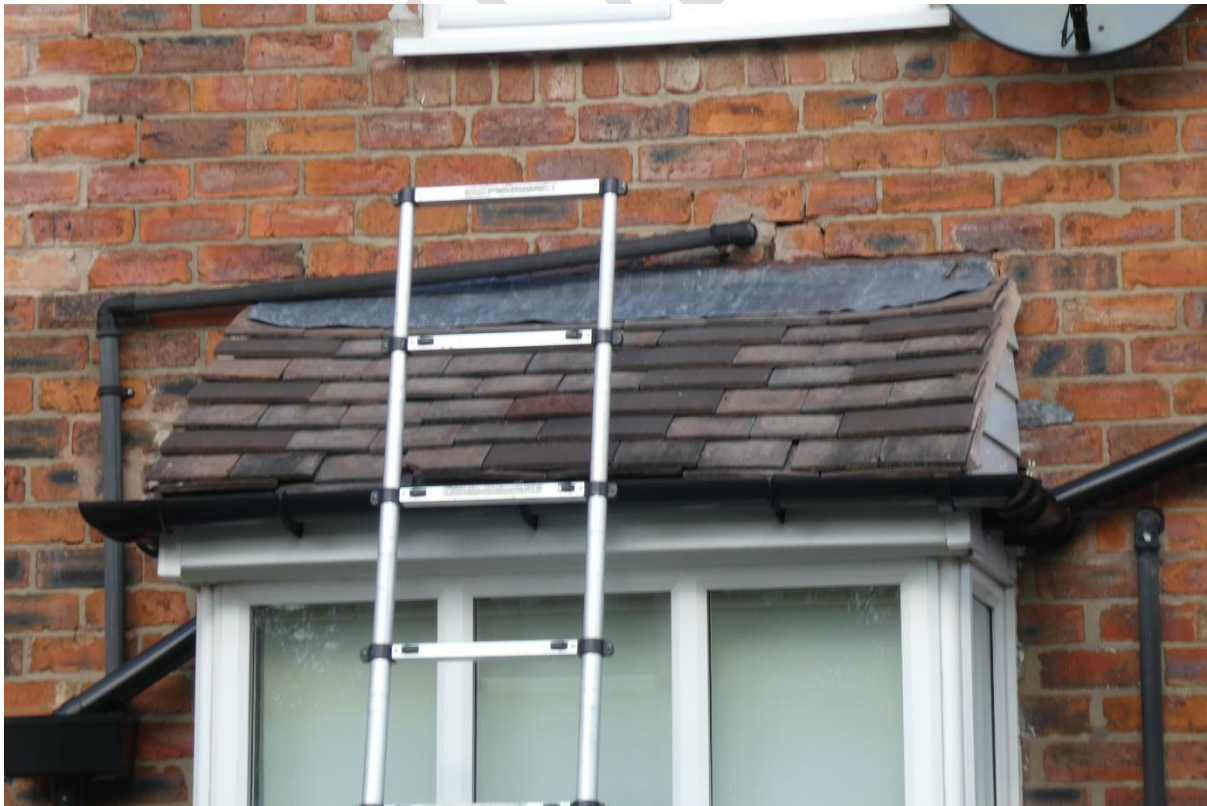
Kitchen bay roof.

THIS ROOF IS NOT ON THE PLANNING DRAWINGS.

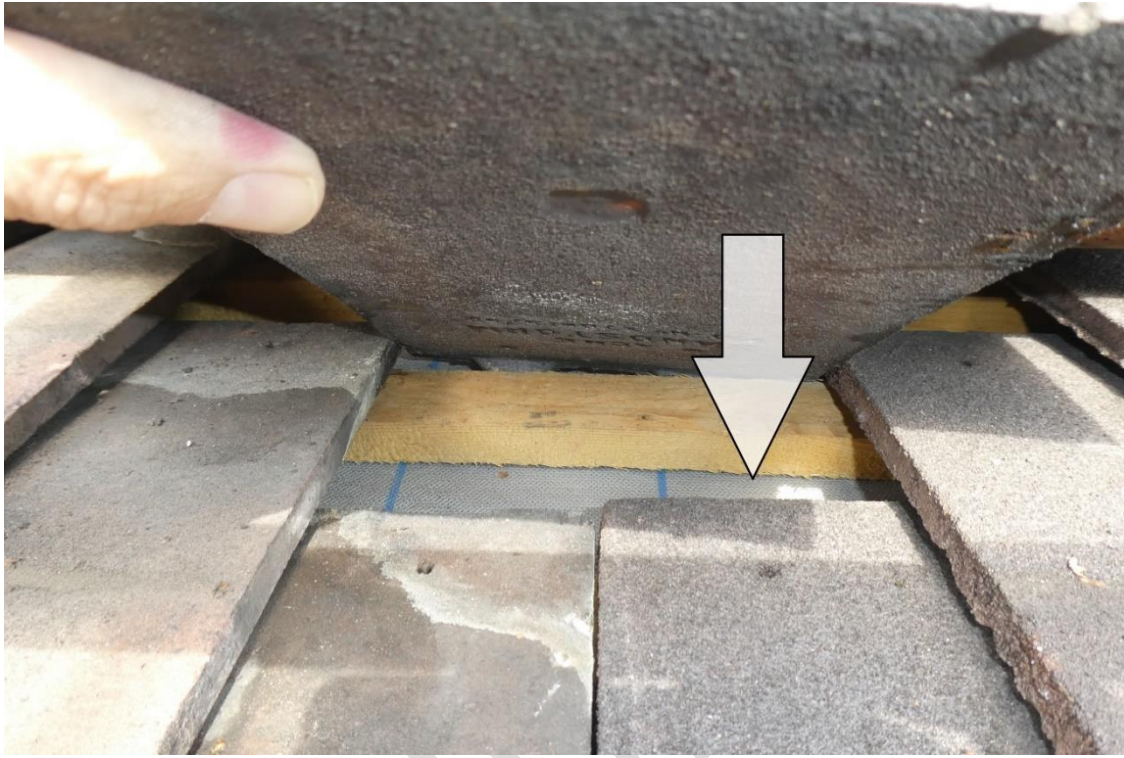
MEMBRANE CAN BE SEEN UNDER THE BATTEN. THE BATTEN LOOKS LIKE UNTREATED TIMBER WHICH IS A CONCERN.

4.02 There is a geotextile membrane to the underside of both roofs. The battens are above this membrane, so we could not see the battens. To the kitchen bay roof, we could see what looked like untreated battens. This is a concern, because if the battens used throughout are untreated, they will be subject to the dampness leaching through old tiles and will eventually rot/deteriorate. We cannot comment further.

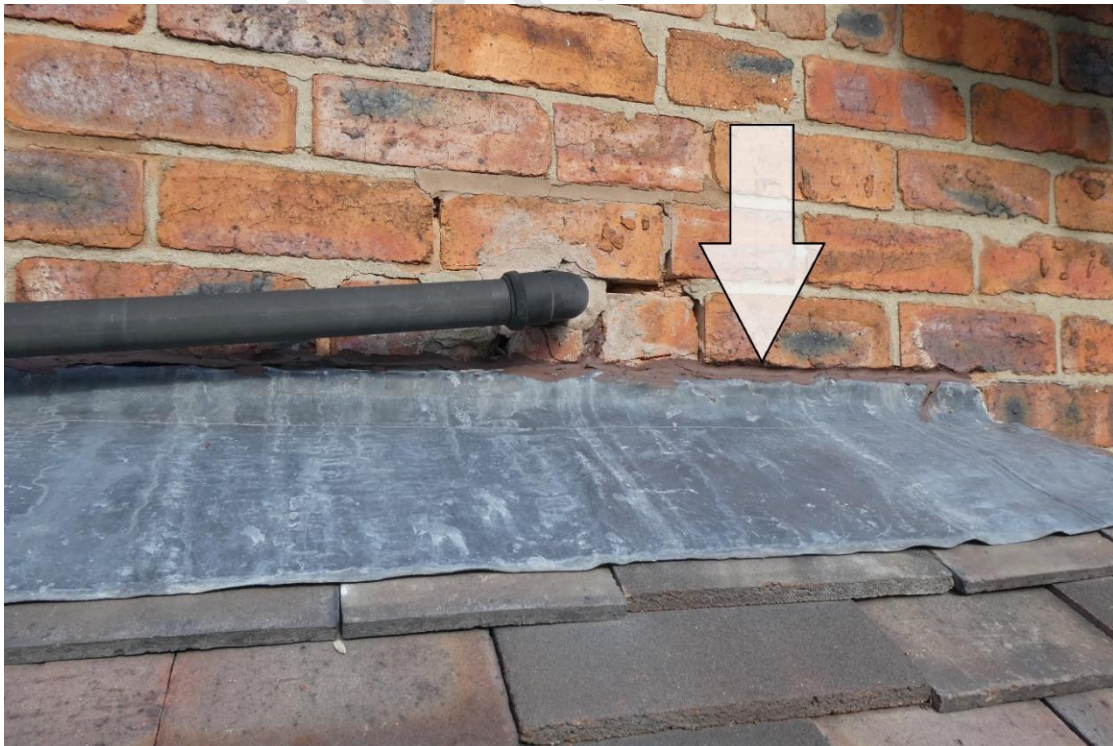
BRICK SILICONE USED TO REPOINT THE FLASHING. IT IS UNTIDY.

3.16 The flashing should be replaced with lead roll which covers the whole of the joint. It needs to be repointed correctly with silicone sealant.

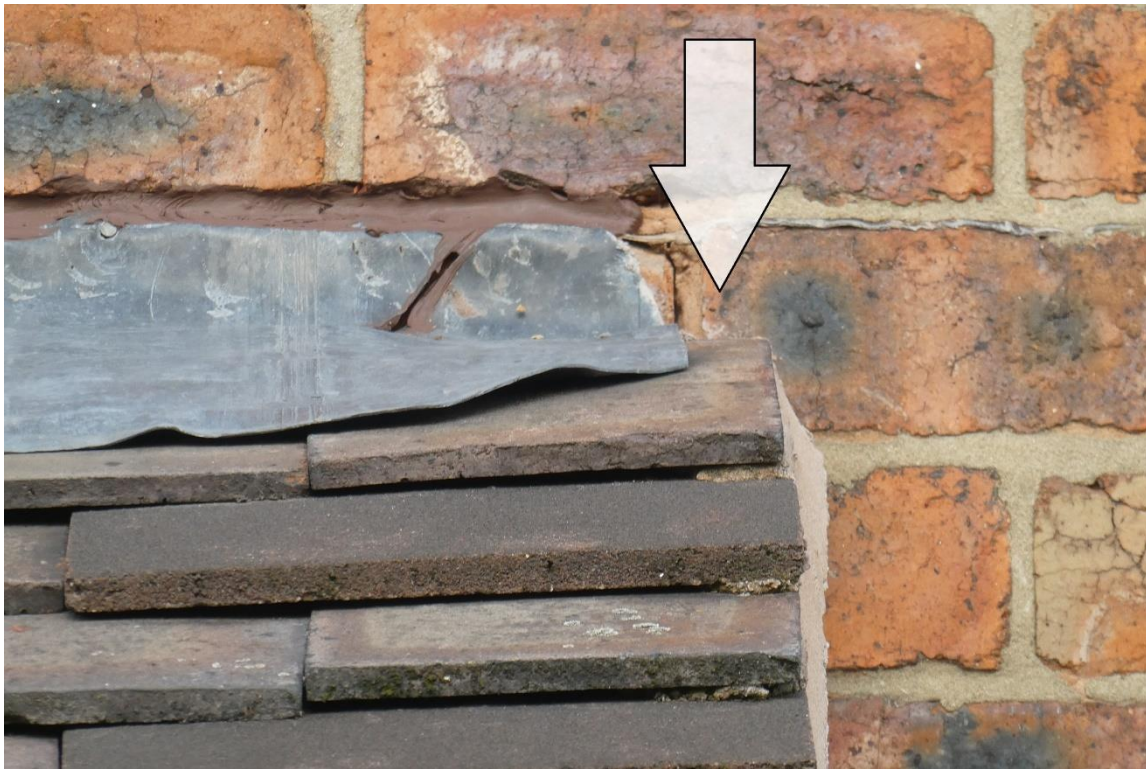
FLASHING IS TOO SHORT.

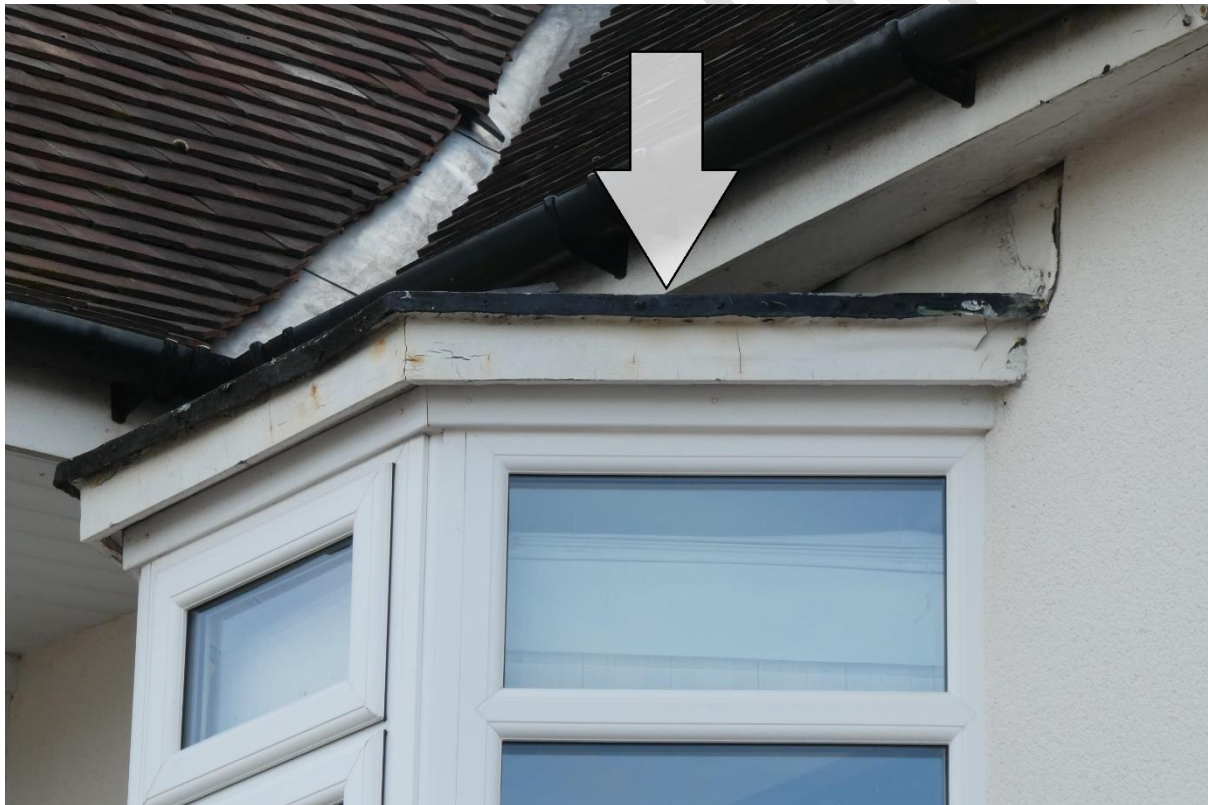
Front small bedroom bay roof.

3.20 There were no signs of leakage within the bedroom, but the material is now very old, and you should budget for renewal or covering in EPDM. Again, a quotation should be obtained.

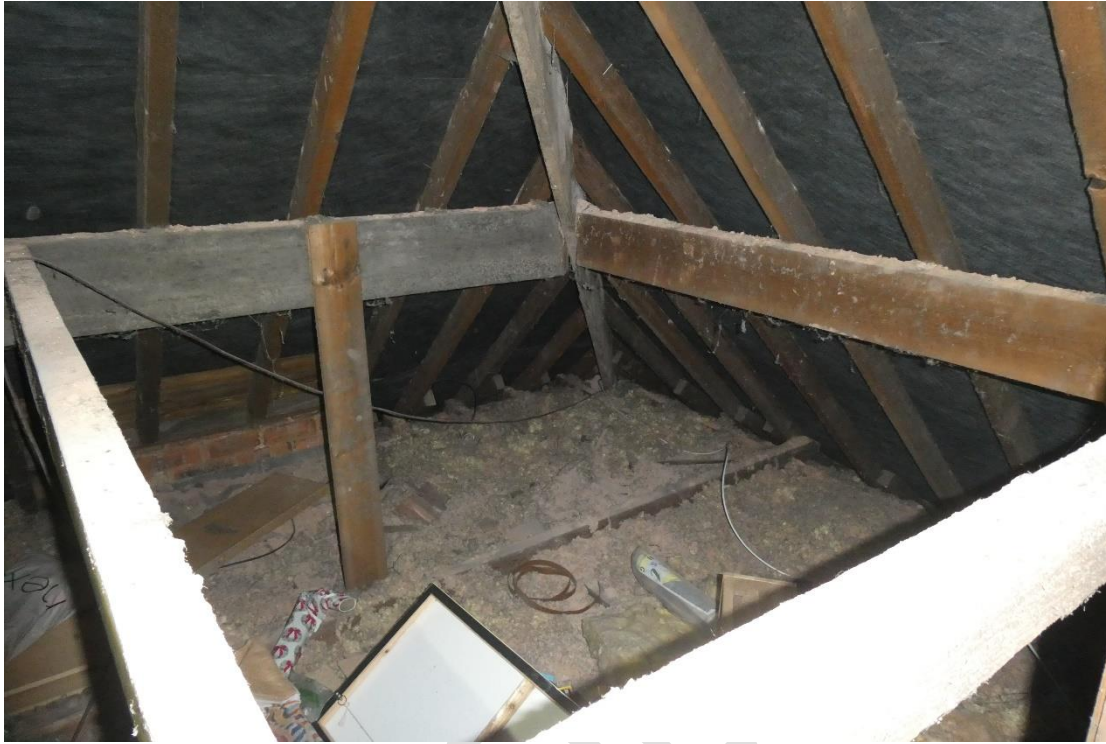
4.07 There is little insulation to both floors, and this is unusual to the extension as it should comply with building regulations. Current recommendations are a minimum of 270mm. The complete loft would benefit from the removal of the boards and a uniform 300mm of insulation.

ORIGINAL REAR LEFT-HAND CORNER. NOTE HOW LITTLE INSULATION IS IN PLACE.

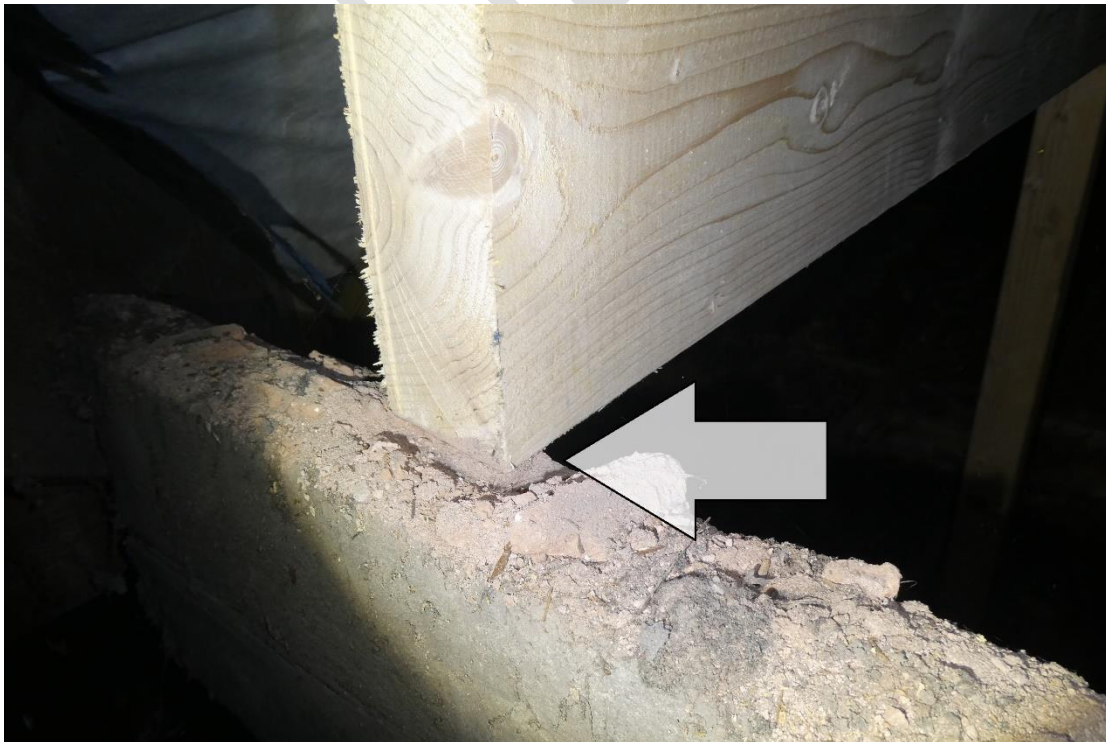
5. The rear purlin is only just resting on the original side purlin. The front purlin is not even resting upon the other end of the original purlin; it is resting up in the air supported by one small prop and another near the hip timber. The roof structure appears below the standard that we would expect to see, and the vendor confirmed that there was not a Structural Engineer involved in either the design or the construction. It is our opinion that the roof structure has not been formed to the standard that it should have been. We recommend:

REAR PURLIN JUST SITS UPON THE ORIGINAL SIDE PURLIN.

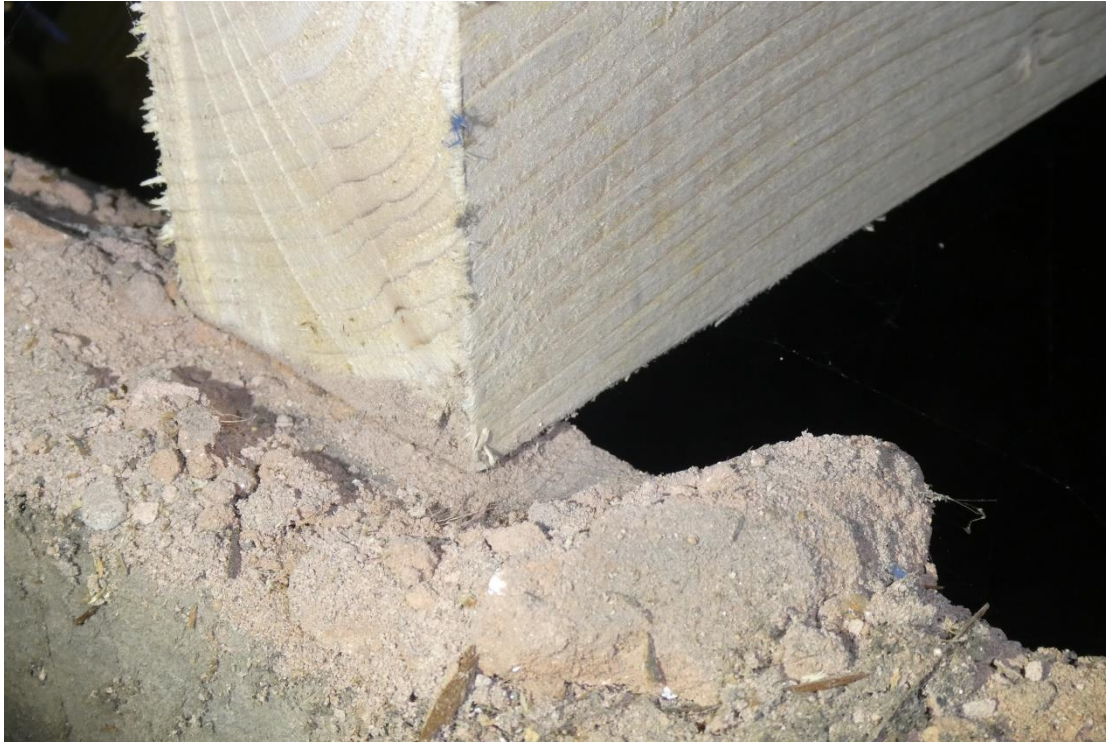
REAR PURLIN JUST SITS UPON THE ORIGINAL SIDE PURLIN.

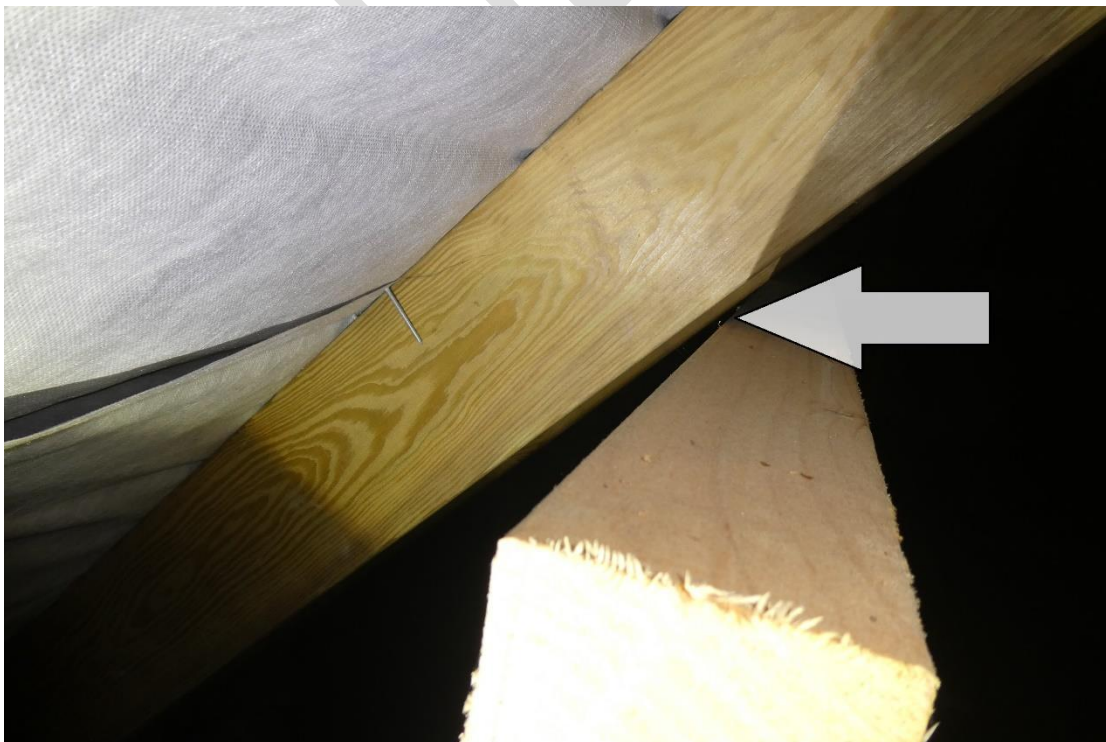
3. The purlins appear to be simply supported on vertical props without any form of restraint/fitting into the hip timbers and the original side purlin. We also noted that at least one rafter does not meet the purlin and there is a gap. This means that the purlins are effectively held in place by the small number of props and may be providing very little support to the rafters and theoretically, the roof could spread.

AIR GAP BETWEEN THE REAR PURLIN AND ONE RAFTER.

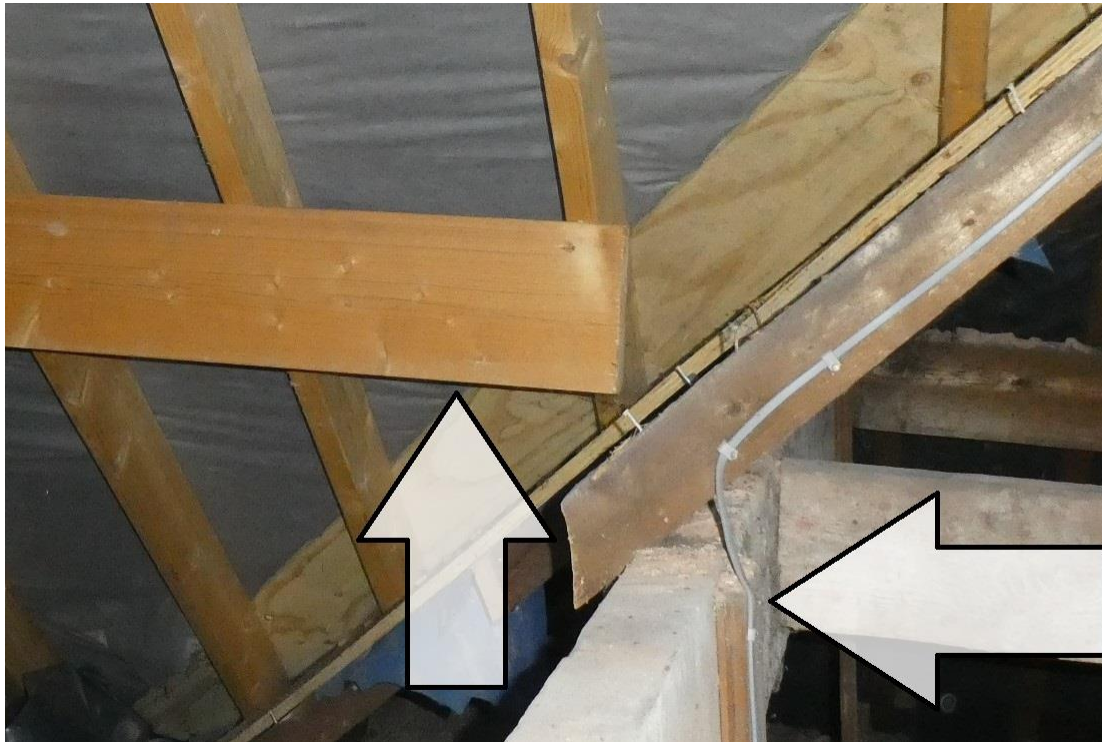
APART FROM TWO SMALL PROPS THE FRONT PURLIN IS HANGING IN THE AIR. IT SHOULD BE RESTING ON THE ORIGINAL SIDE PURLIN.

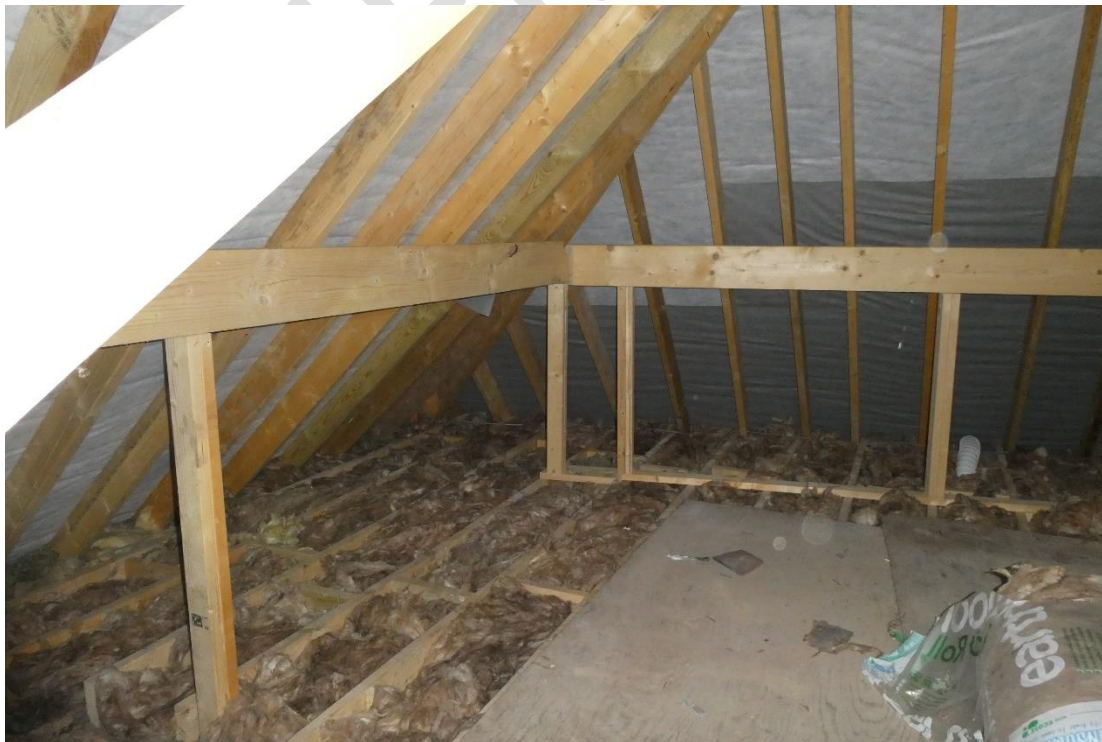
LOOKING ACROSS TO THE SIDE OF THE EXTENSION. NOTE HOW LITTLE INSULATION IS ON THE FLOOR. THE VERTICAL PROPS APPEAR TO BE ALL THAT ARE HOLDING THE PURLINS IN PLACE.

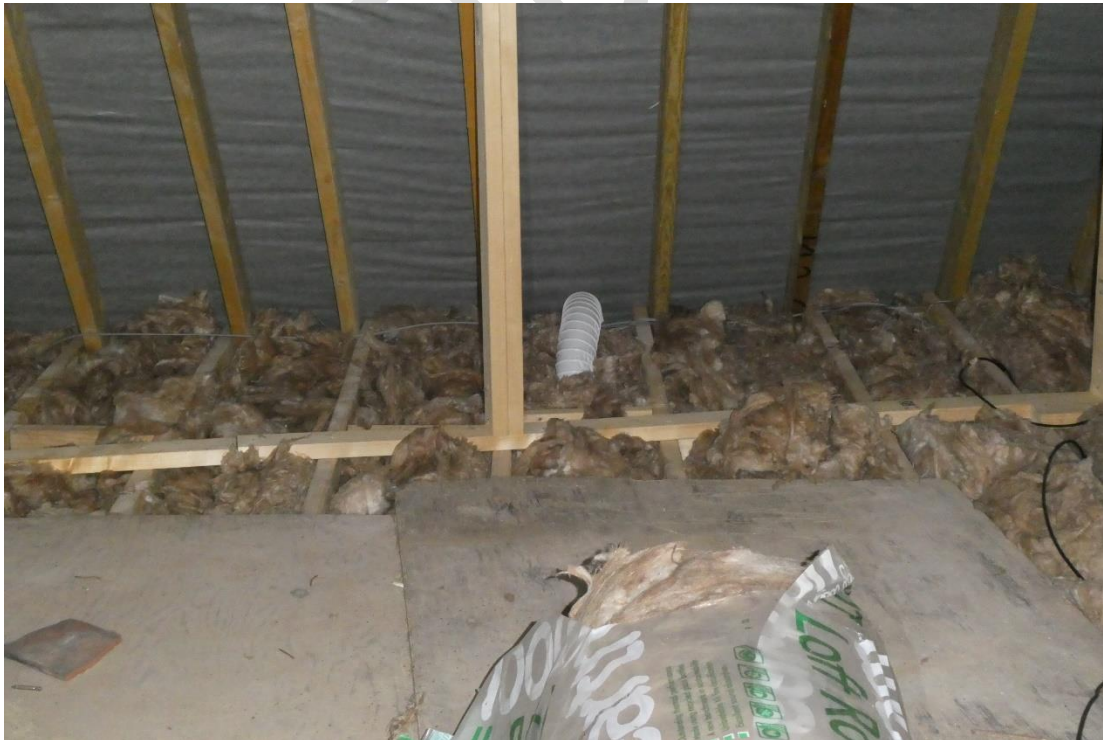
4.08 We noted extractor fans discharging into the roof space and the eaves. The extractor ducts must discharge to outside air. These should be fitted to proprietary roof tiles.

ENSUITE EXTRACTOR FAN DISCHARGING INTO THE EAVES.

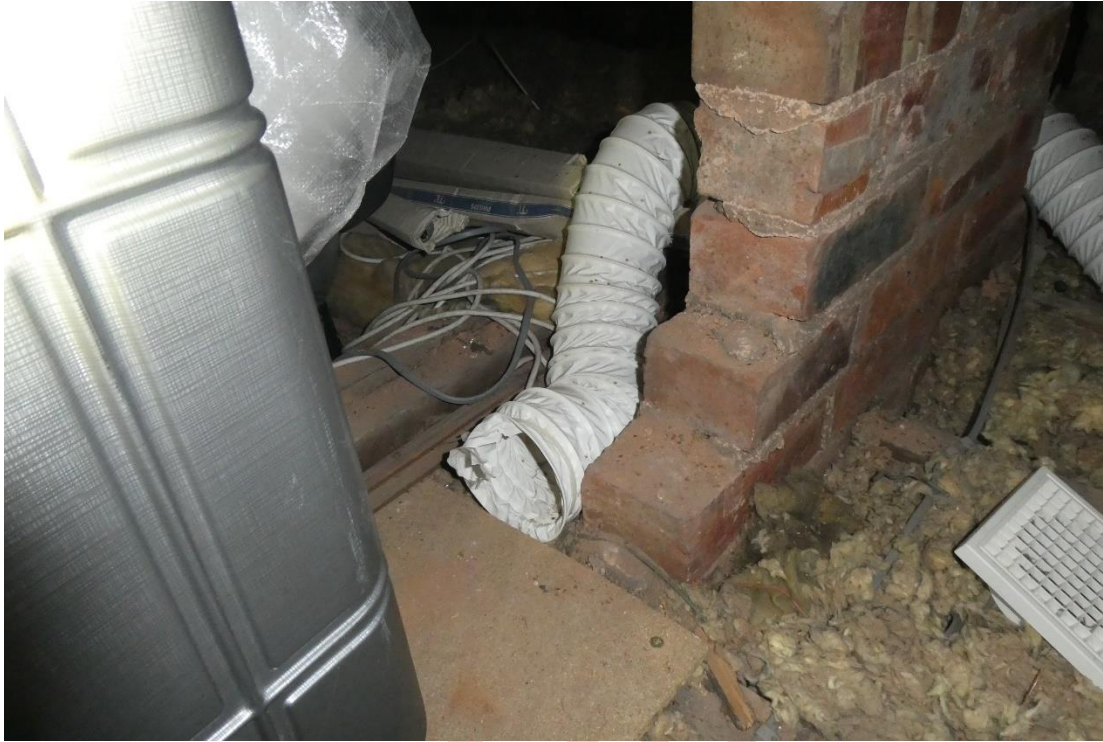
BATHROOM EXTRACTOR FAN DISCHARGING INTO THE ROOF SPACE.

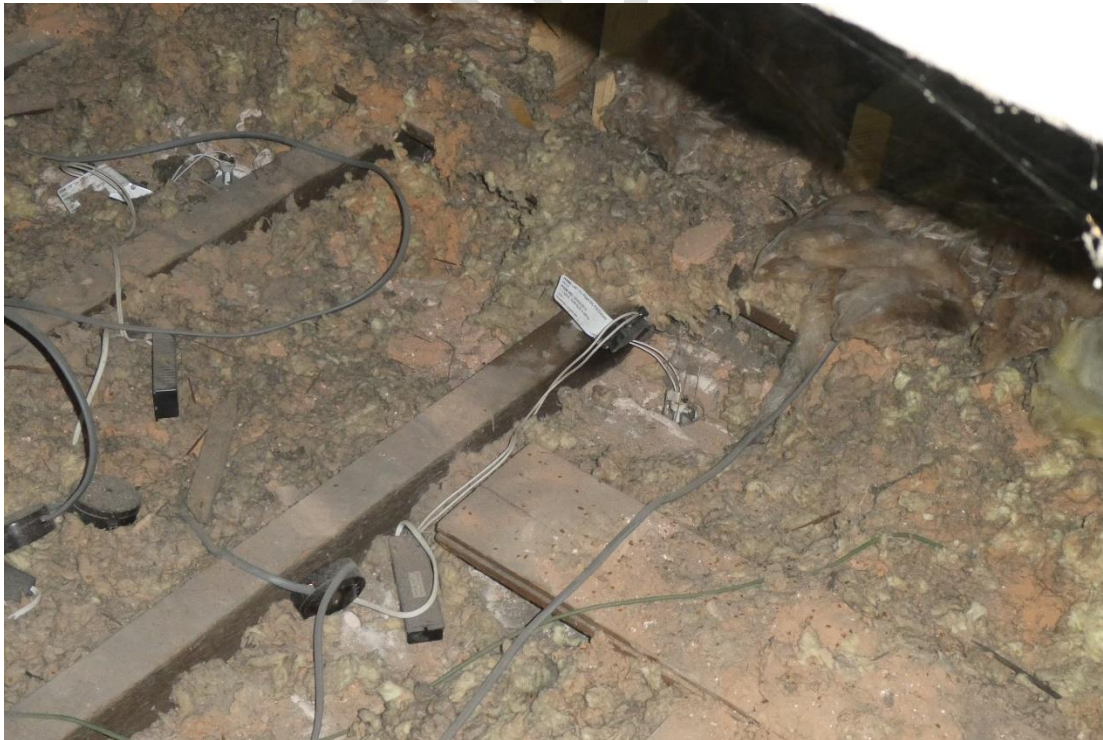
4.10 Downlighter to the bathroom are not fire-rated. All downlighters should be checked and replaced with fire-rated units to ensure the fire integrity of each ceiling.

NON-FIRE RATED DOWNLIGHTERS ABOVE THE BATHROOM. THE ELECTRIC CABLES LOOK OLD.

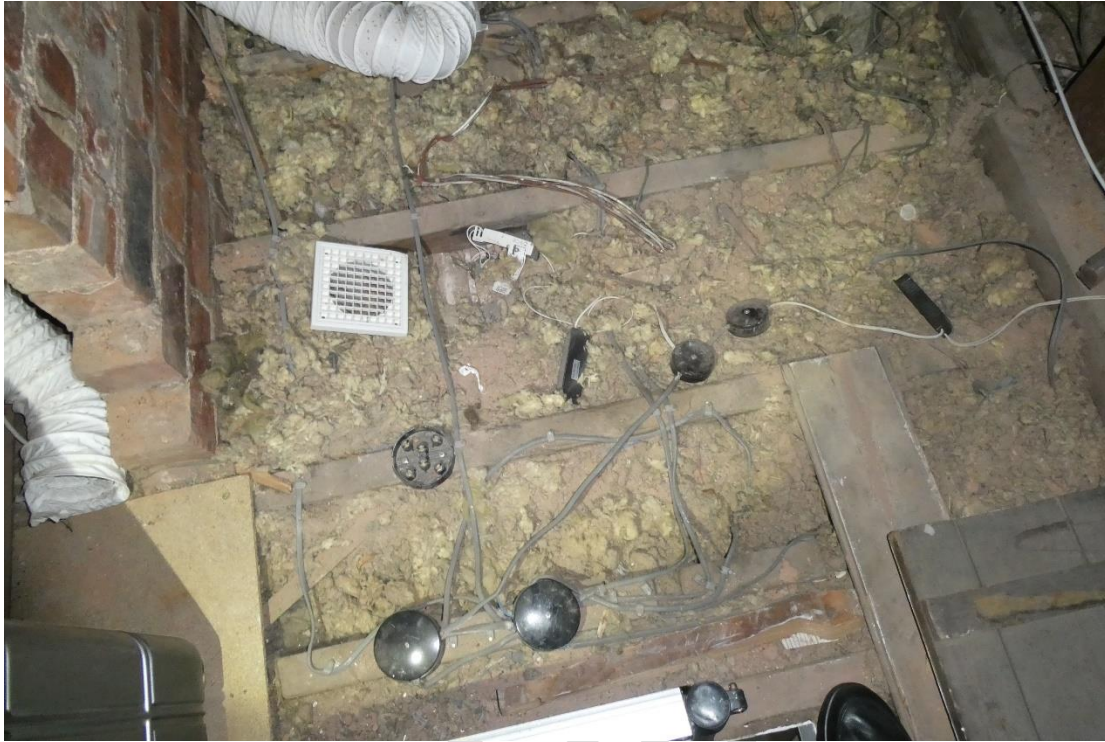
THE ELECTRIC CABLES LOOK OLD.

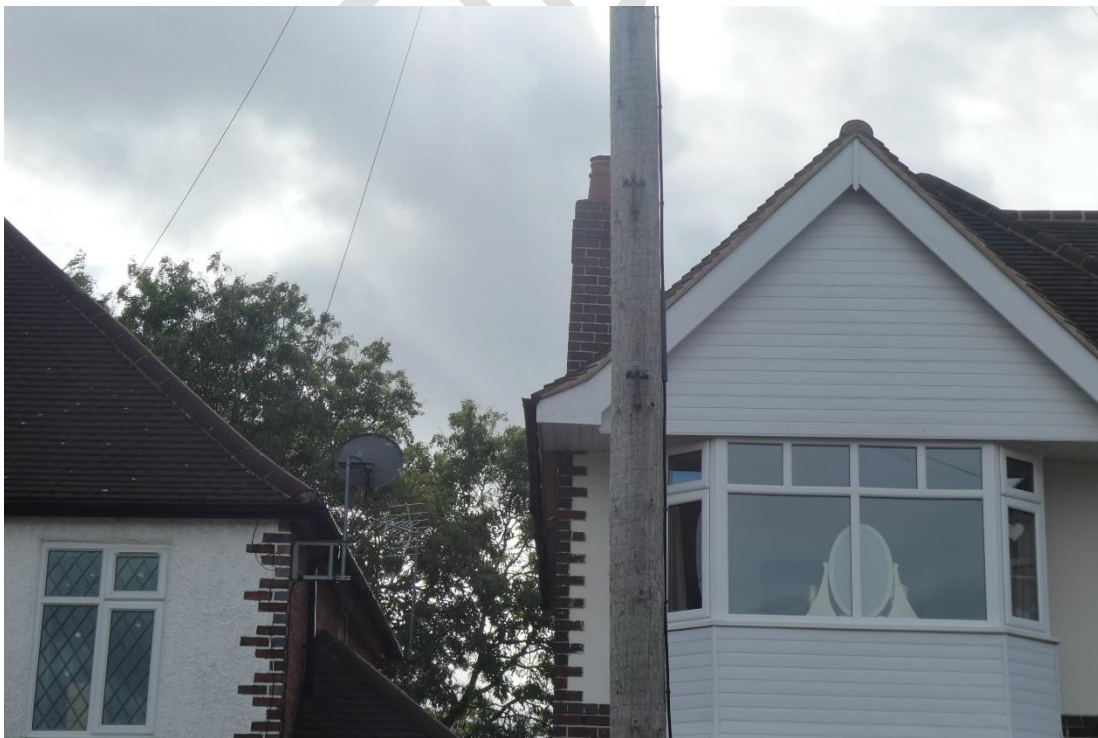
LEAN TO FRONT SIDE CHIMNEY STACK AGAINST THE REASONABLY VERTICAL TELEGRAPH POLE.
