BUILDING SURVEY

BUILDING SURVEY FOR *****

Date of Survey: *****

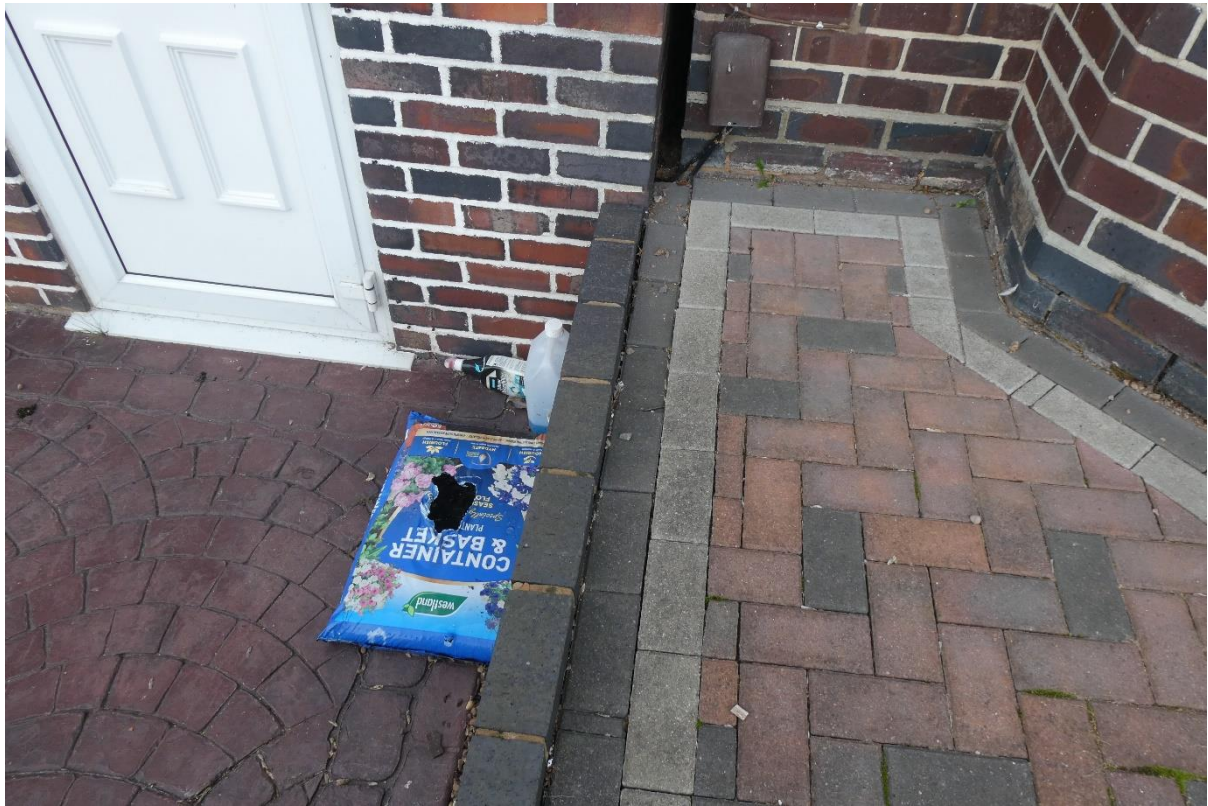
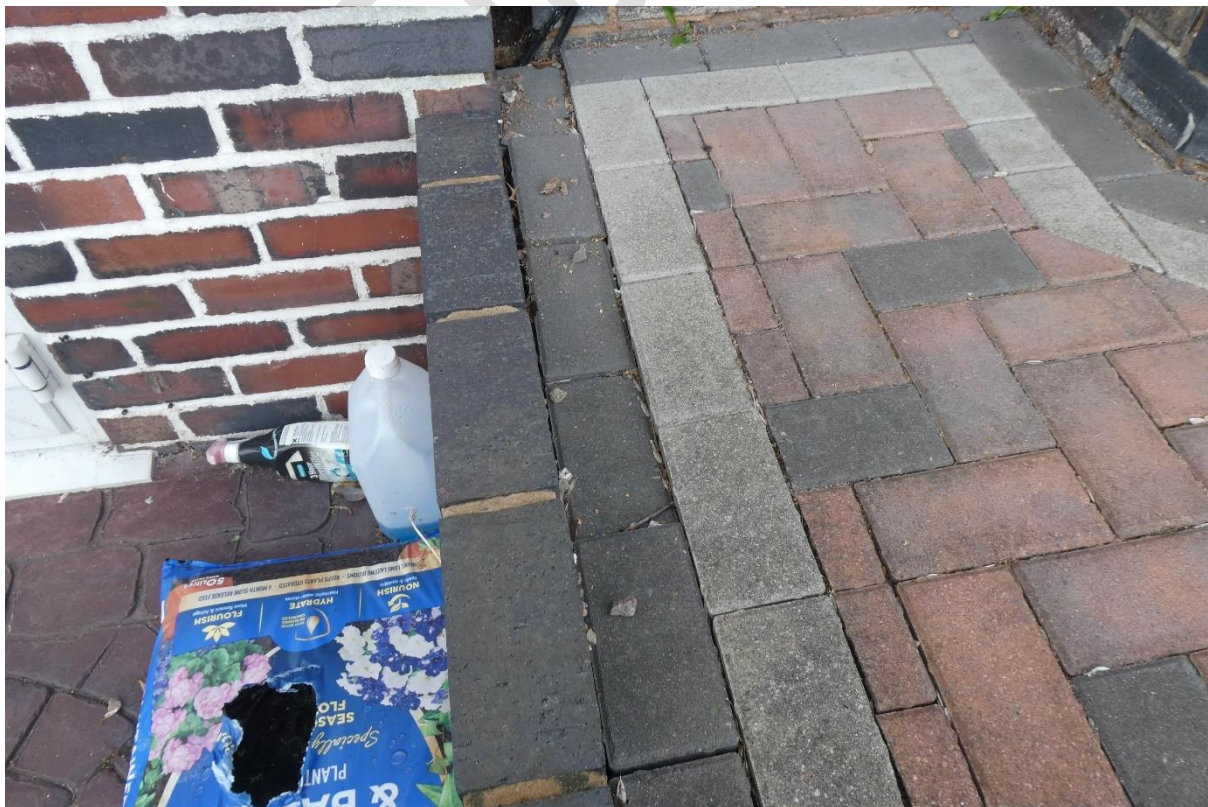
BLOCKS HAVE SUNK HERE AND THERE IS A GAP AGAINST THE WALL.

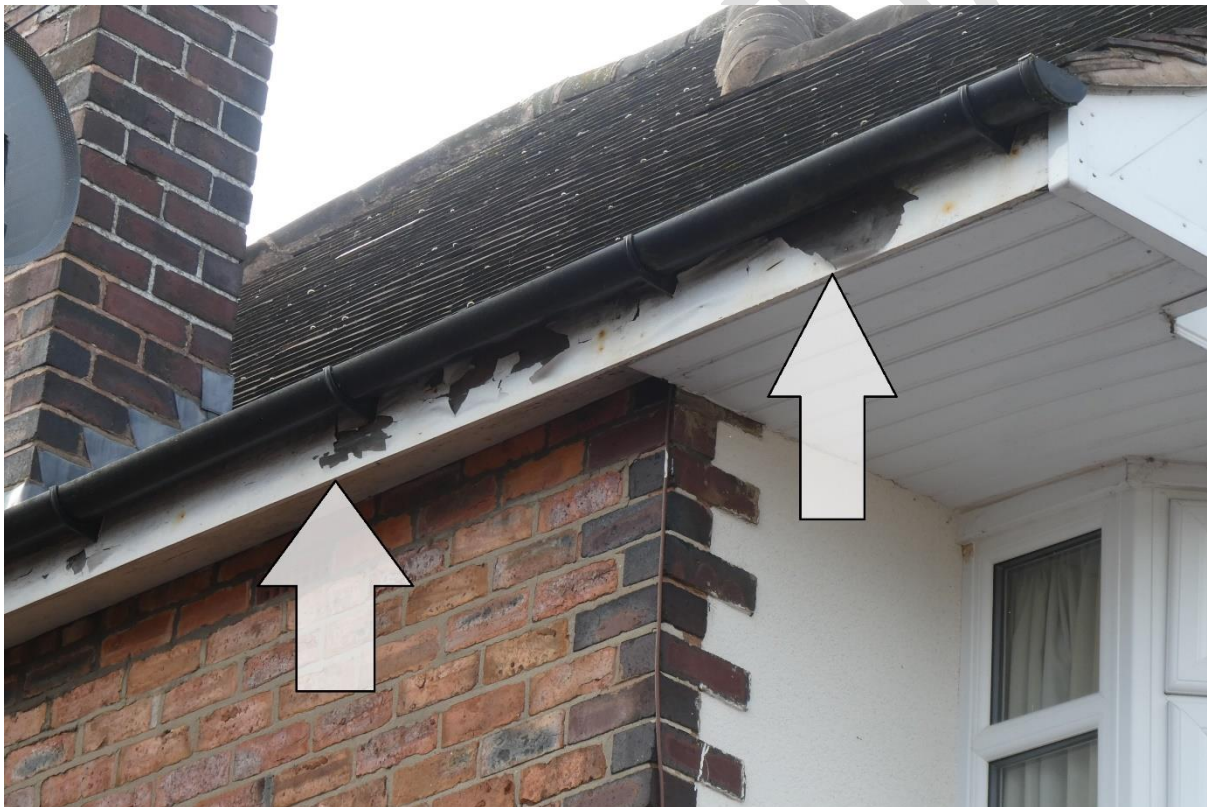
7.01 To the original house, the fascia and soffit boards are a mixture of original softwood and UPVC board without a vent. The softwood boards have not been maintained/painted for many years and all sections require attention prior to redecoration. This will require scaffold/tower access

ORIGINAL FASCIA/SOFFIT IN DISREPAIR.

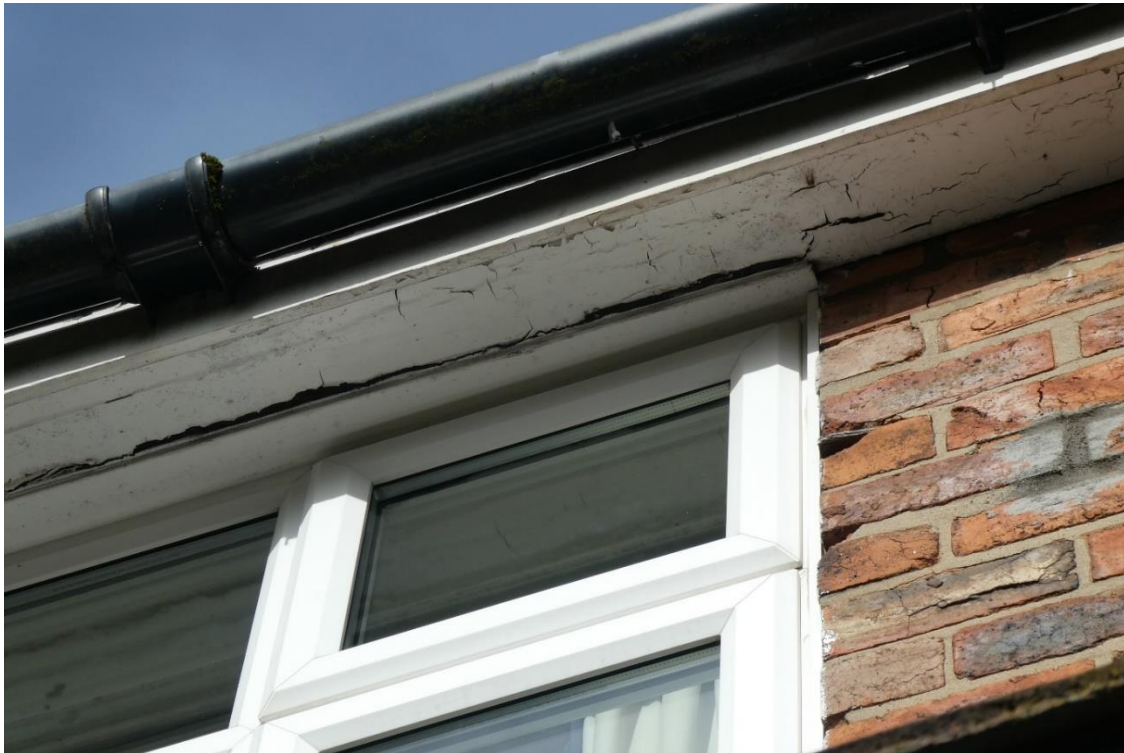
SOFFIT BOARD IN POOR CONDITION.

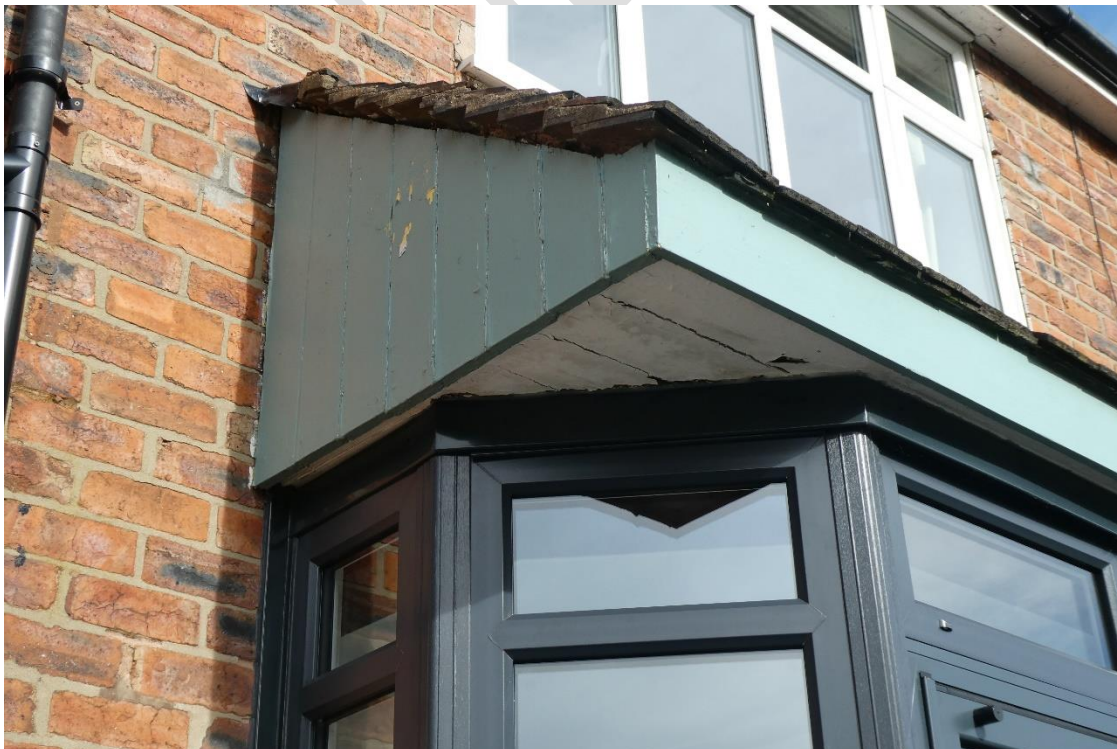
SOFFIT BOARD AND GABLE BOARD REQUIRE ATTENTION/REDECORATION.

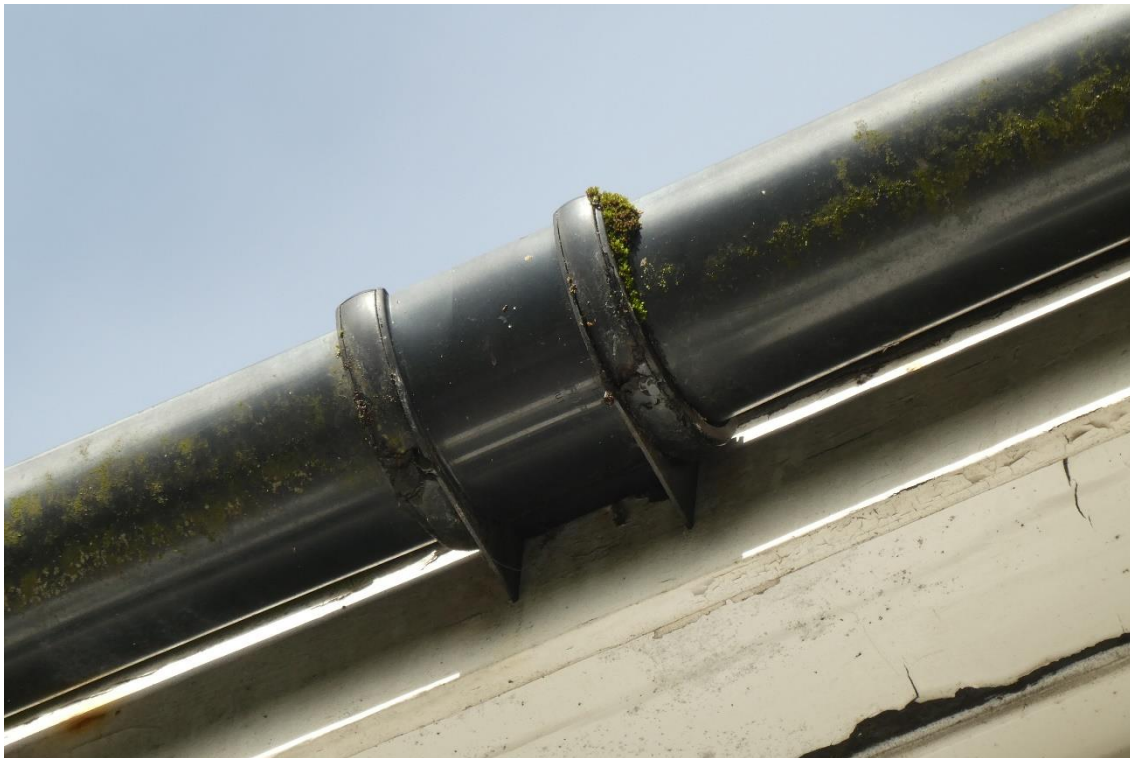
1. The original installation was not renewed with the extension. We noted leaking joints to the rear and left-hand side. All leaking joints should be replaced.

MOSS CAN BE SEEN TO THE LEAKING JOINT TO ORIGINAL SECTION AT THE REAR.

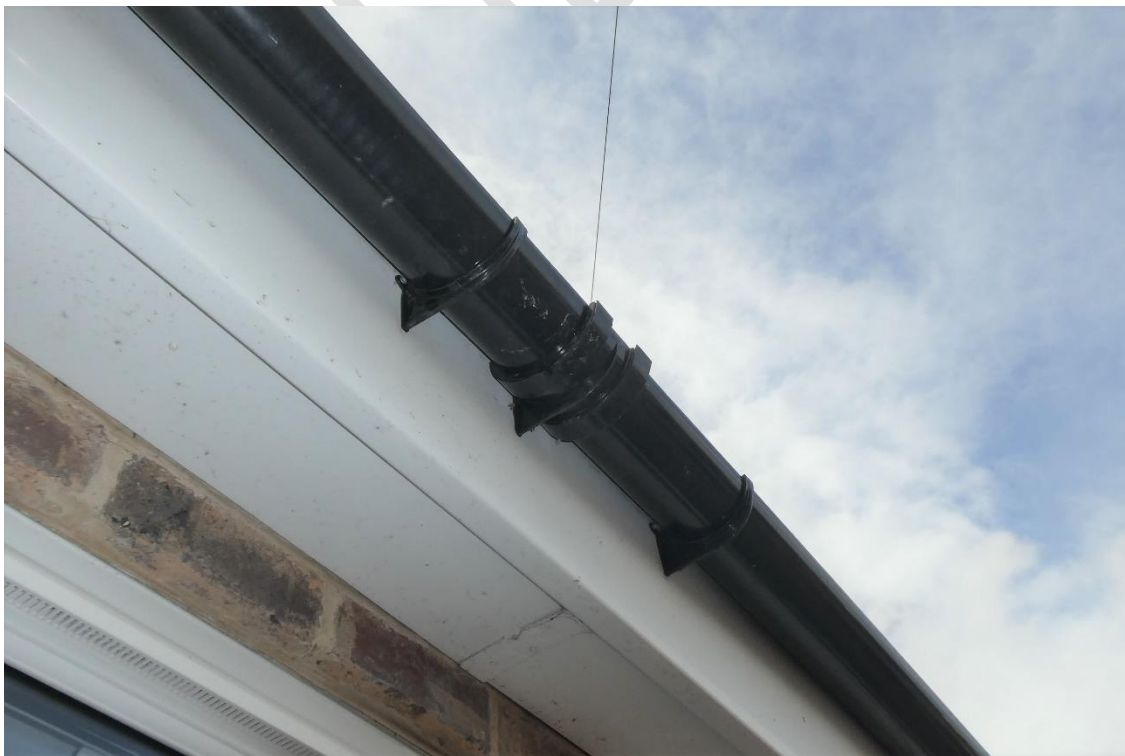
2. There is leakage on the joint above the family room window. This is dampening the brickwork and should be replaced.
3. Stormwater discharge should be checked to the front channel. The channel was full of detritus/leaf litter. It needs to be cleared.

LEAKING JOINT ABOVE FAMILY ROOM.

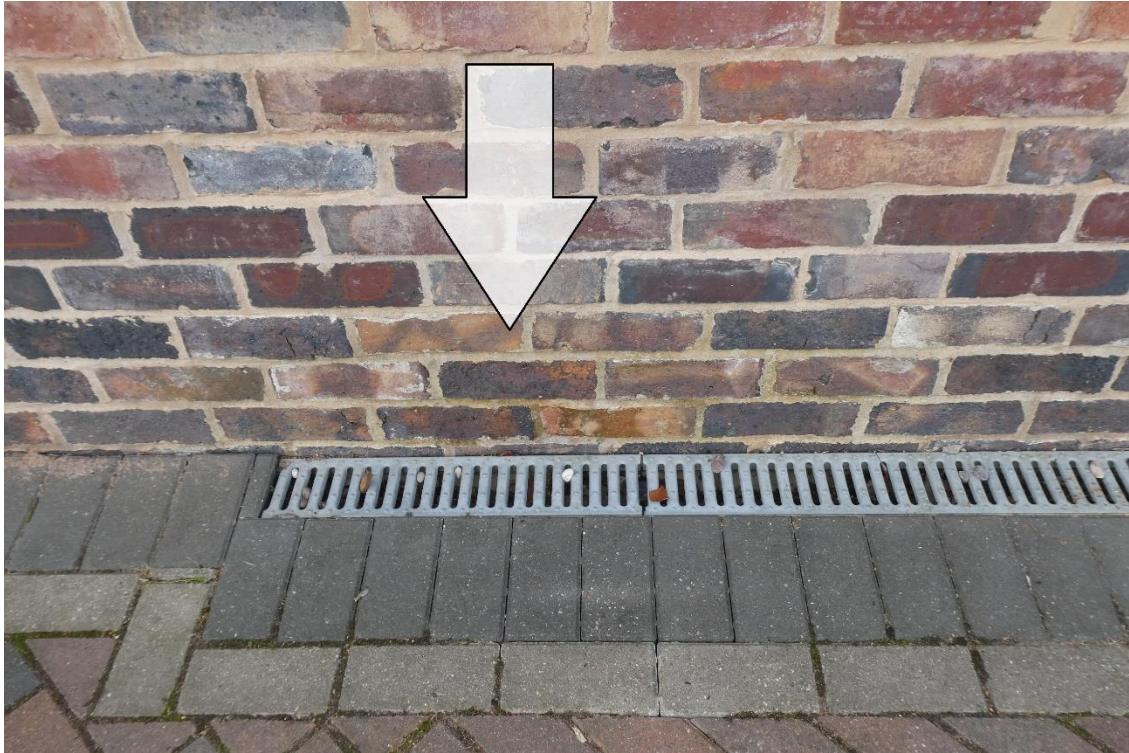
DAMP BRICKWORK.

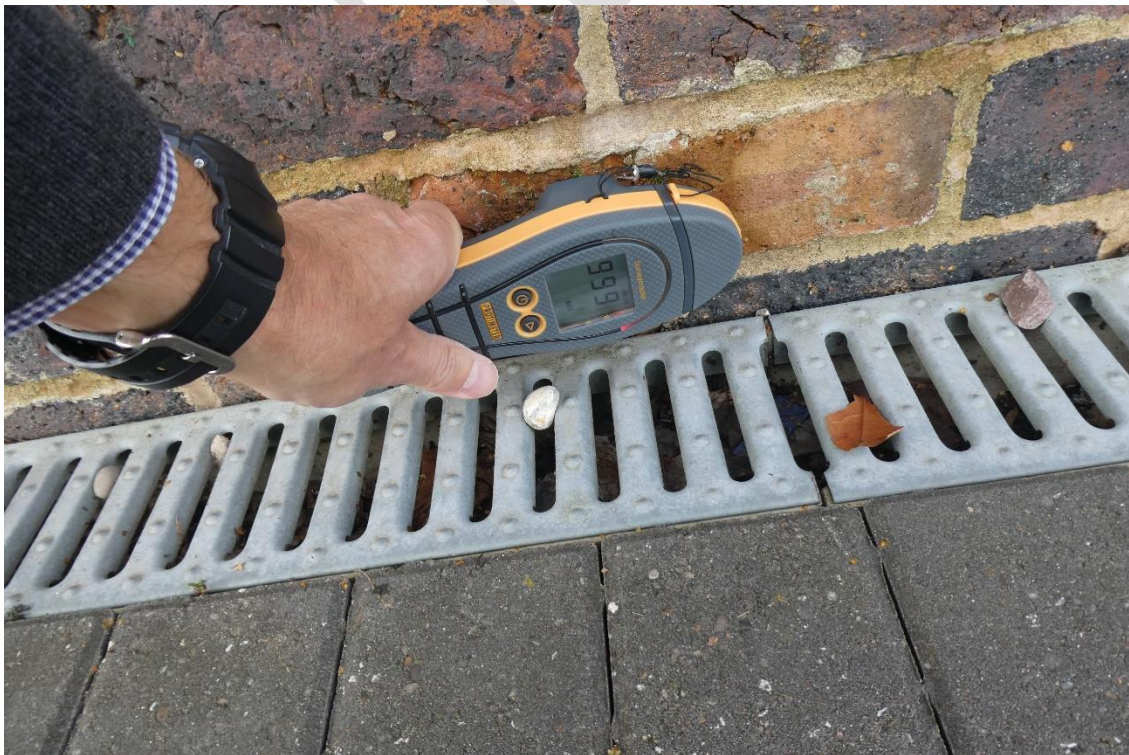
999 IS THE MAXIMUM DAMP READING.

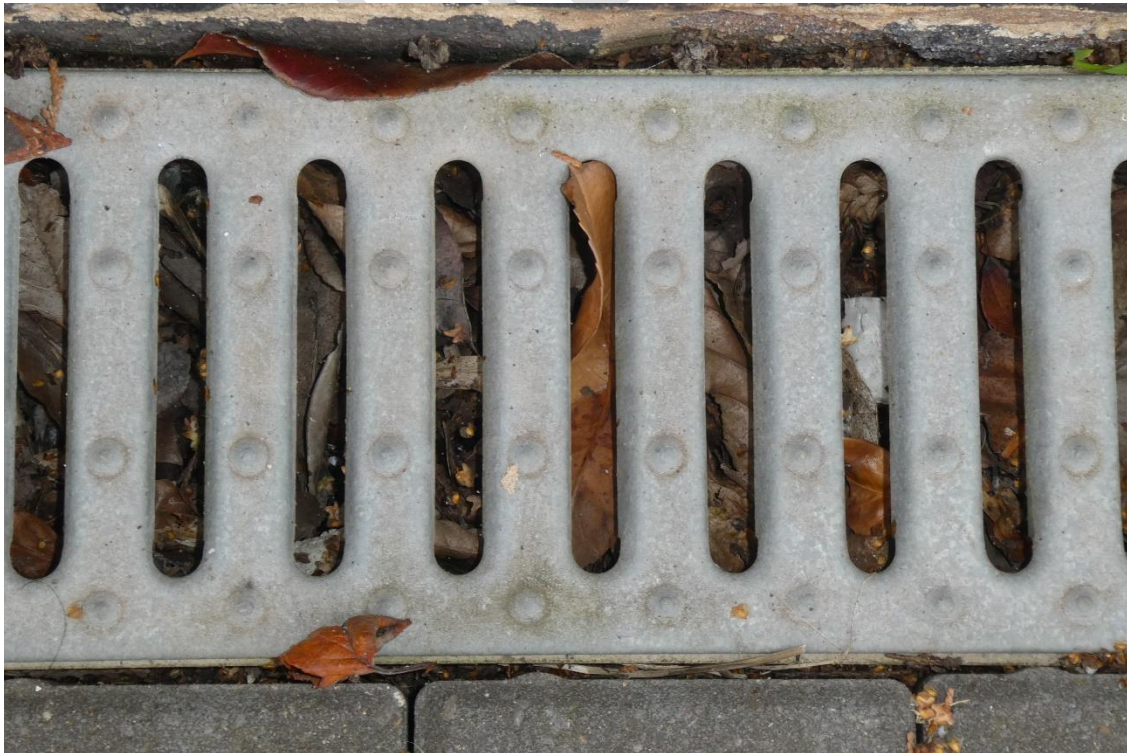
CHANNEL NEEDS TO BE CLEARED.

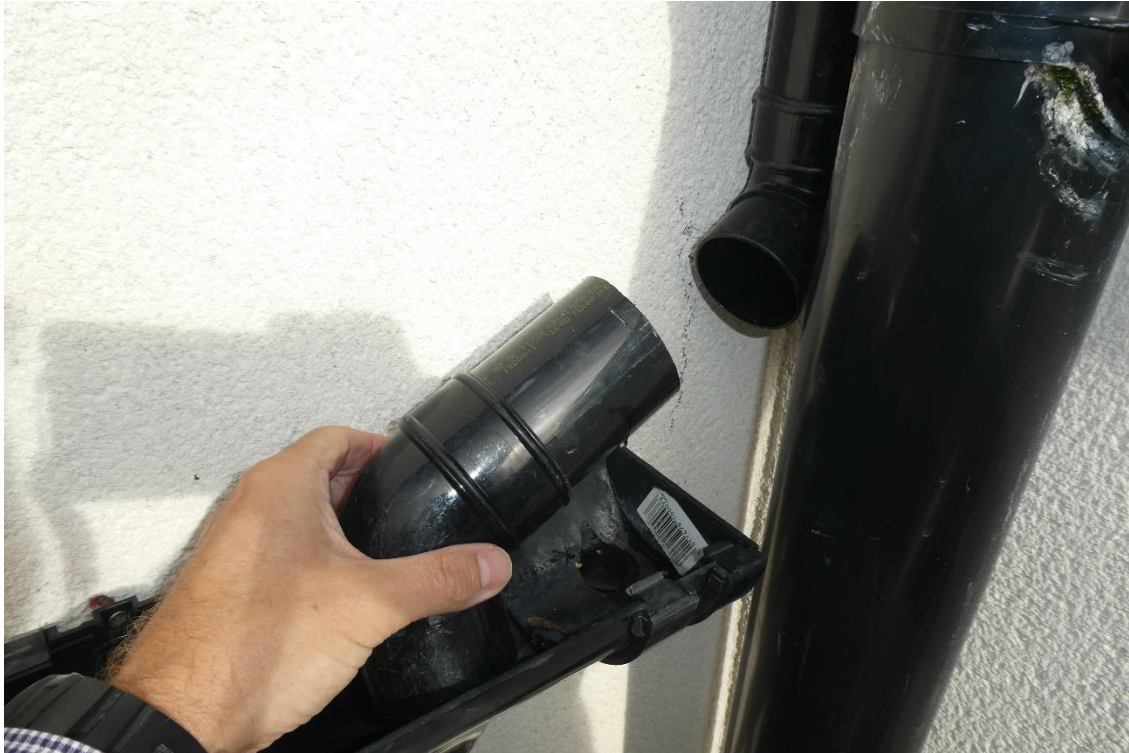
DOWNPIPE SHOE IS LOOSE.

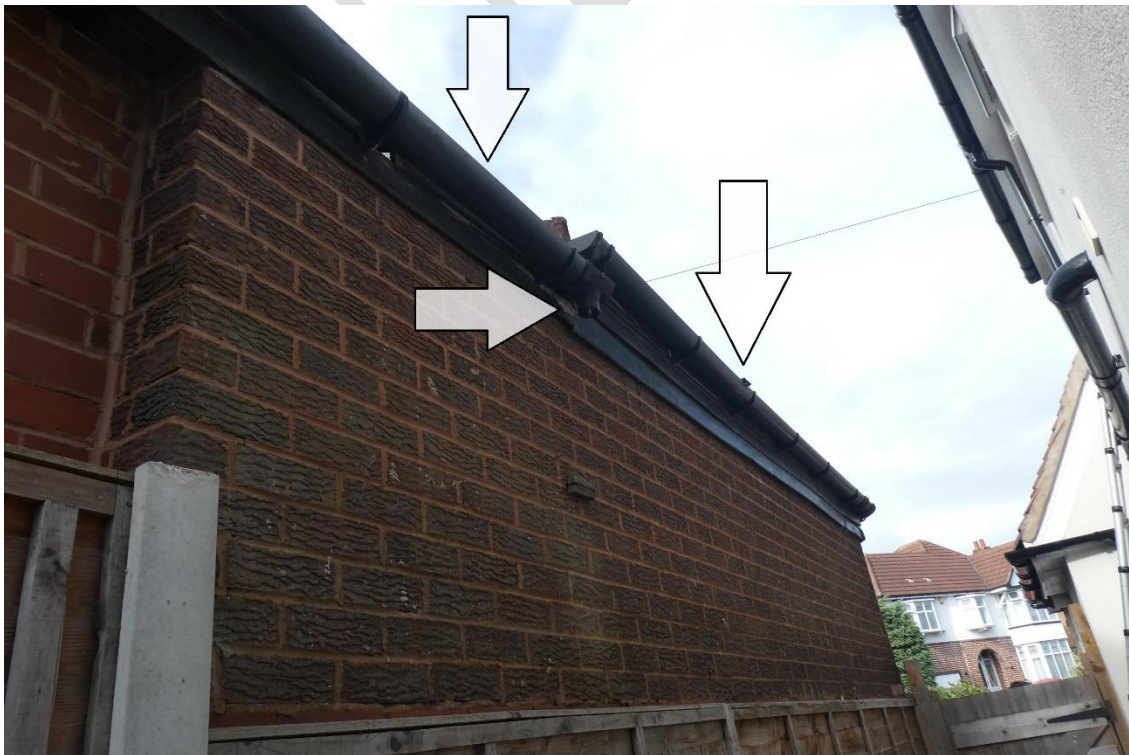
NEIGHBOUR'S OVERSAILING GUTTER AND OUTLET WITHOUT A DOWNPIPE.

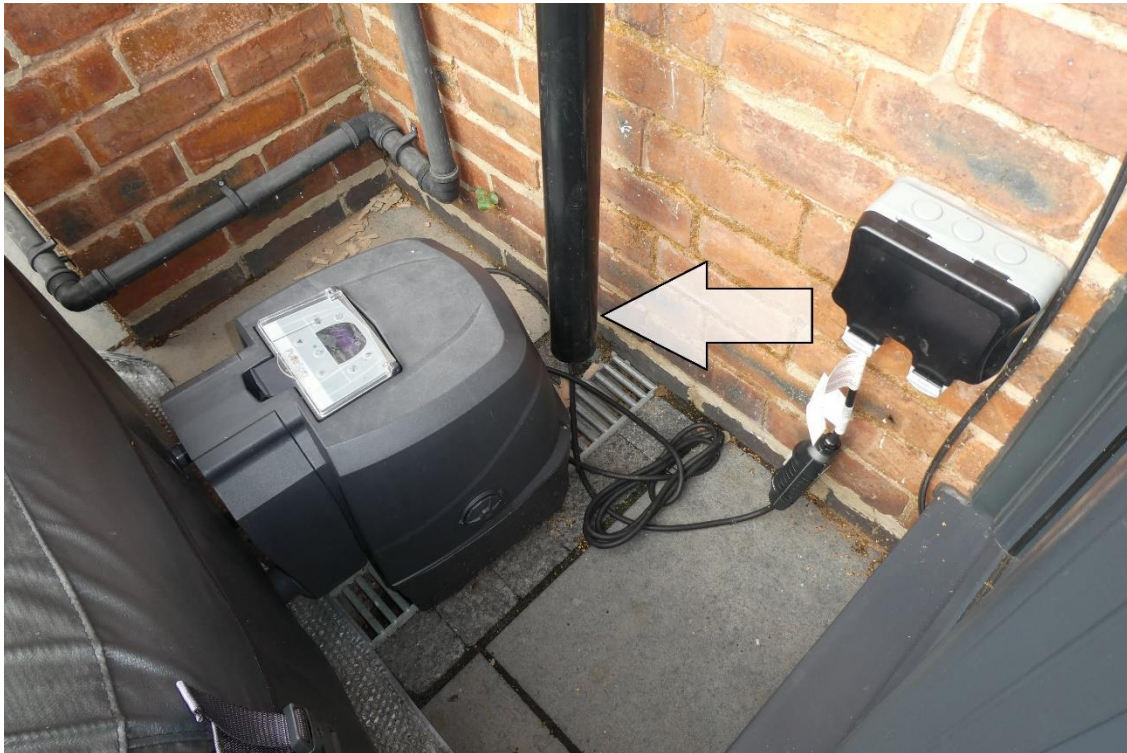
DOWNPIPE CUT SHORT AND DISCHARGING ABOVE THE CHANNEL. SPA IS ON TOP OF THE CHANNEL.

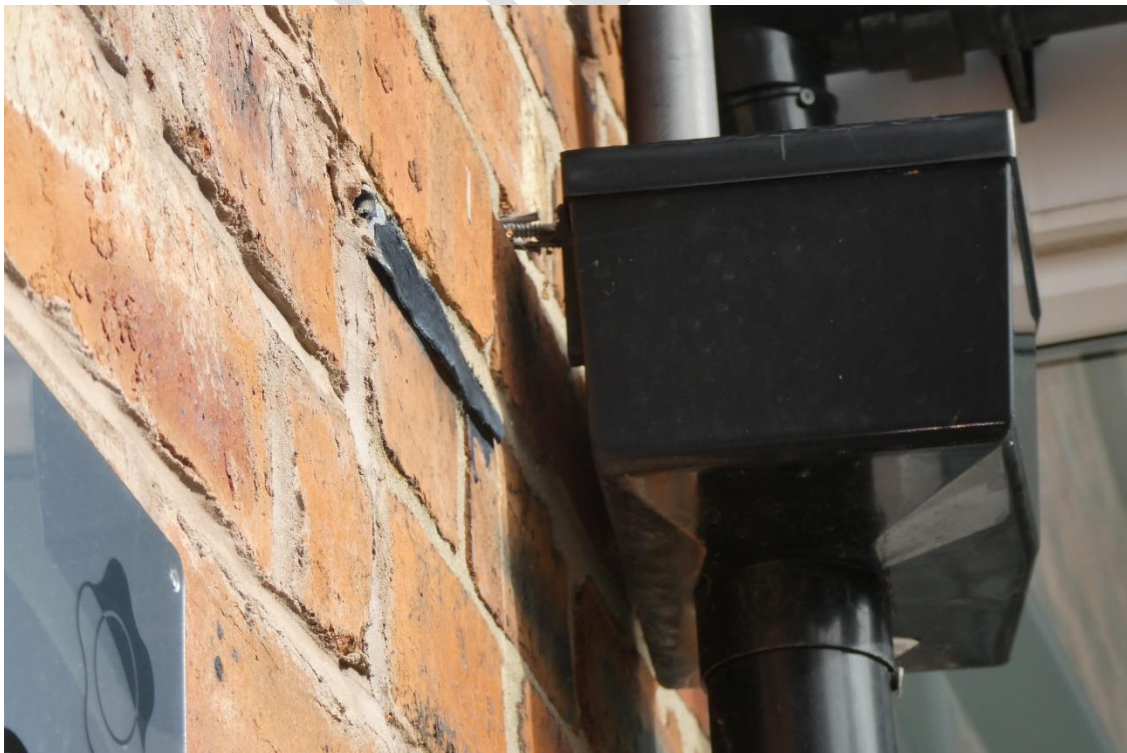
8. There is leakage on the kitchen gutter stop-end. This should be replaced.
9. The hopper and downpipe collecting the kitchen rainwater has not been fixed correctly. It looked like it could be pulled off the wall.

HOPPER AND DOWNPIPE NOT FIXED SECURELY.

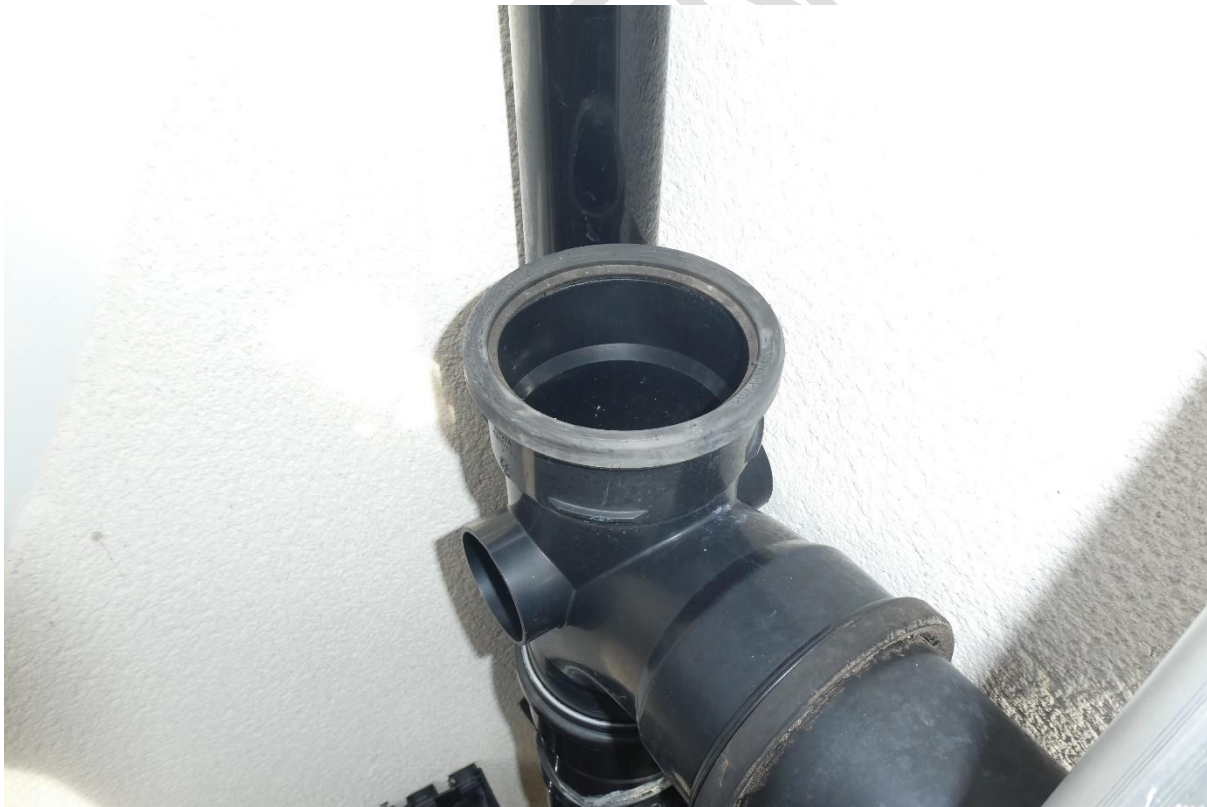
1. The top discharges just above head height and not above the roof eaves. The top is open which could allow sewer smells to the side of the house. The pipe should be extended, and an external air admittance valve installed.
2. There looks like there is leakage from one incoming waste connection. It should be repaired.
3. There is no maintenance access panel at the base.

OPEN TOP TO THE SOIL AND VENT PIPE. SEWER SMELLS WILL COME FROM THIS PIPE.

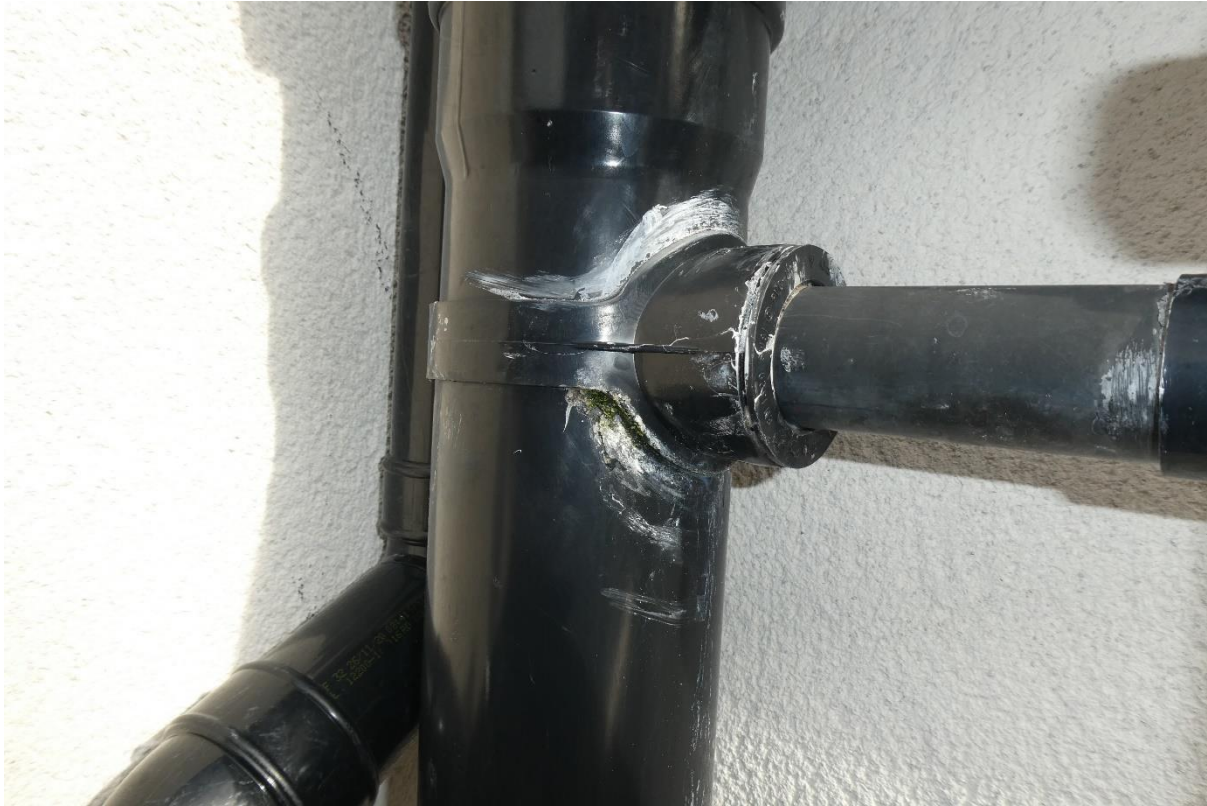
LEAKAGE ON INCOMING WASTE.

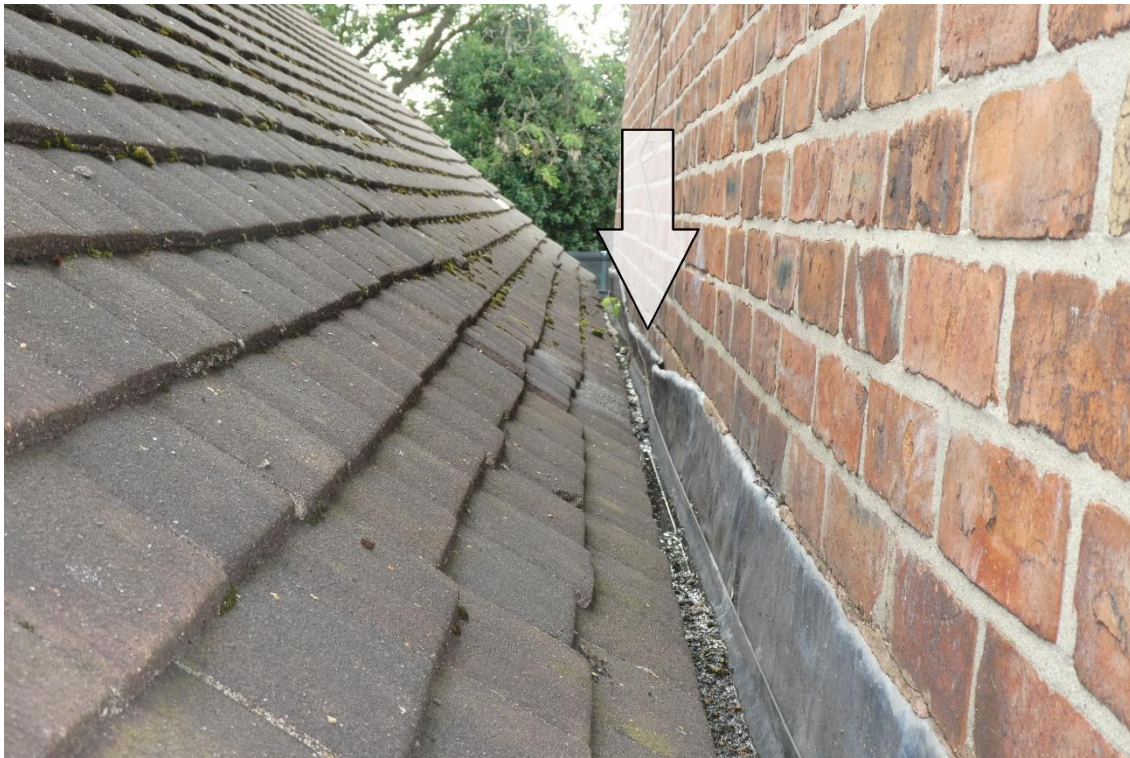
LEAD FLASHING HAS FALLEN OUT OF THE BRICKWORK.

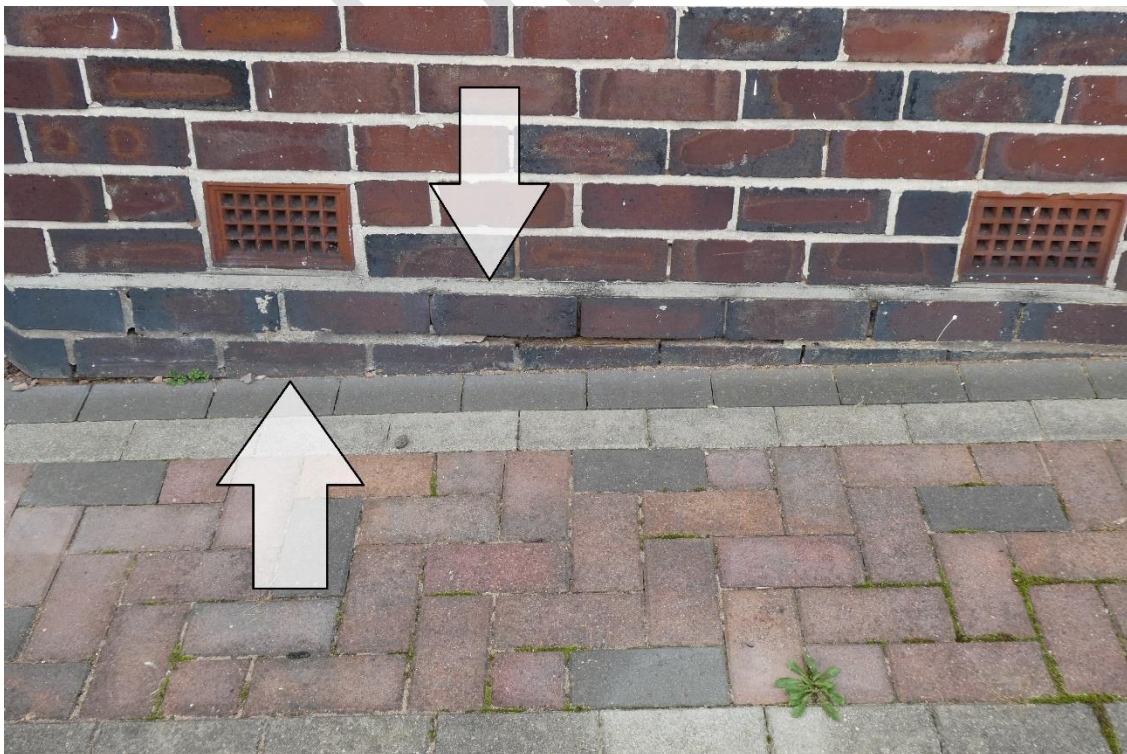
PAVING SHOULD BE 150mm (TWO BRICKS) BELOW THE DPC.

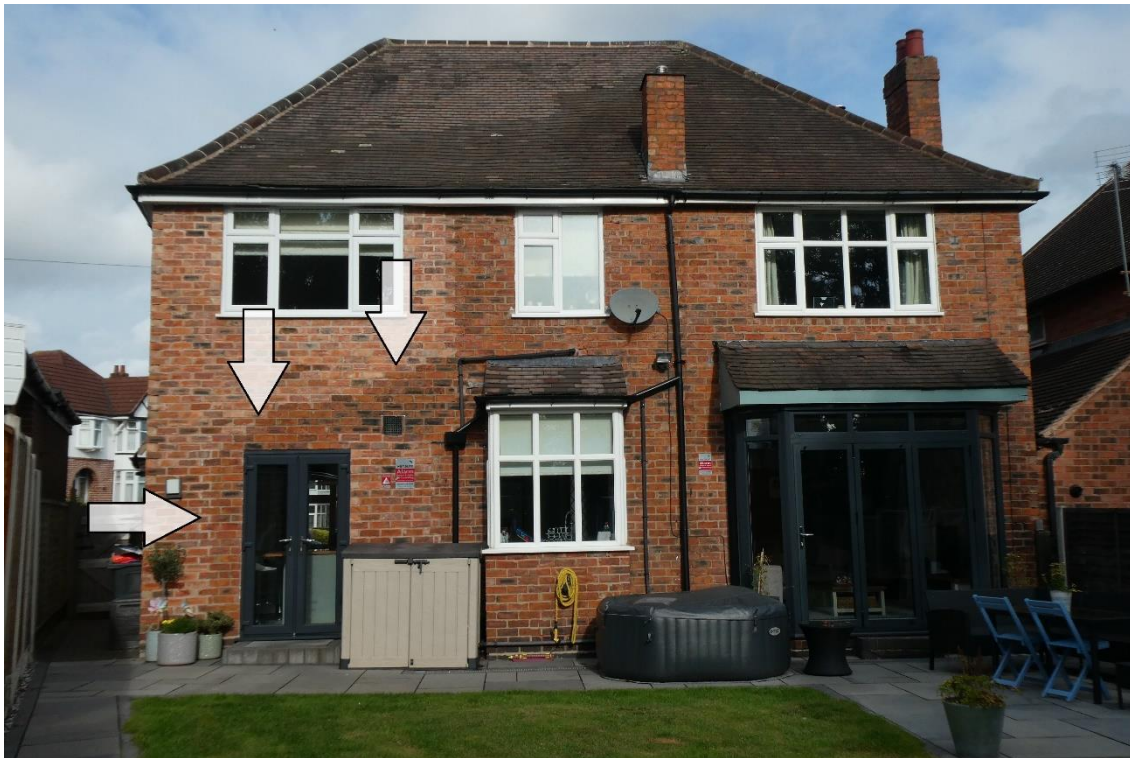
Rear elevation: It looks like an original side lean-to or similar was built on top of to form the extension. We cannot confirm that the wall nor foundations were/are suitable. This should have been checked prior to building on top of the existing wall.

IT LOOKS LIKE THE REAR OF THE EXTENSION WAS BUILT UPON AN OLD LEAN-TO.

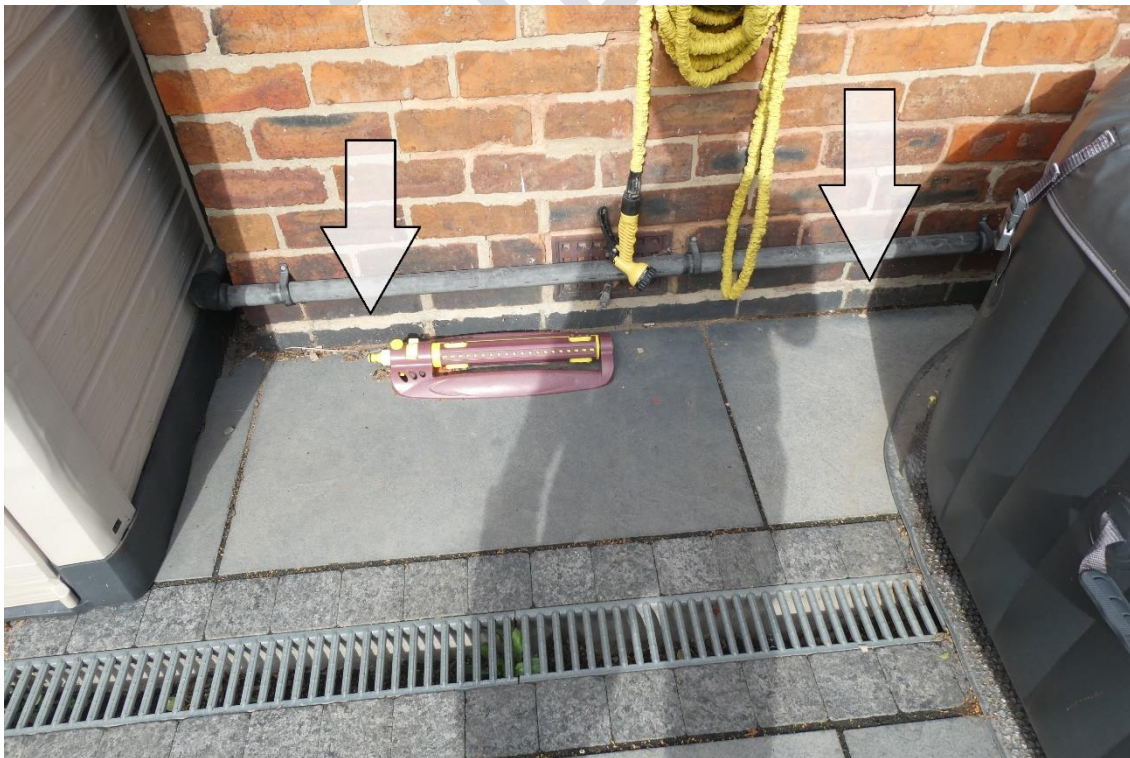
AGAIN, THE PAVING IS TOO HIGH TO THE REAR.

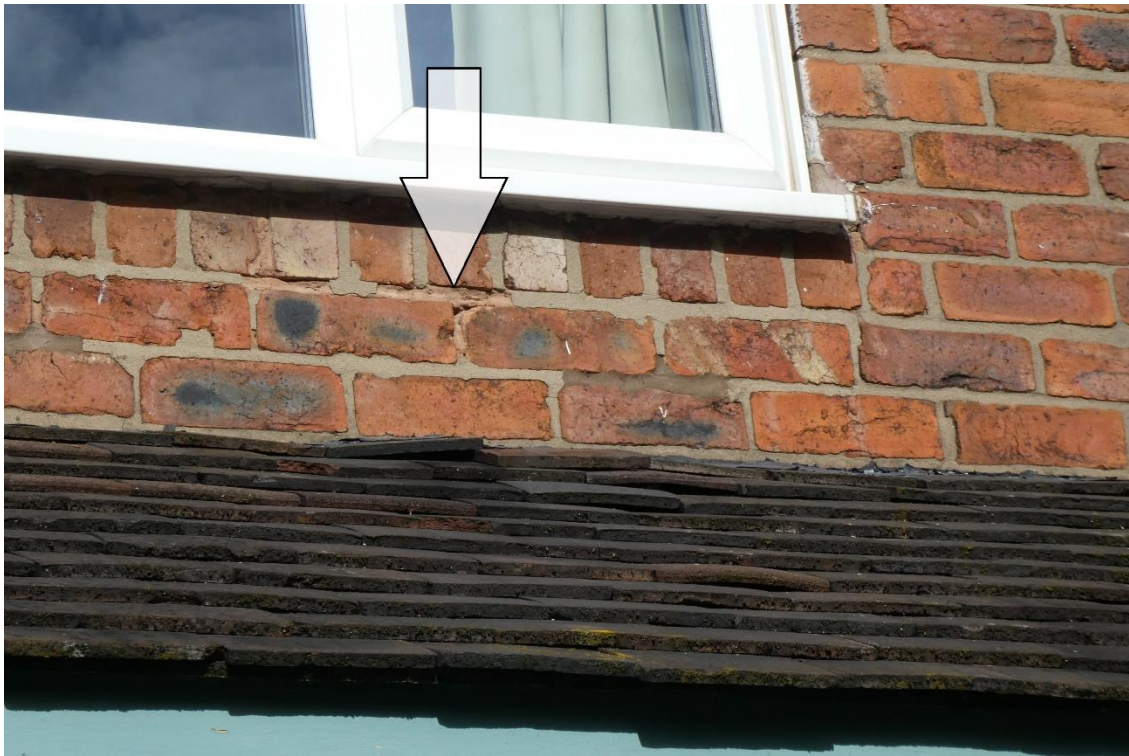
EXAMPLE OF SHALLOW REPOINTING.

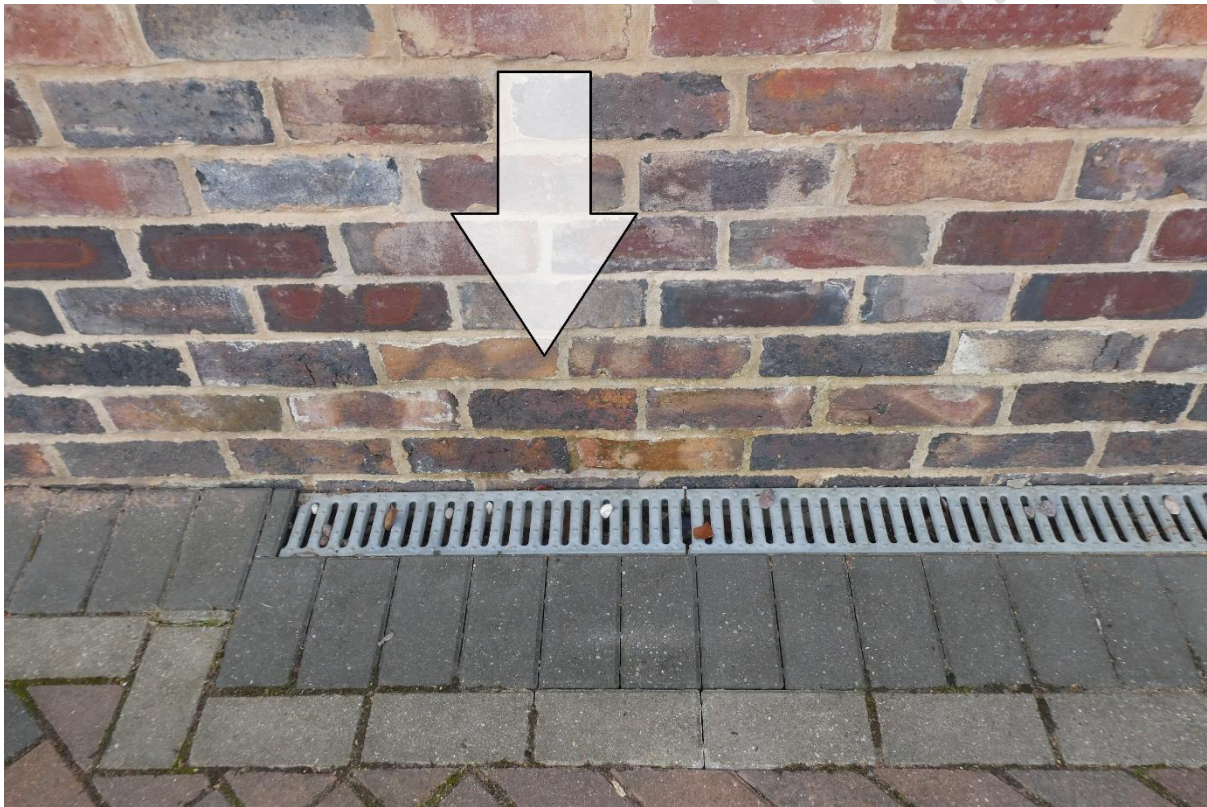
THERE IS NO OBVIOUS DPC NOR CHANGE IN BRICKS BENEATH THE LEVEL OF A HIDDEN DPC.

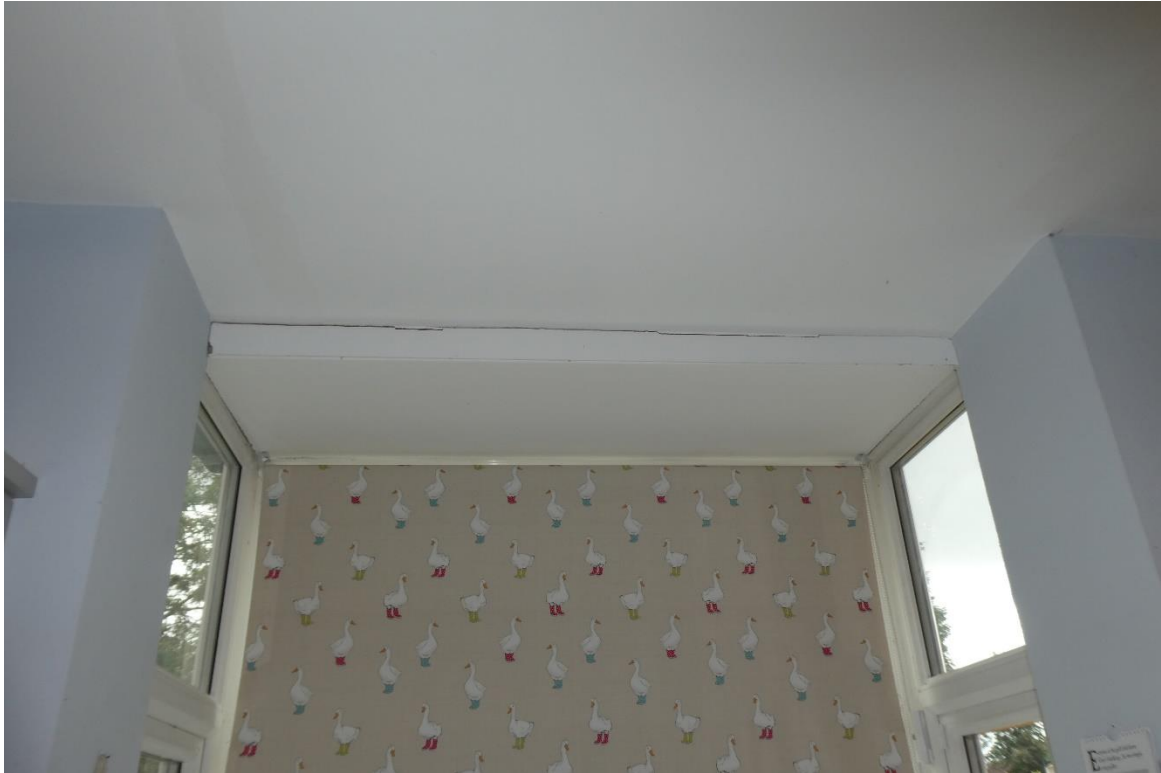
DISTURBANCE TO KITCHEN BAY CEILING.

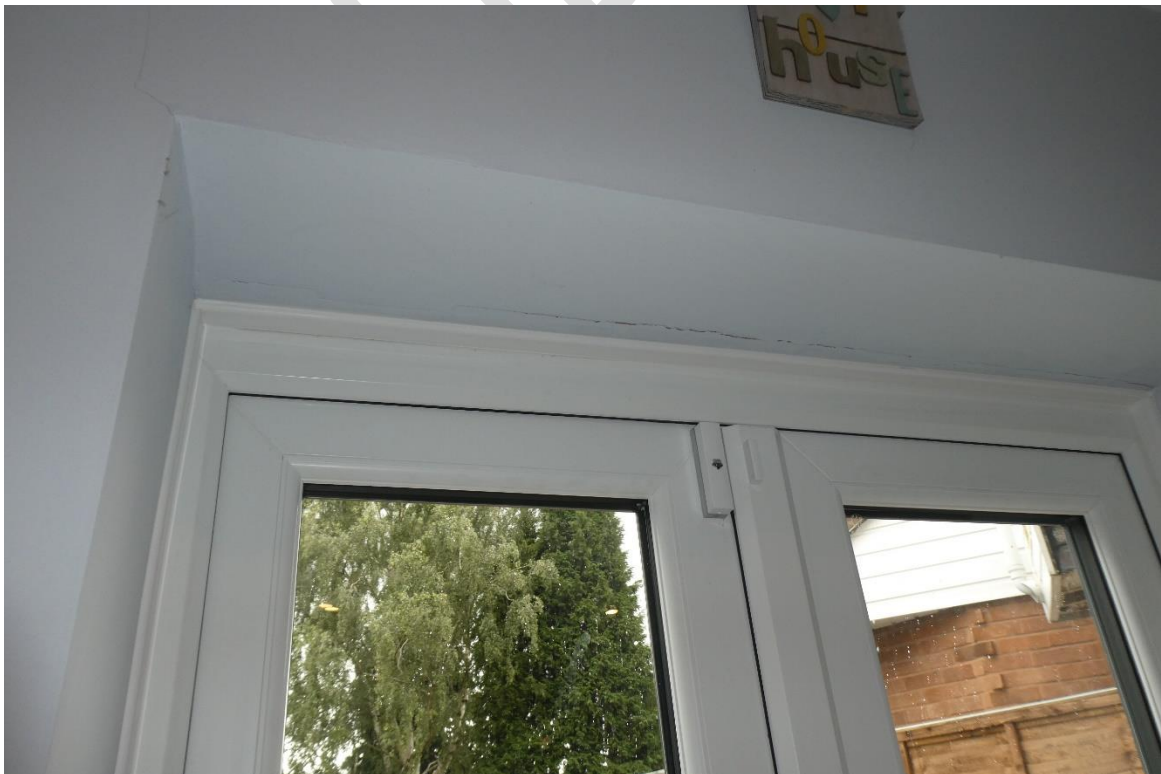
DISTURBANCE TO KITCHEN DOOR SOFFIT.

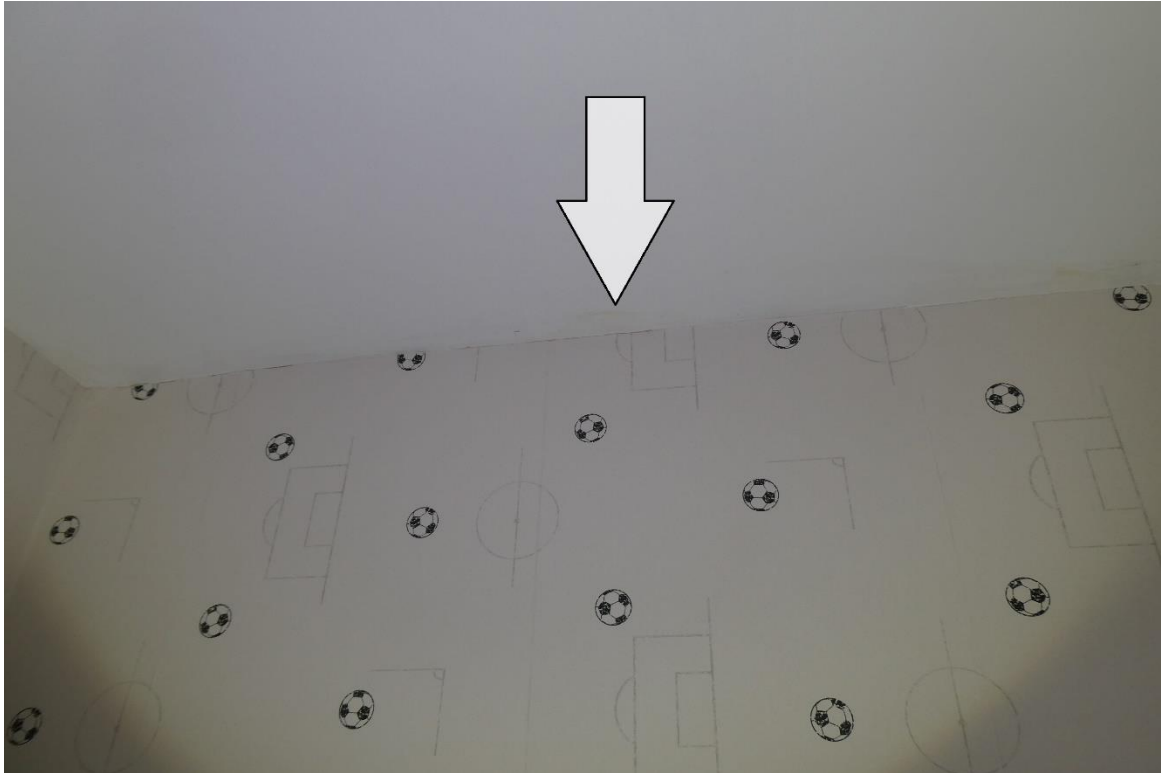
WATER MARK TO BEDROOM CEILING.
