BUILDING SURVEY

BUILDING SURVEY FOR *****

Date of Survey: *****

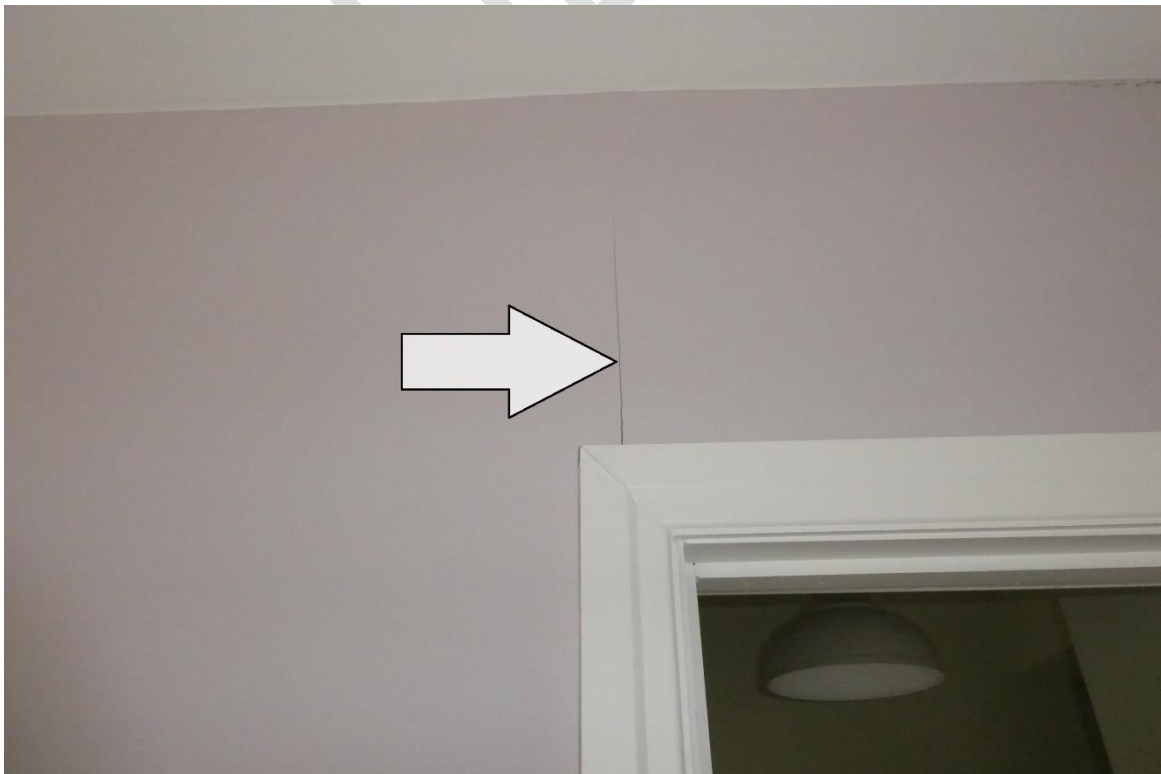
CRACK TO BEDROOM STUD PARTITION.
