# BUILDING SURVEY

BUILDING SURVEY FOR \*\*\*\*\*

Date of Survey: \*\*\*\*\*

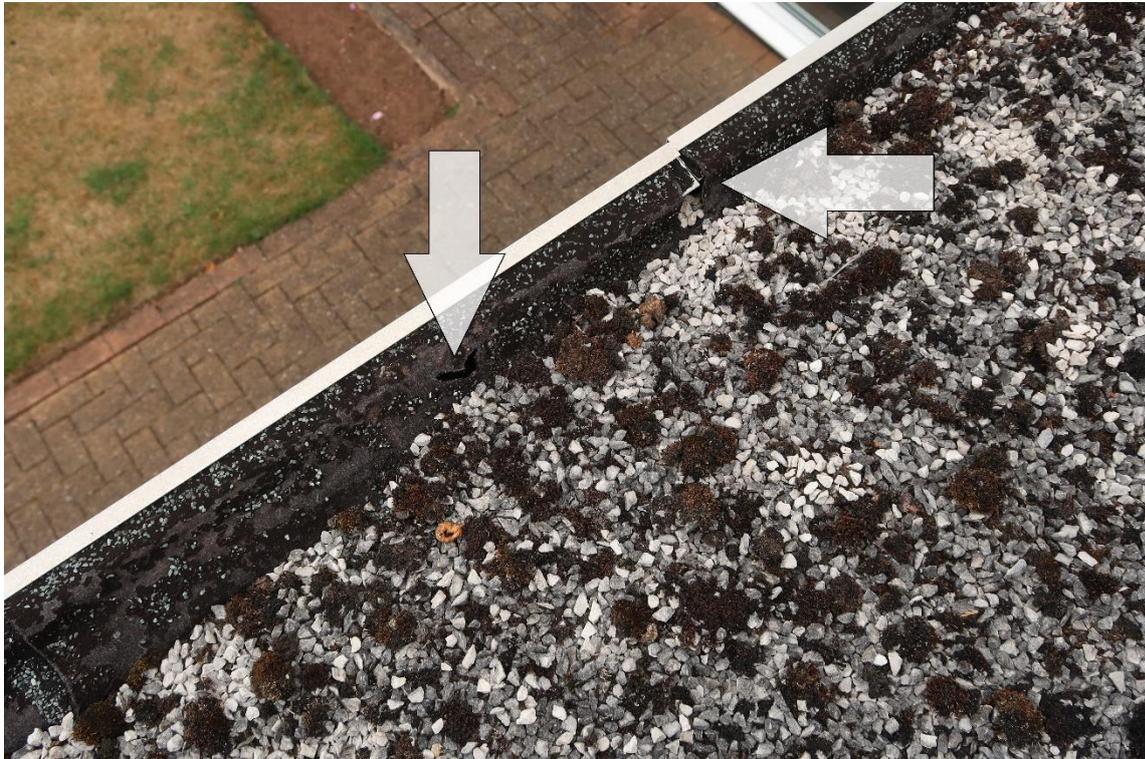
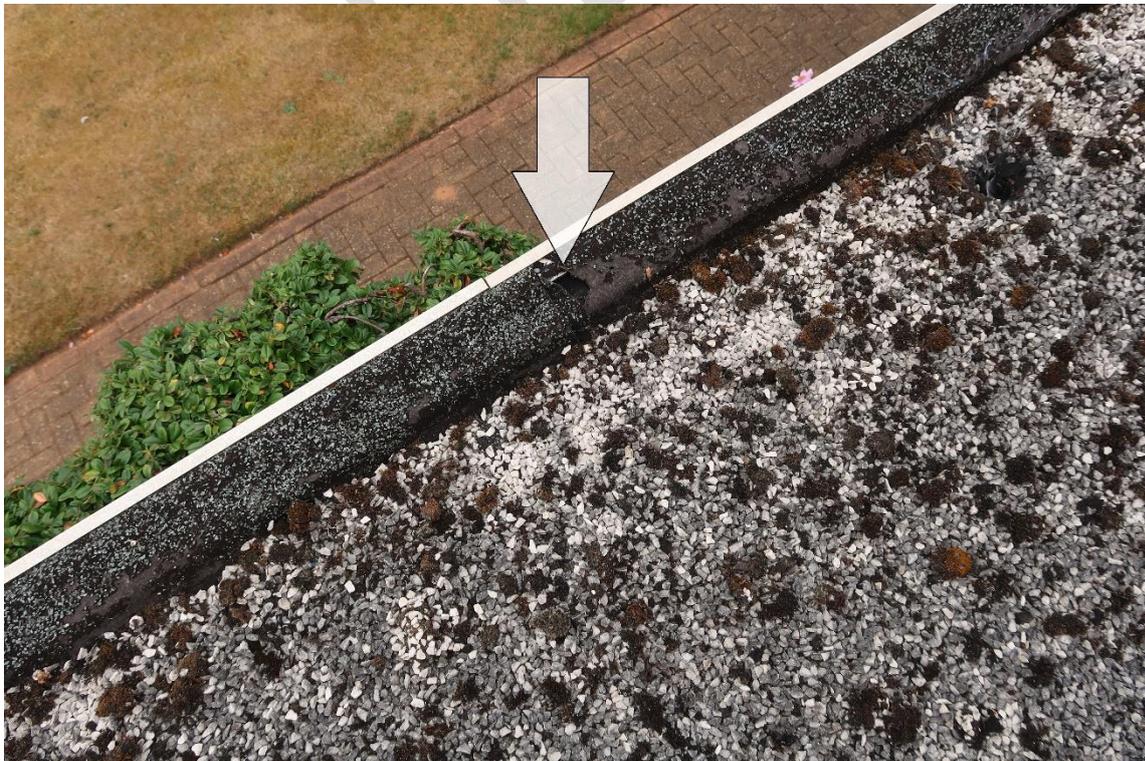
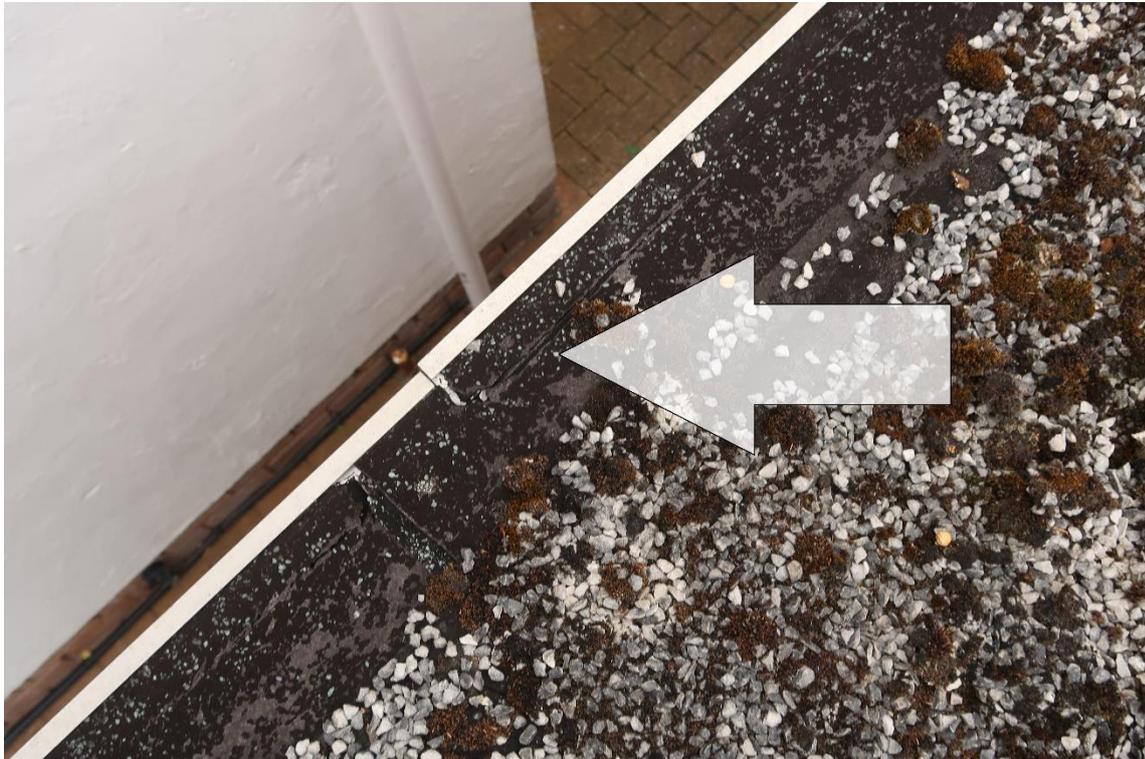
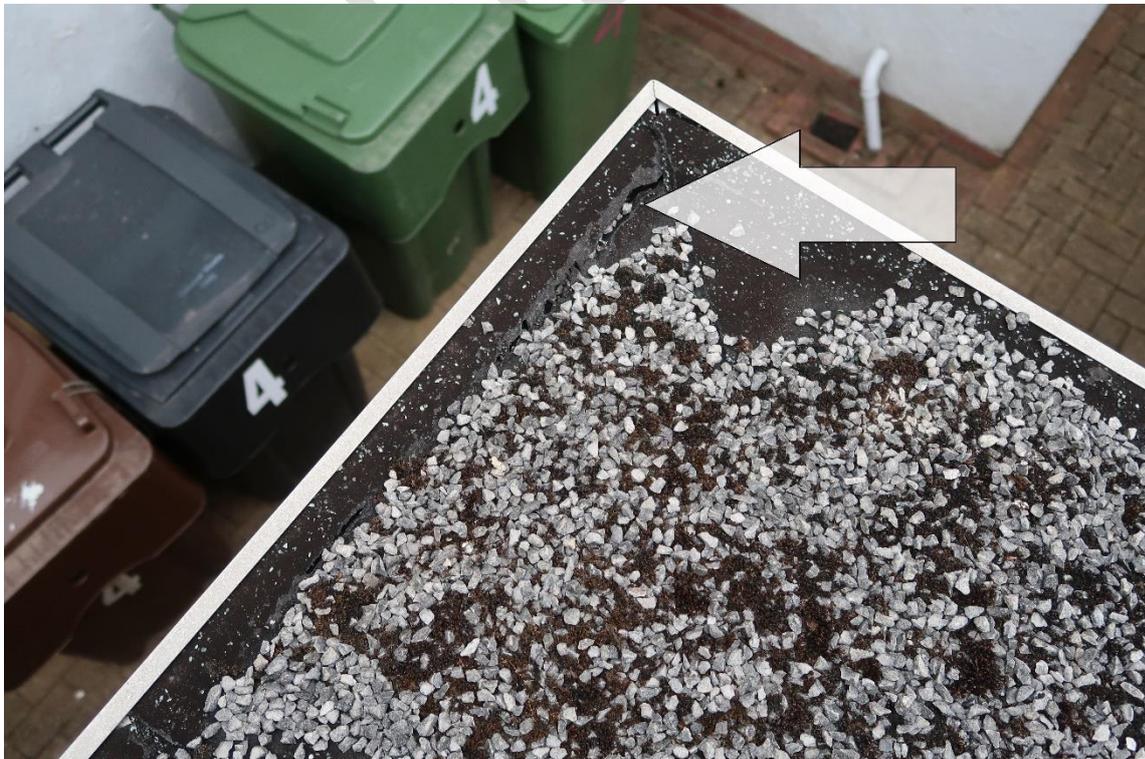
3.15 The felt is aged and where it is exposed around the edge upstands, the felt has split and deteriorated. We were surprised that there is not clear evidence of leakage within the garage and store.

3.16 We climbed onto the roof and there is movement in the decking. This could be caused by leakage through the felt.

SPLITS TO THE EDGE.

3.17 We have discussed this with you and recommended immediate renewal including new decking.

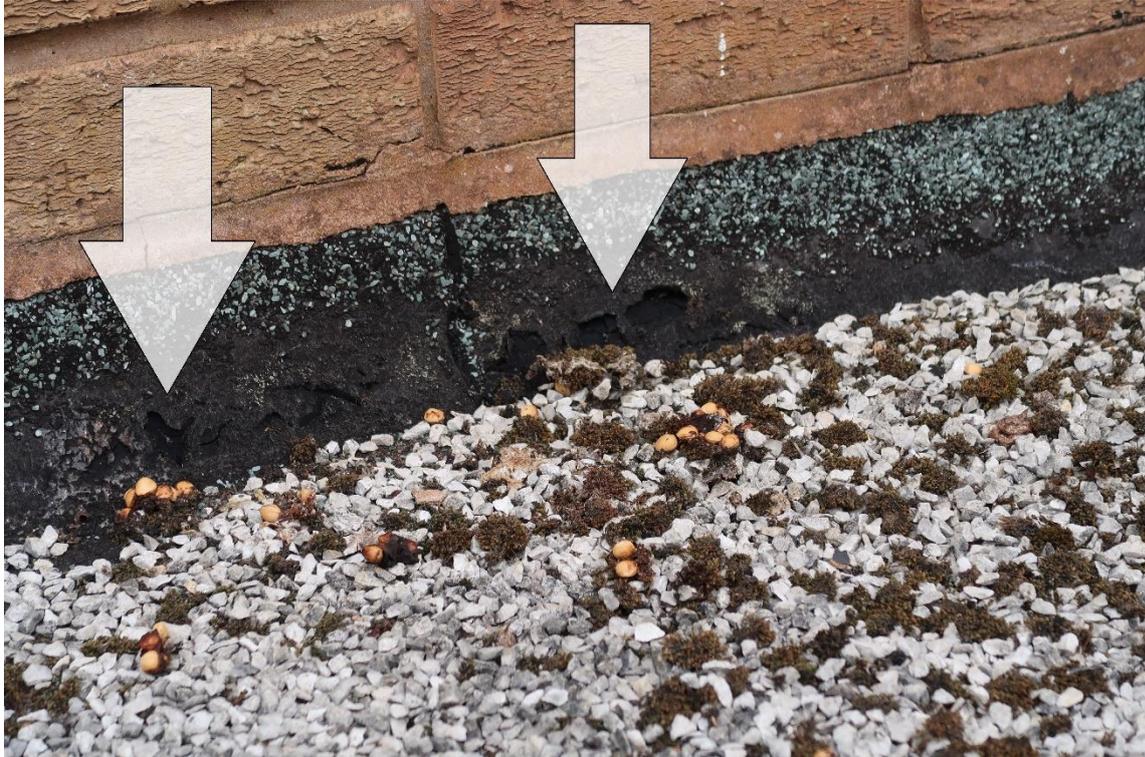
3.21 Again, the felt is aged and where it is exposed around the edge upstands, the felt has split and deteriorated. We were surprised that there is not clear evidence of leakage.

3.22 We climbed onto the roof and there is movement in the decking. This could be caused by leakage through the felt.

SPLITS TO THE EDGE.

3.23 We have discussed this with you and recommended immediate renewal including new decking.

3.24 If you wish to extend the lifespan of the new roof, you should consider a long-life material such as EPDM or GRP which should last approximately thirty years. Bitumen felt will only last ten to fifteen years.

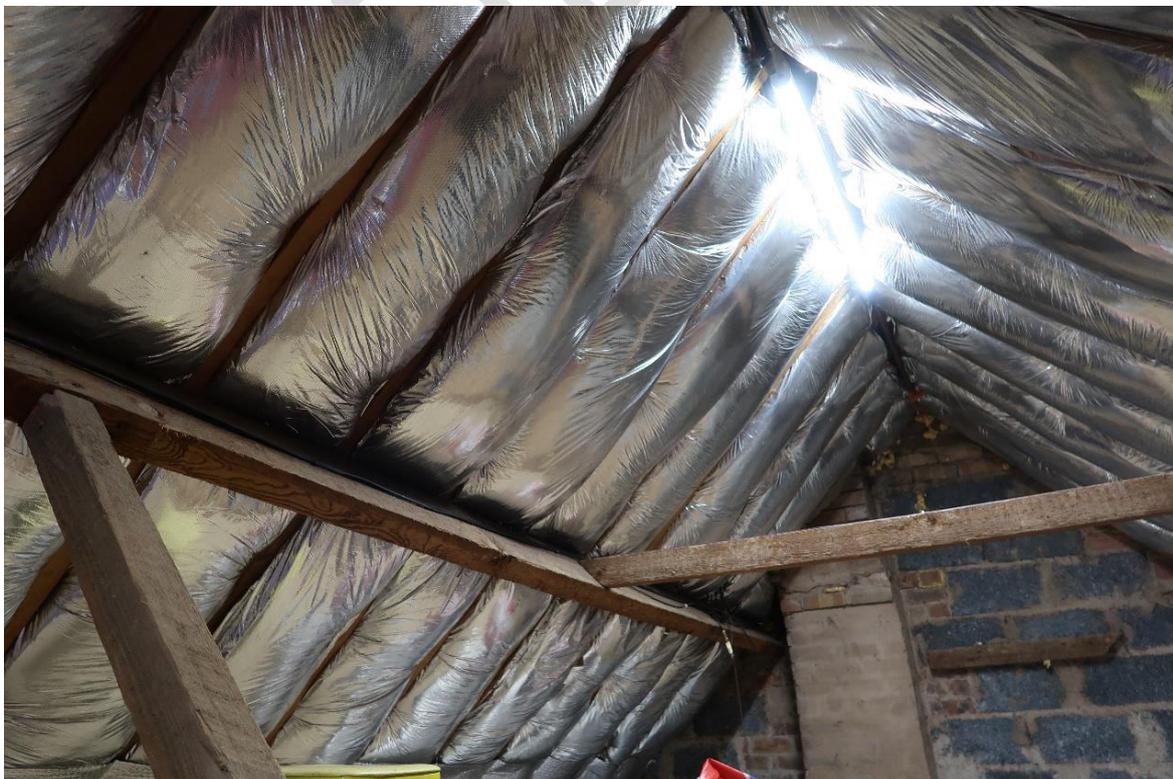
4.02 The foil insulation should be removed as this could cause interstitial condensation which could affect the bedrooms. It is also forming a “warm roof” where you are in effect heating the roof space. We recommend that the floorboards are removed and 300mm of quilt insulation is installed across the floor. This forms a “cold roof” and is the most effective way to insulate a house.

THE UNDERSIDE OF THE ROOF IS COVERED IN FOIL WRAPPED INSULATION.

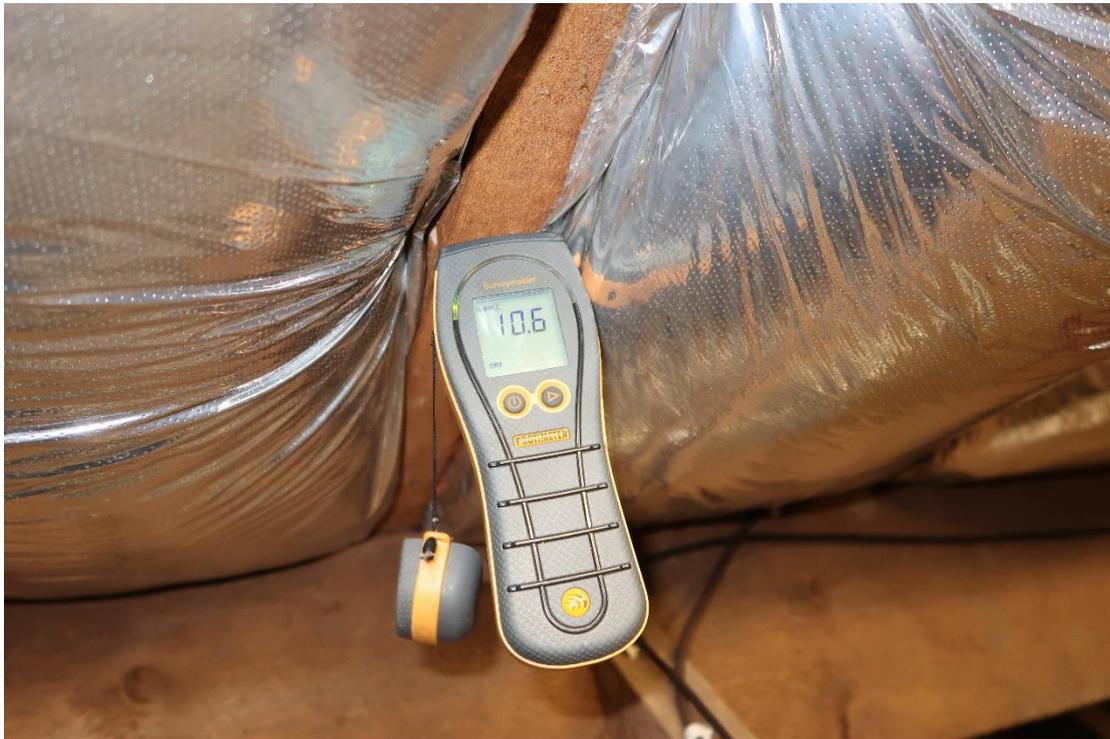
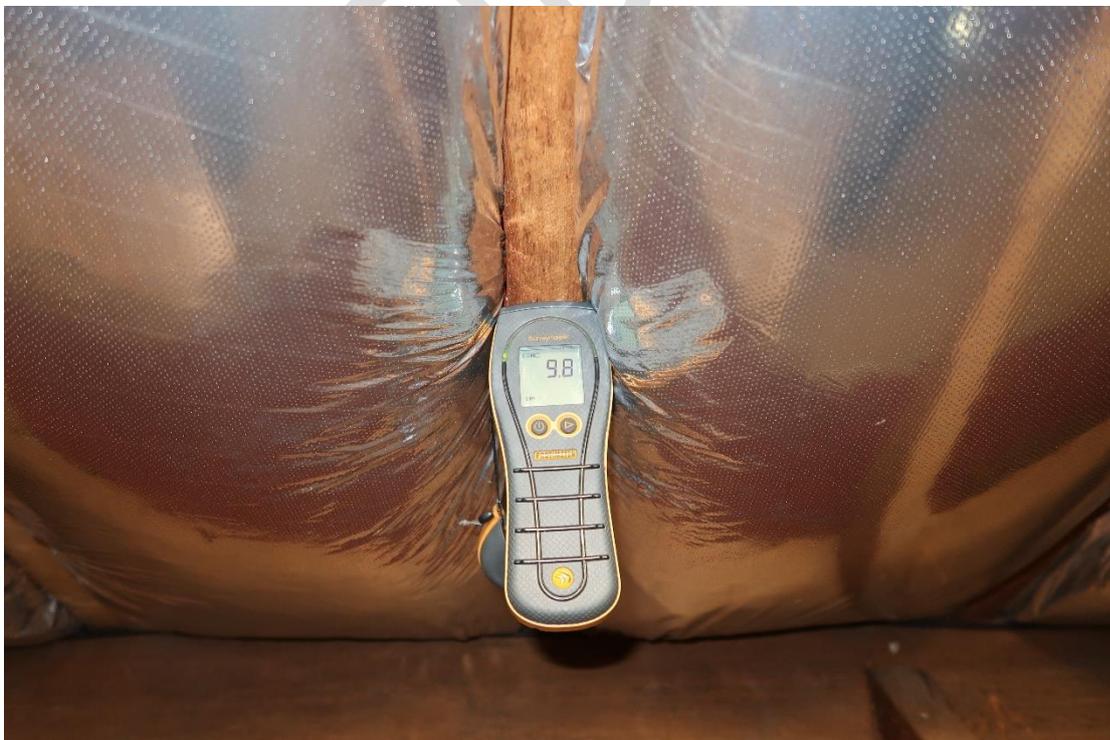
4.06 We tested a small number of accessible roof timbers with a moisture probe meter and registered moisture readings between 9% to 11%. These are reasonably low measurements due to the hot summer. The threshold for rots and woodworm is approximately 20%. We have advised you to install ventilation into the new roof finish.

MOISTURE TESTING A RAFTER.

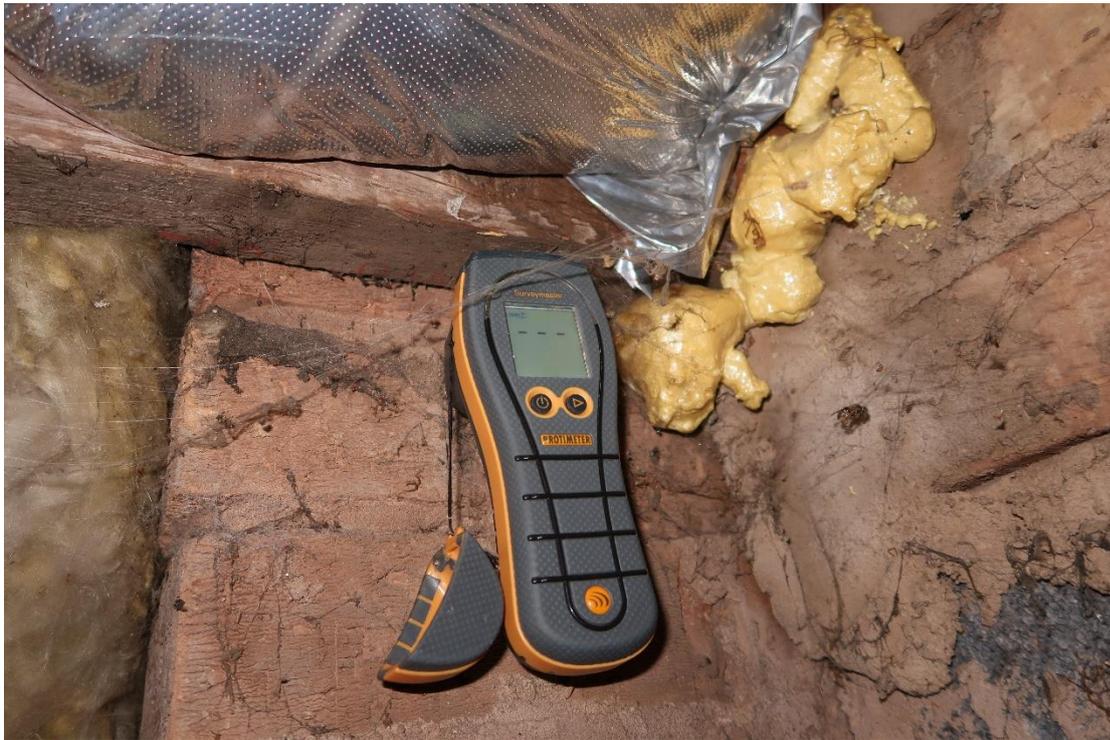
TESTING THE PURLIN NEAR THE GABLE WALL. YOU CAN SEE THE INJECTED UFFI FOAM.

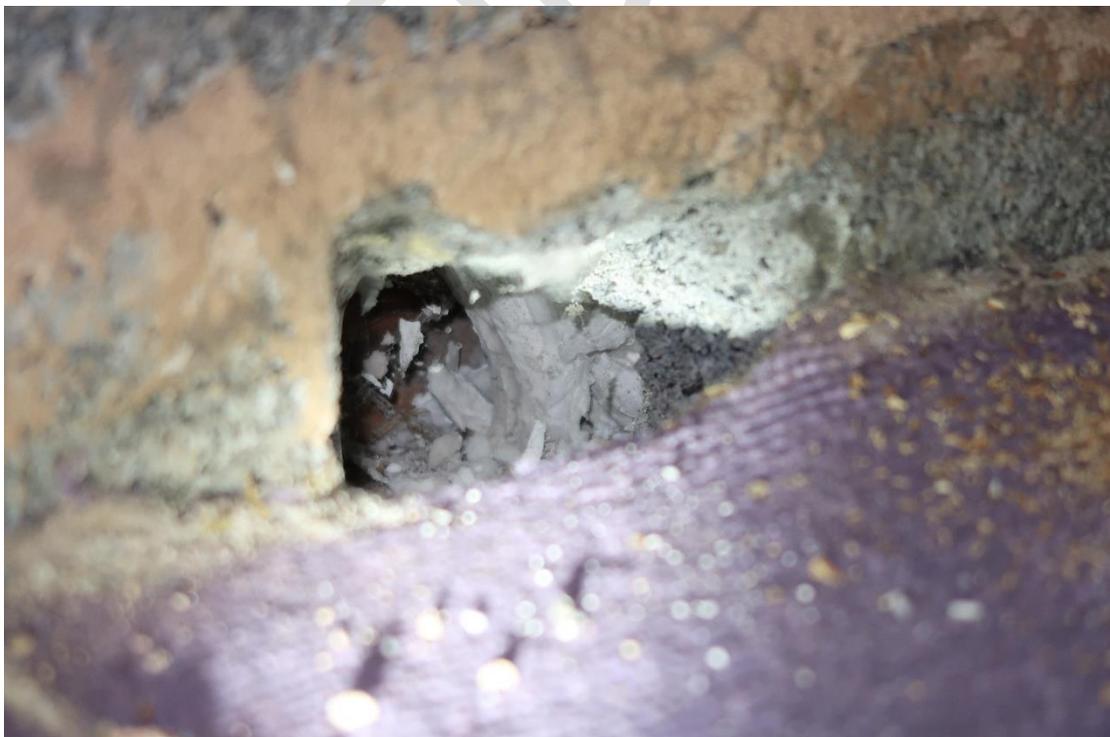
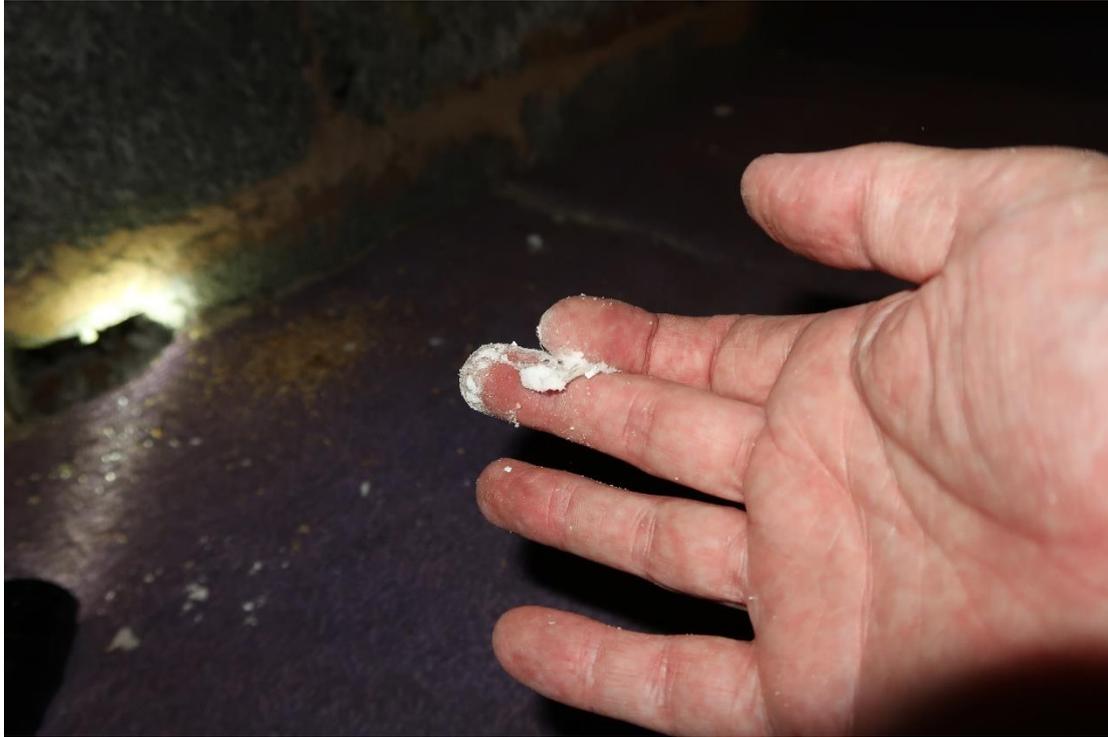
4.07 The party walls are formed with blockwork which also forms the internal skin of the walls. We noted foam coming out of gaps to the wall and could see a small hole where we could see into the cavity. We could see that the foam has disintegrated and we believe that this foam is Urea formaldehyde foam insulation (UFFI). We have discussed this with you and recommend that due to the concern that it may emit formaldehyde gas and the risk of cold bridges due to disintegrated areas of insulation, the complete cavity around the house should be cleared of this installed installation. You should obtain an immediate quotation for the removal of the foam from the cavity as this could be expensive.

HOLE IN THE PARTY WALL. YOU CAN SEE THE DETERIORATING INSULATION.

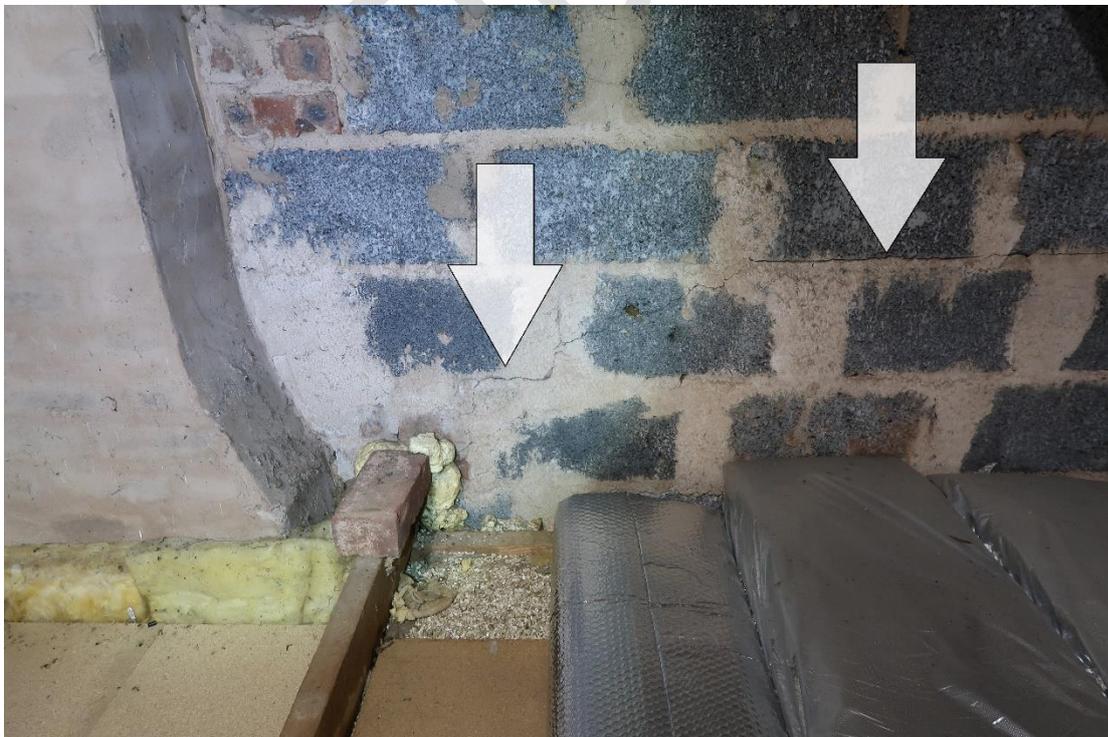
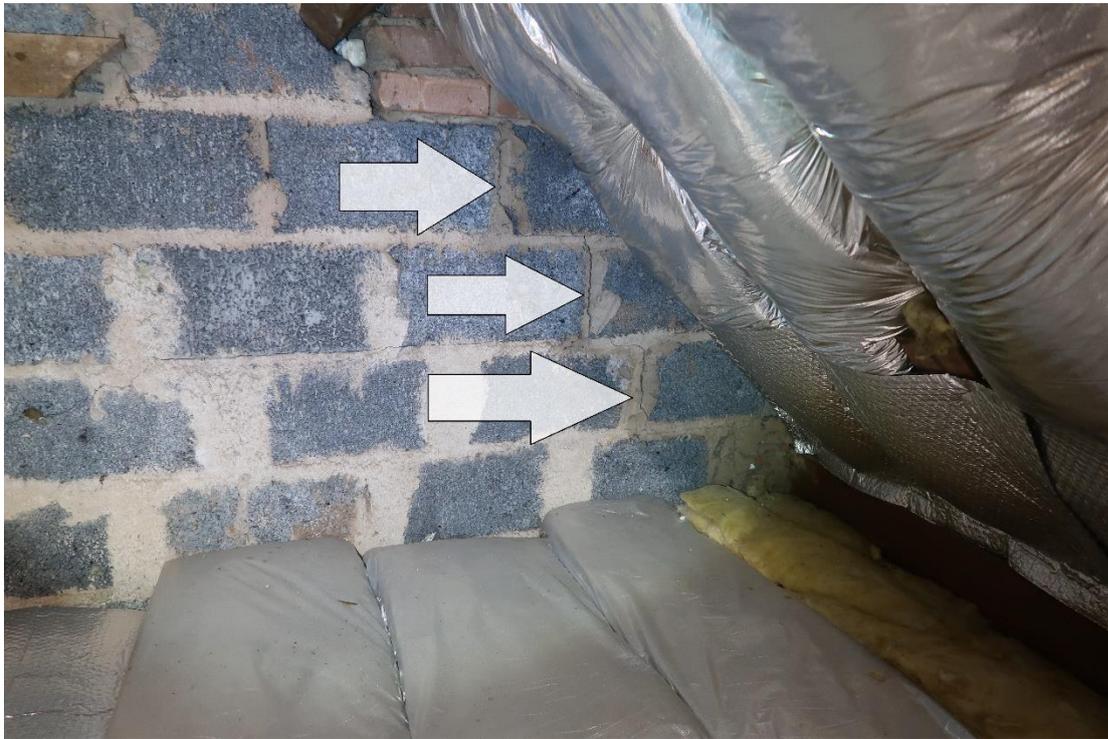
4.08 To the right-hand party wall, we noted a crack which is partly along the bed joint. This type of crack can be caused by corroding wall ties and the risk of this issue increases where the cavity has been injected with insulation. Although wall ties corrosion cracks are more often seen to the outside face of the brickwork, you should commission an invasive inspection of the wall ties to ensure that they are free of corrosion.

CRACK TO PARTY WALL.

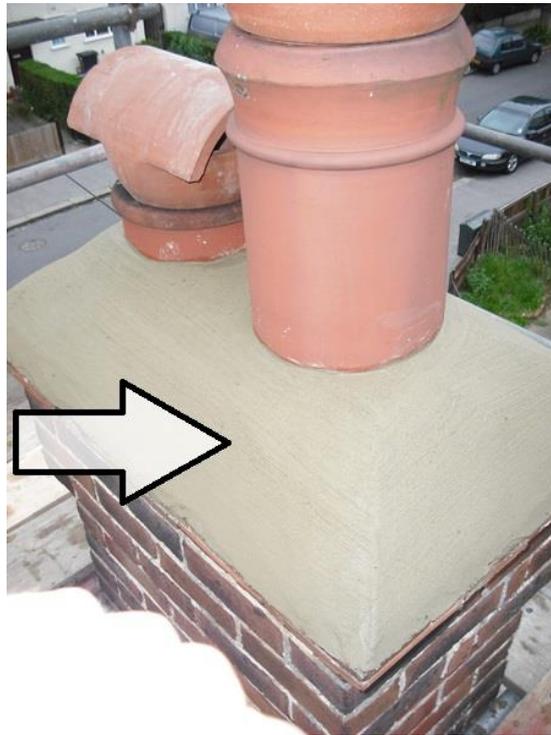
EXAMPLE OF MORTAR FLAUNCHING.

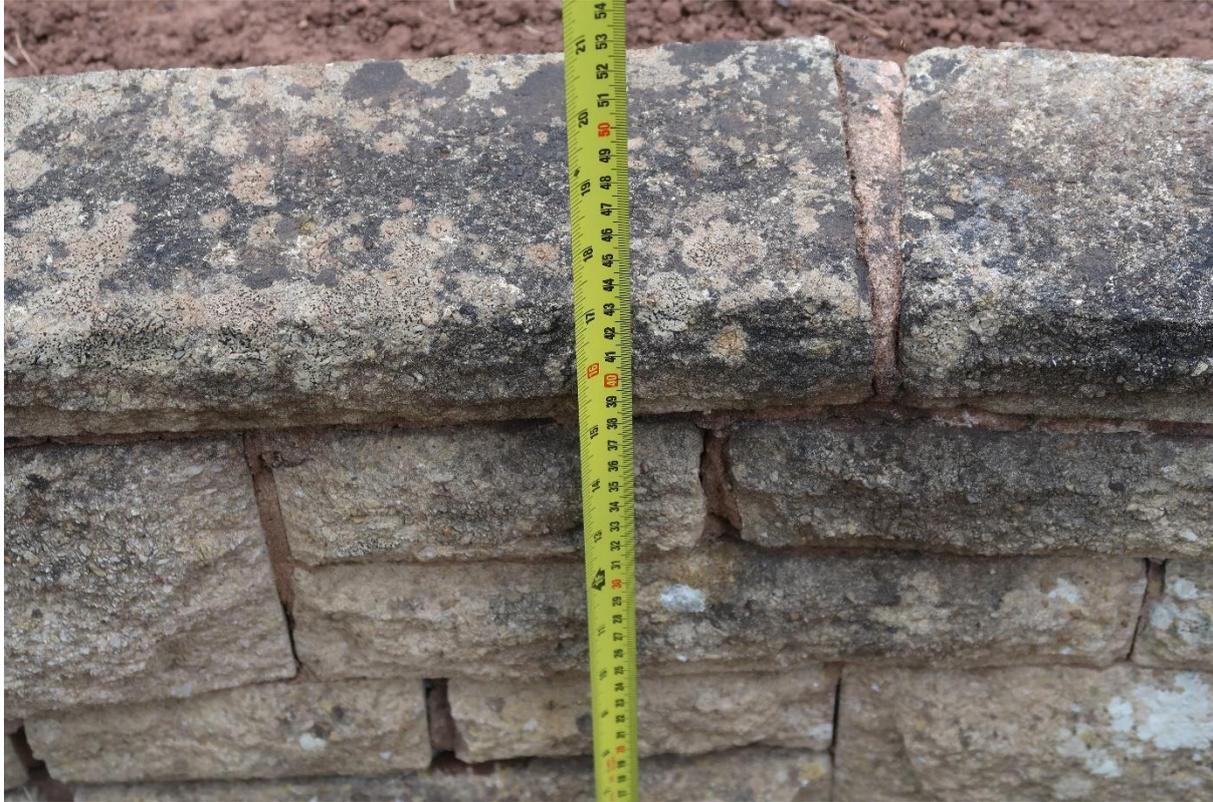
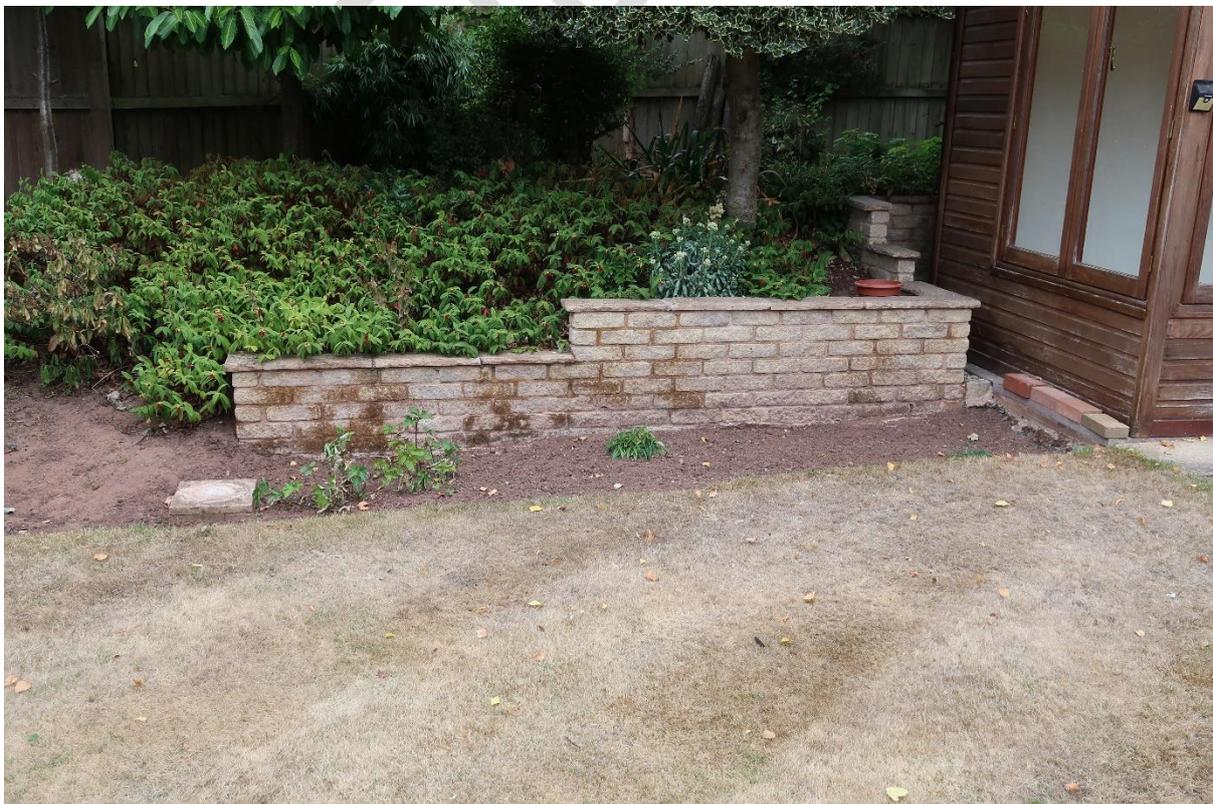
A BALUSTRADE IS REQUIRED WHERE A WALL EXCEEDS 300mm.

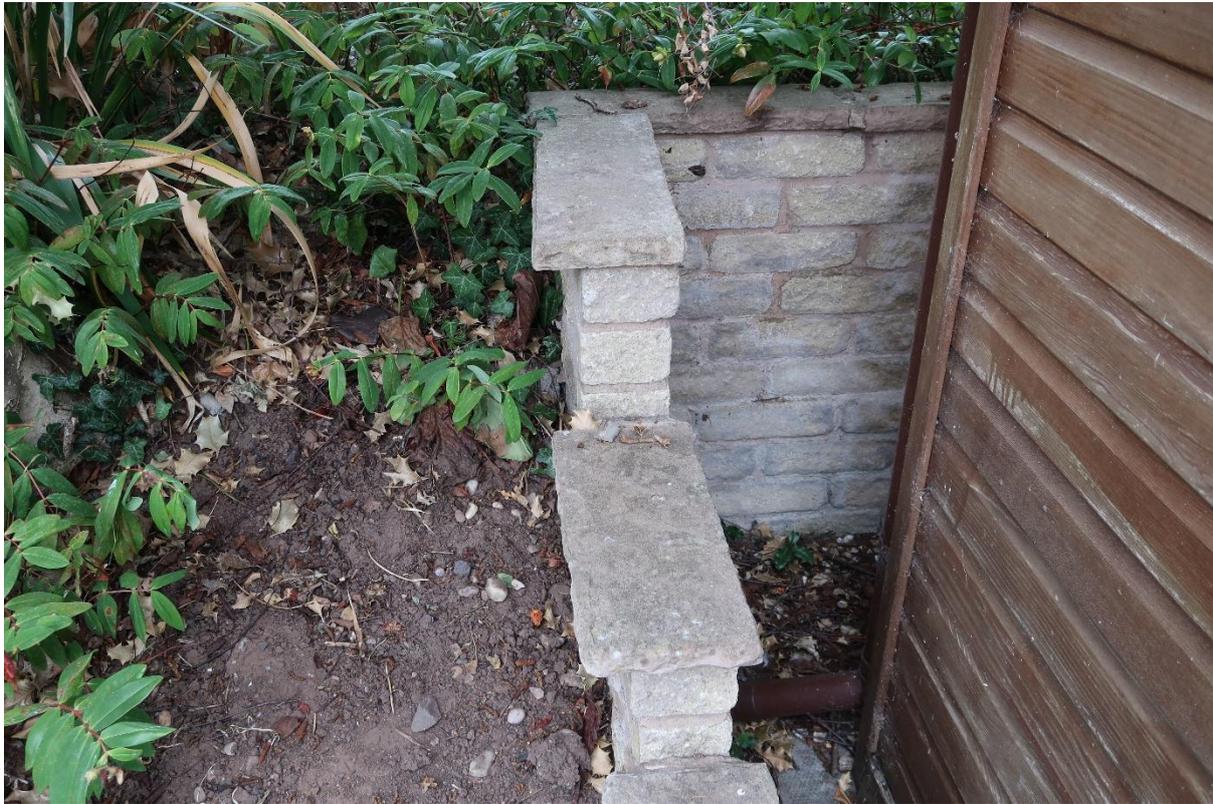
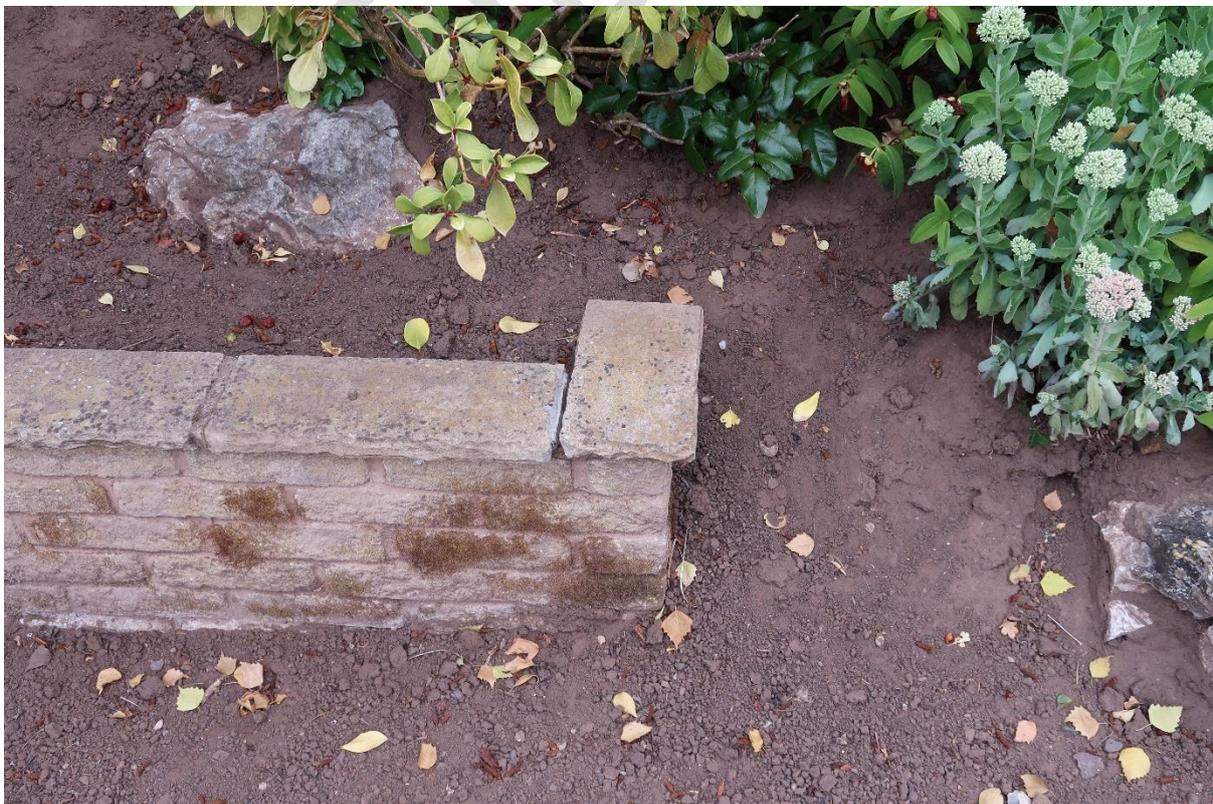
6.03 We noted a number of coping stones are loose and these can be reset.

SOME OF THE LOOSE COPING STONES.

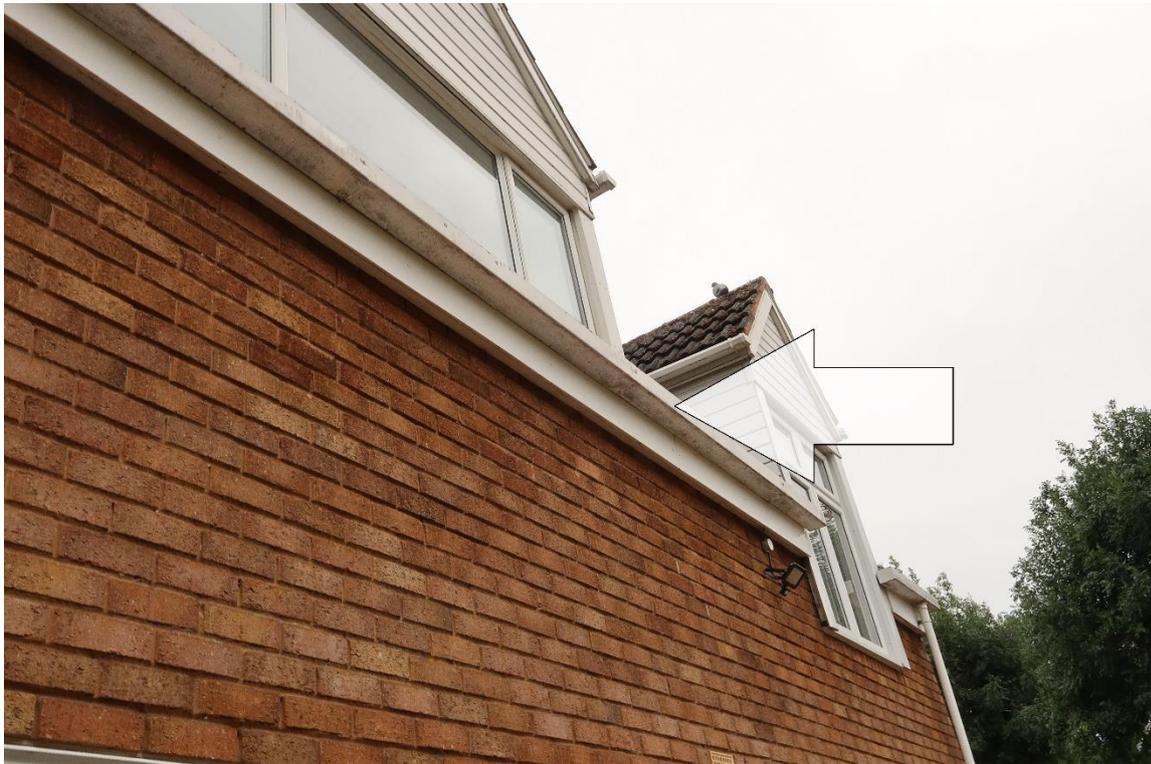
UNUSUAL SQUARE GUTTER.

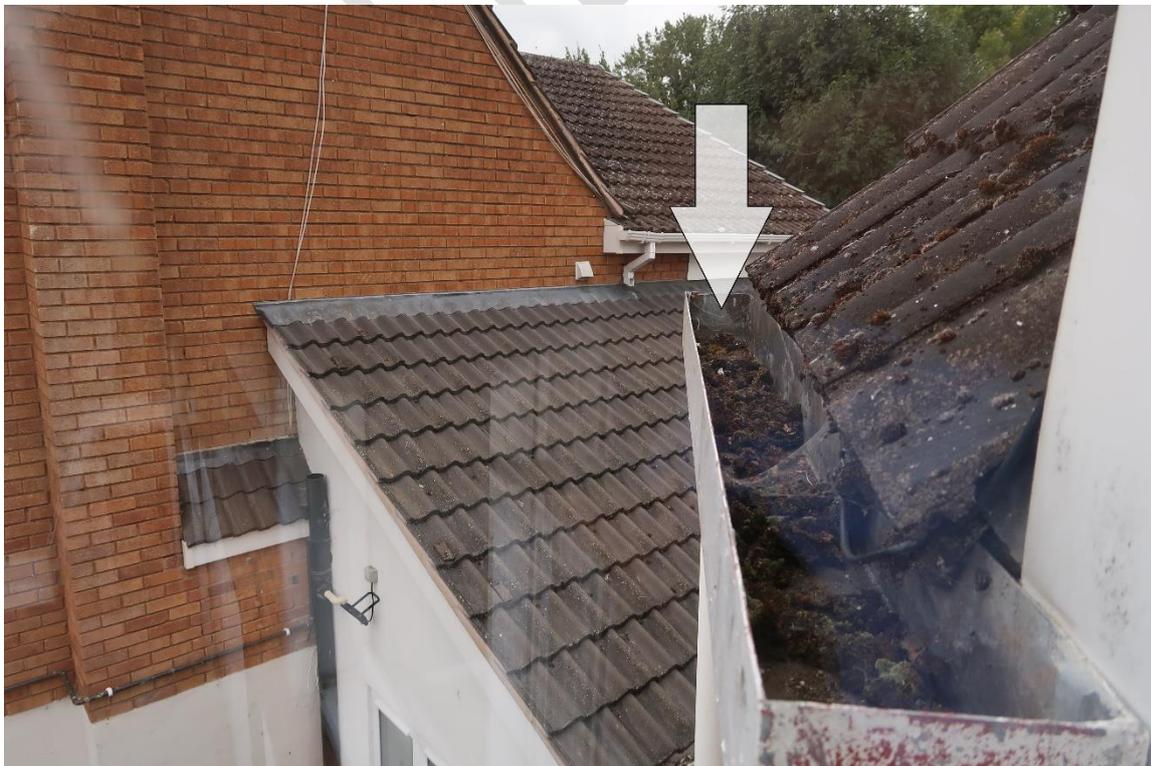
THE GUTTER DOES LOOK LIKE LEAD OR ZINC.

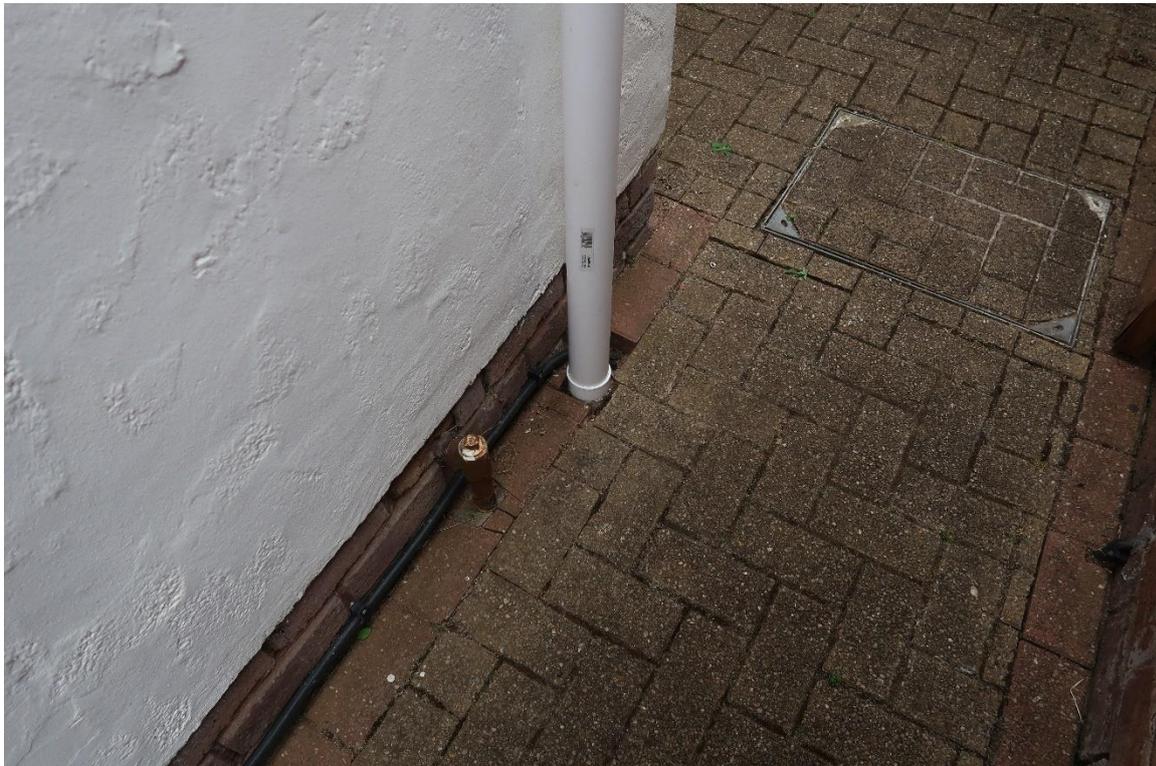
DOWNPIPE INTO THE GROUND.

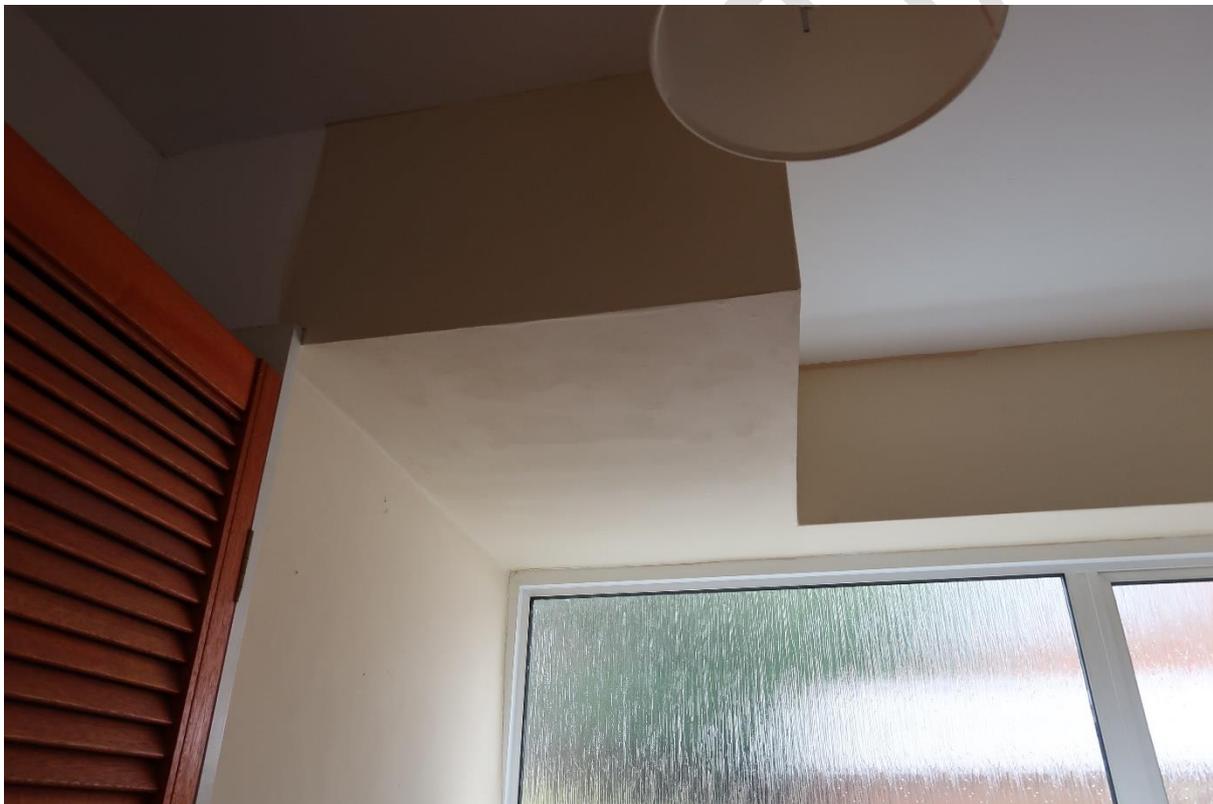
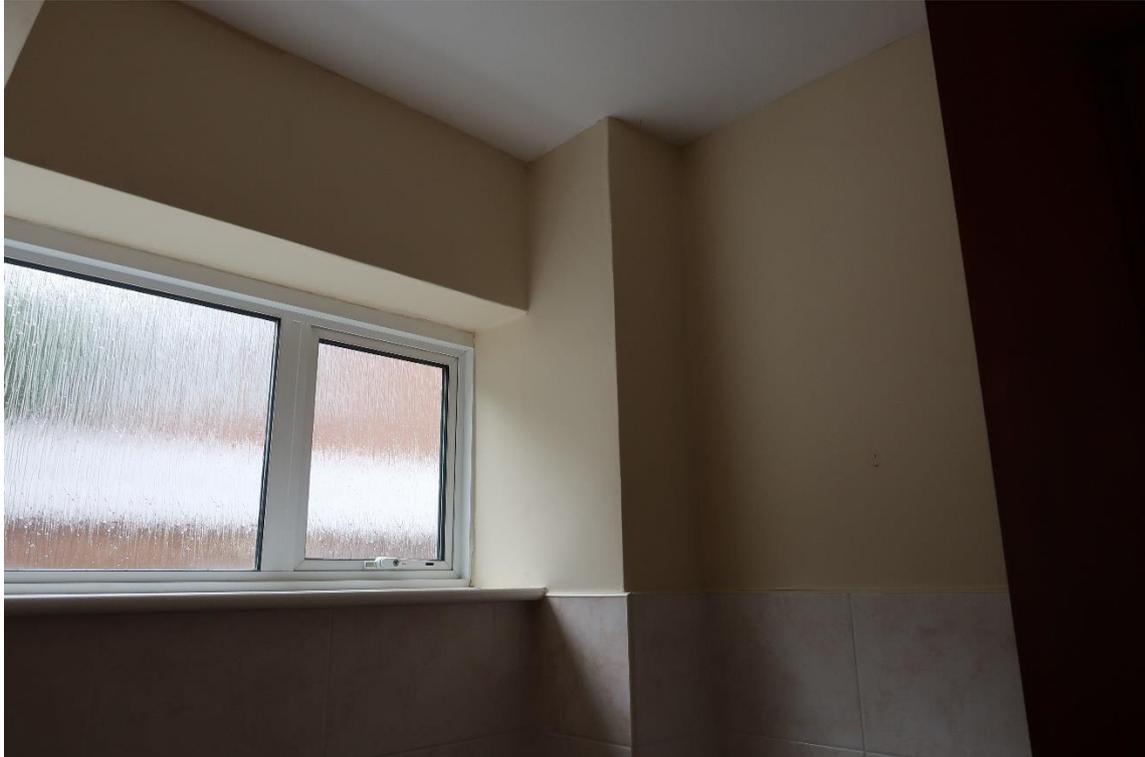
9.02 Due to the boxing, we cannot confirm the condition of the pipe nor the base.

WE ASSUME THAT THE SVP IS HERE.

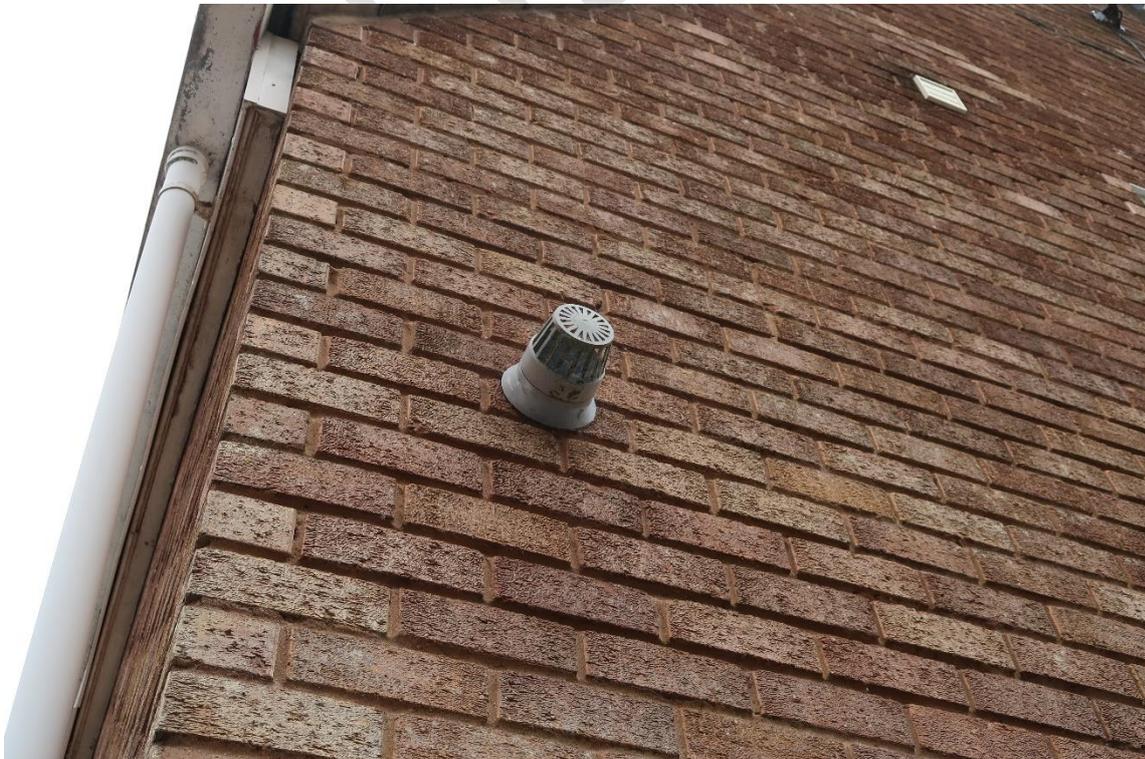
WE ASSUME THAT THIS VENTS THE SVP.

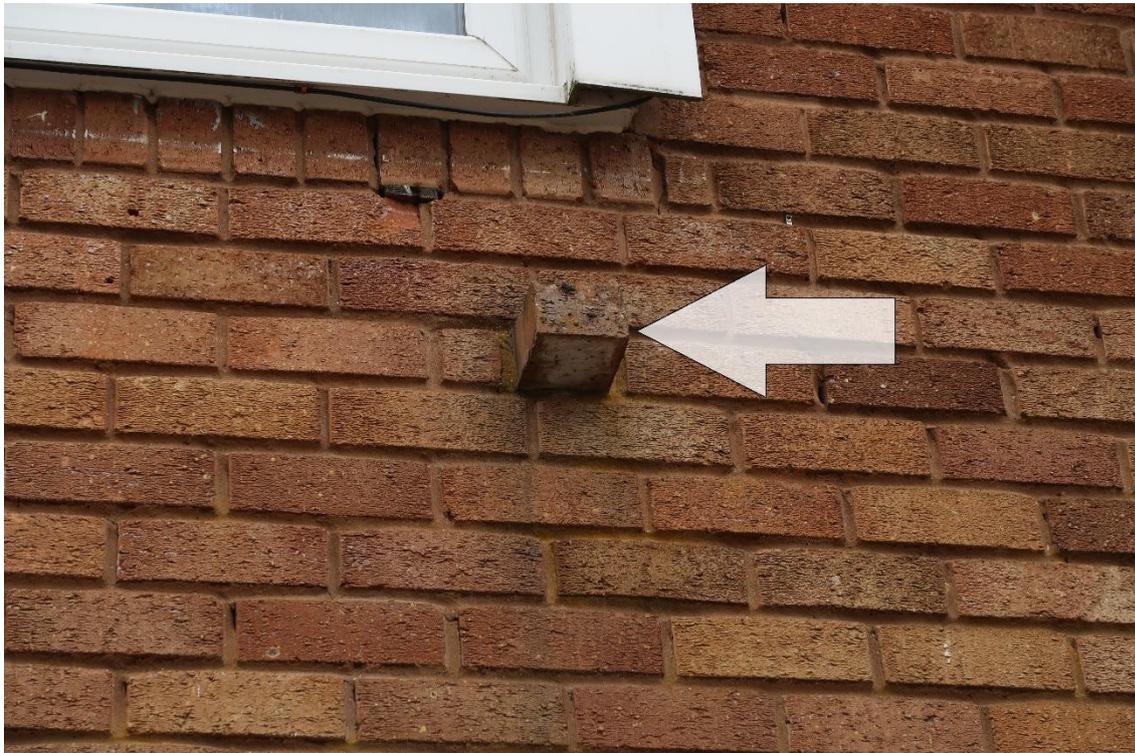
PROTRUDING BRICK.
