# BUILDING SURVEY

BUILDING SURVEY FOR \*\*\*\*\*

Date of Survey: \*\*\*\*\*

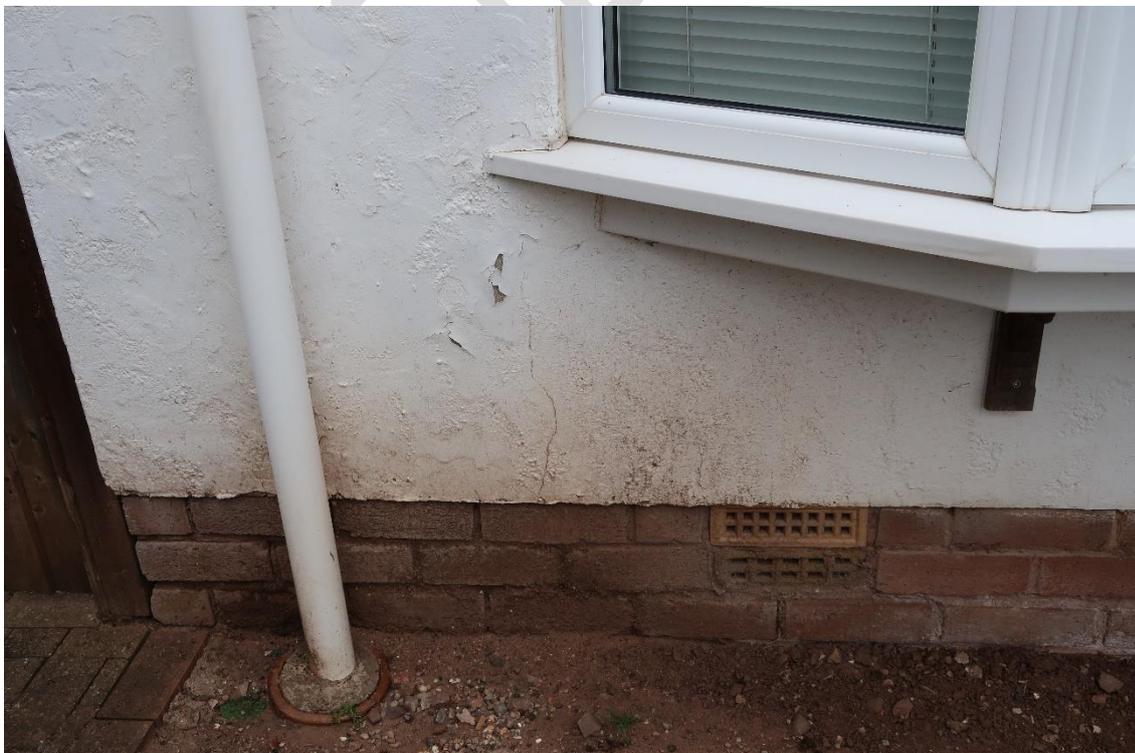
HAIRLINE CRACKS AND PEELING PAINT.

10.10 Where cracked, the render should be sealed and requires painting.

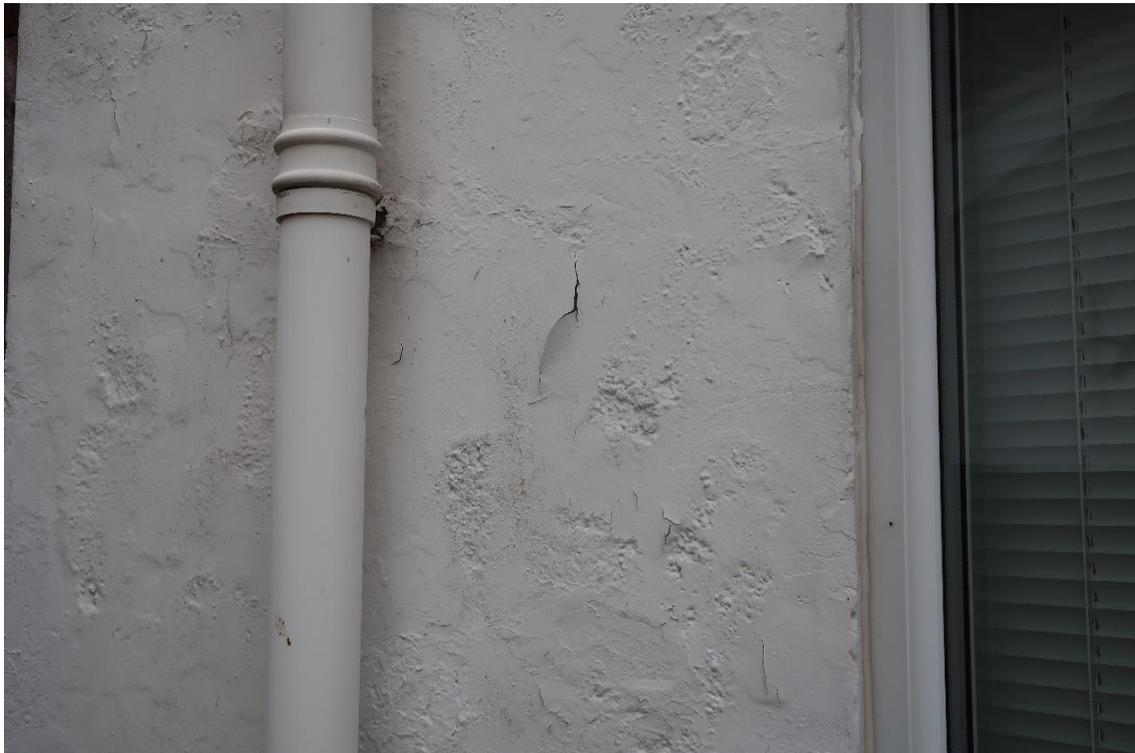
PEELING PAINT.

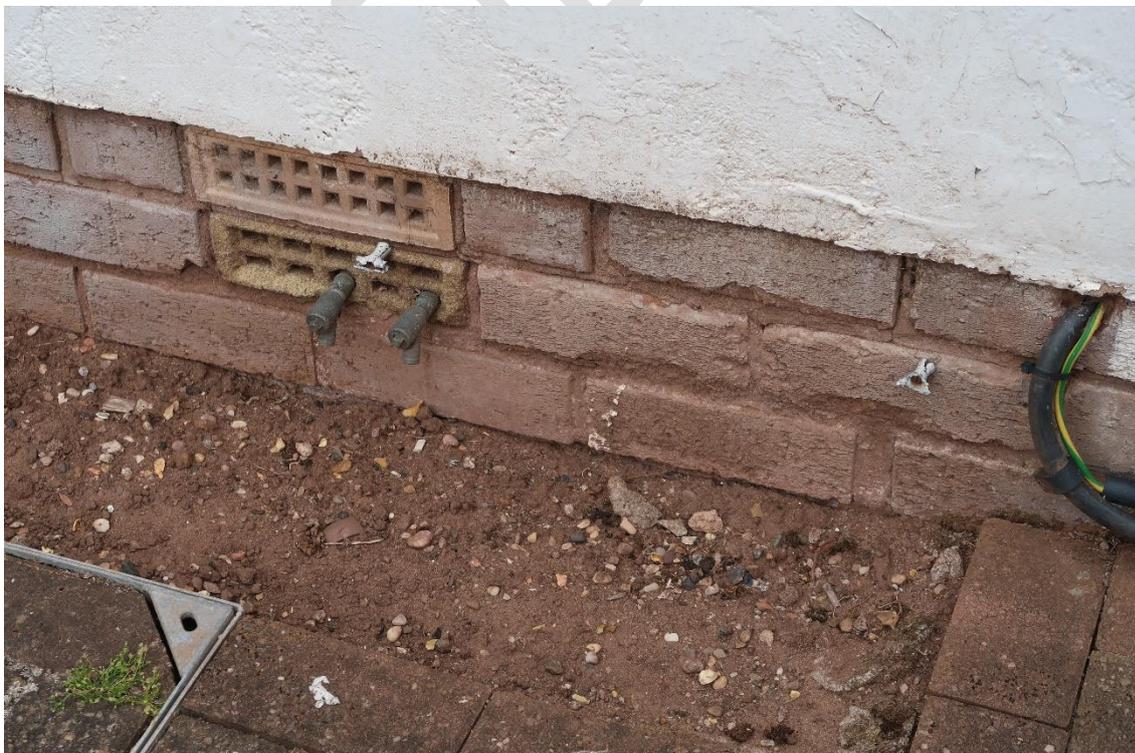
JOINTS BELOW THE RENDER WILL BENEFIT FROM RAKING OUT AND REPOINTING.

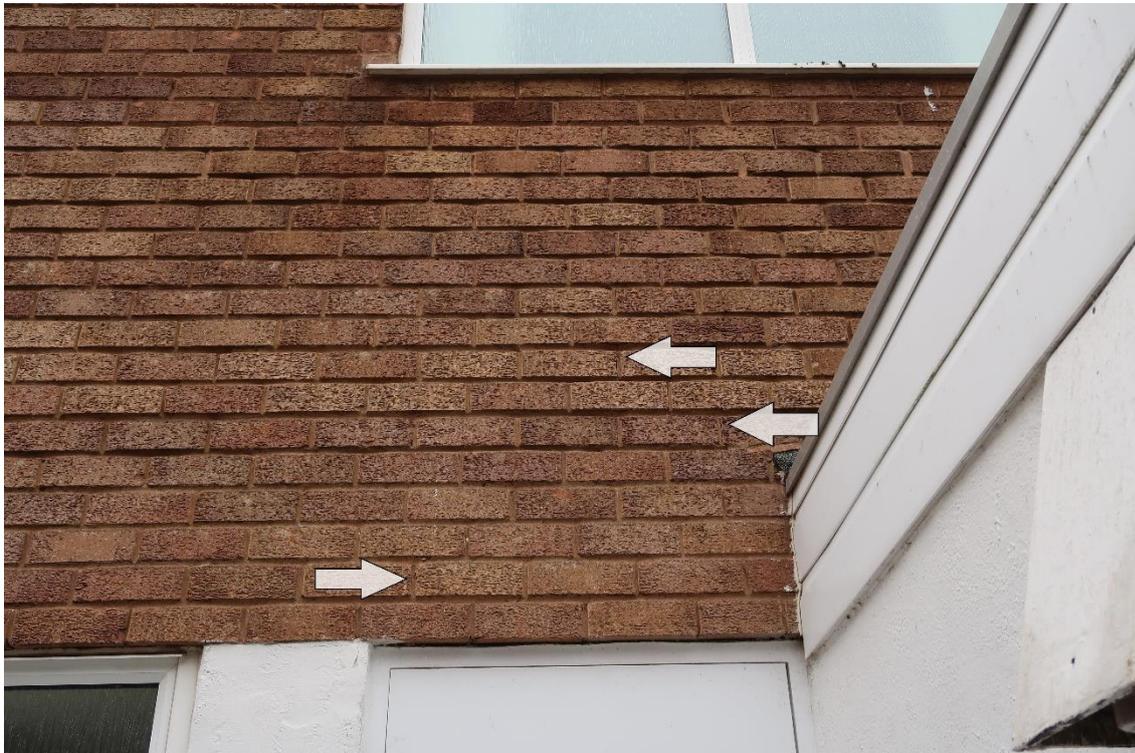
MINOR CRACKING ABOVE BIN STORE DOOR.

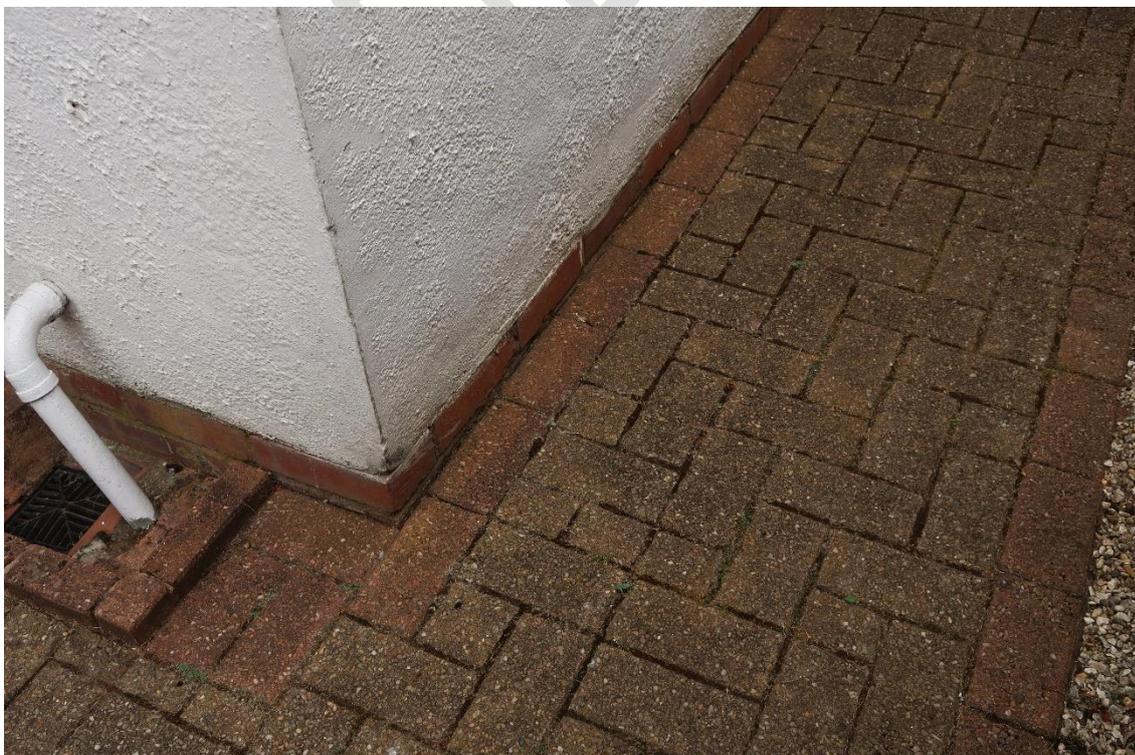
PAVING IS TOO CLOSE TO THE DPC.

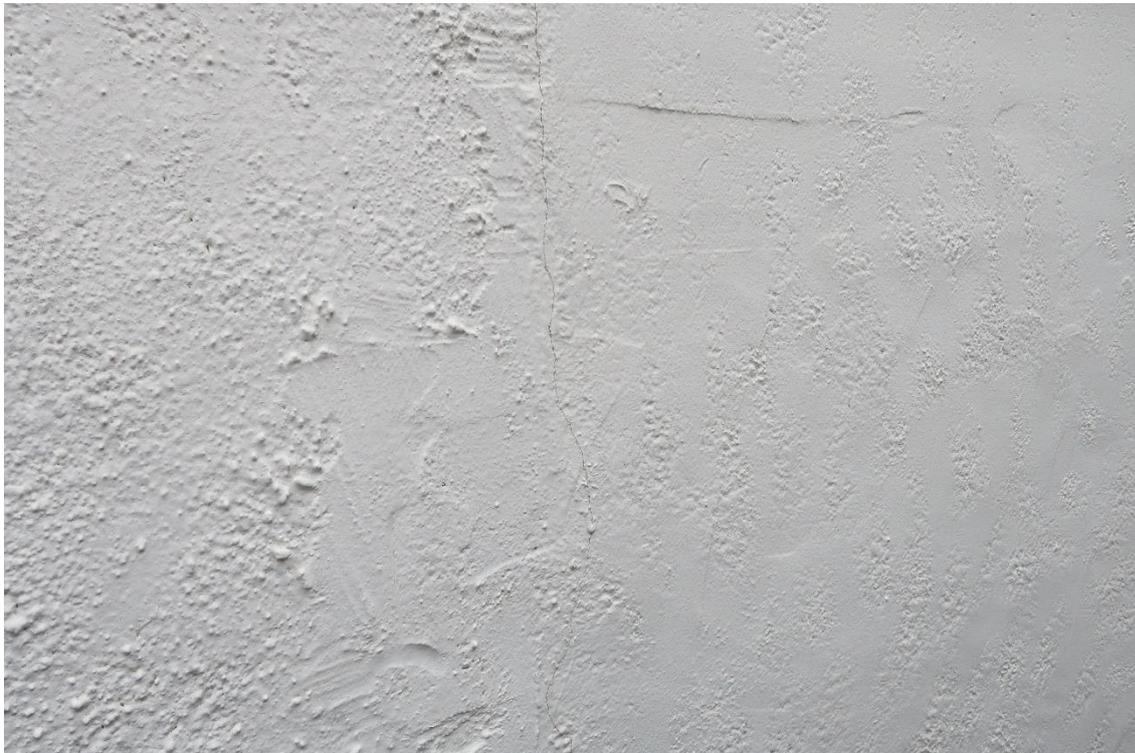
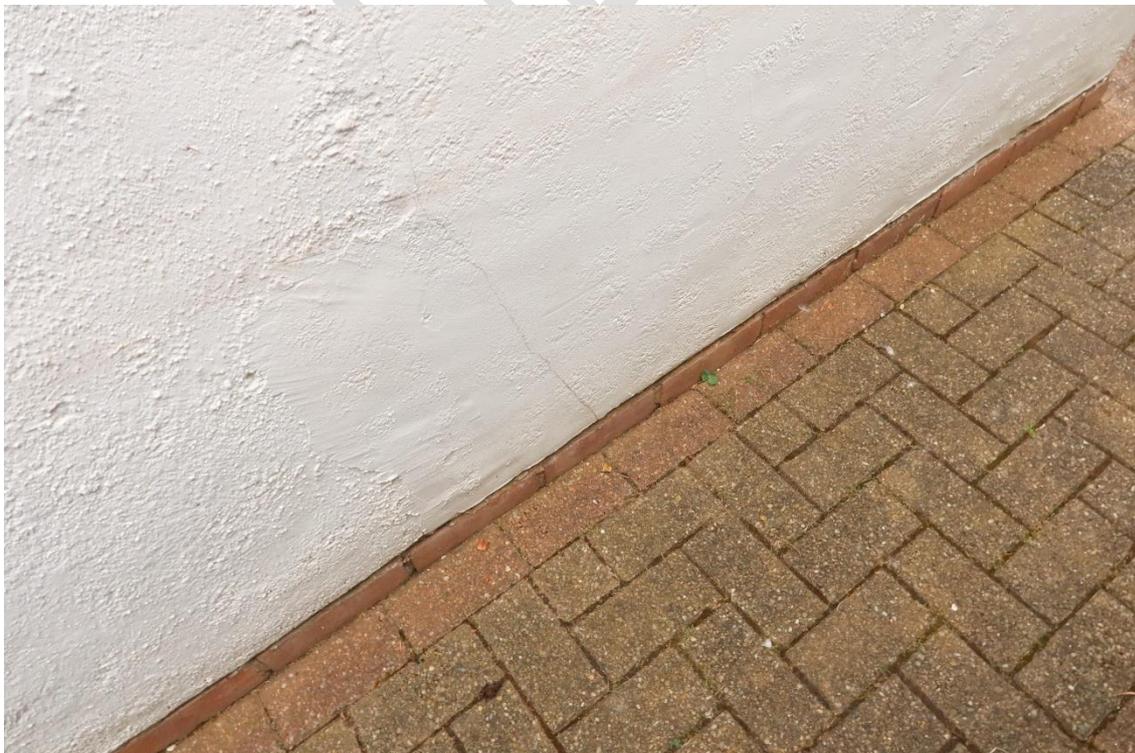
HAIRLINE CRACKING TO SIDE OF UTILITY WHERE "SINGLE SKIN" SECTION HAS BEEN ADDED.

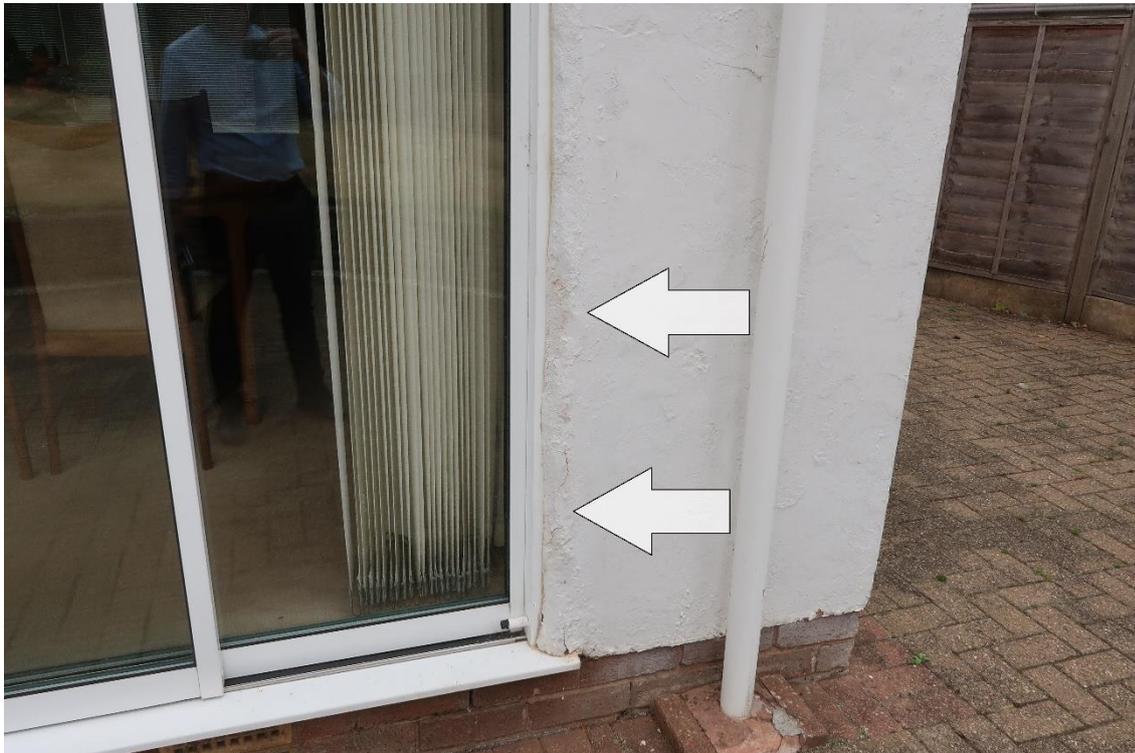
THIS LOOKS LIKE DAMP DAMAGE.

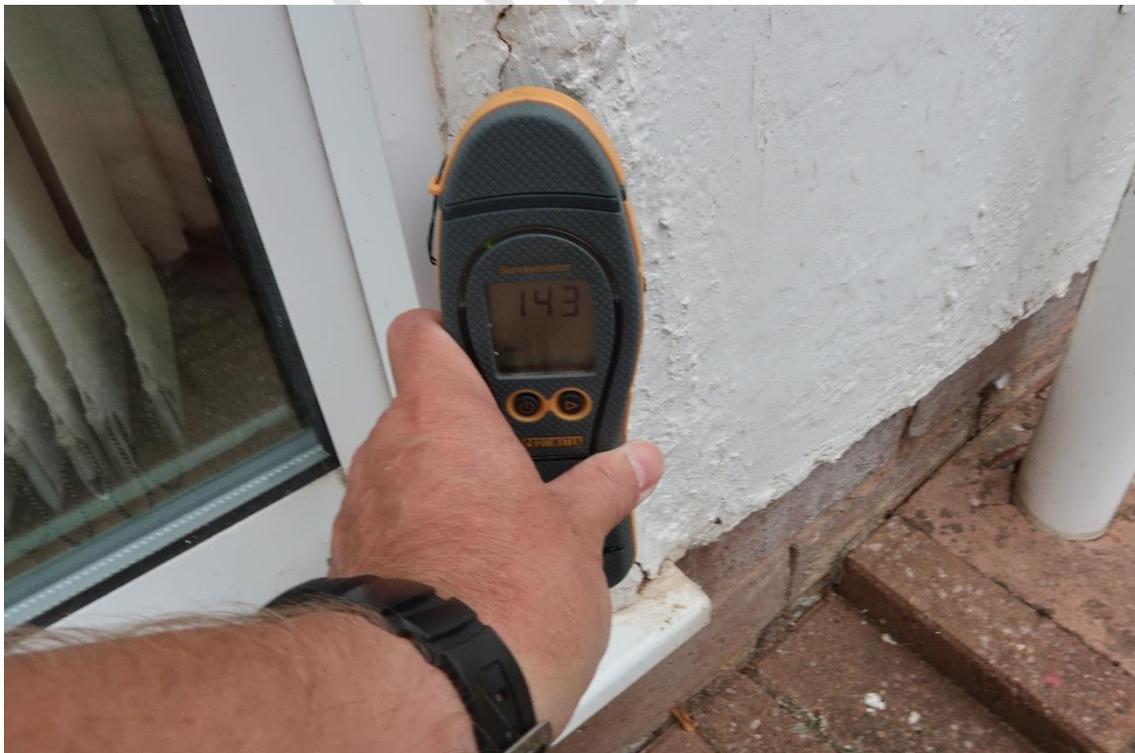
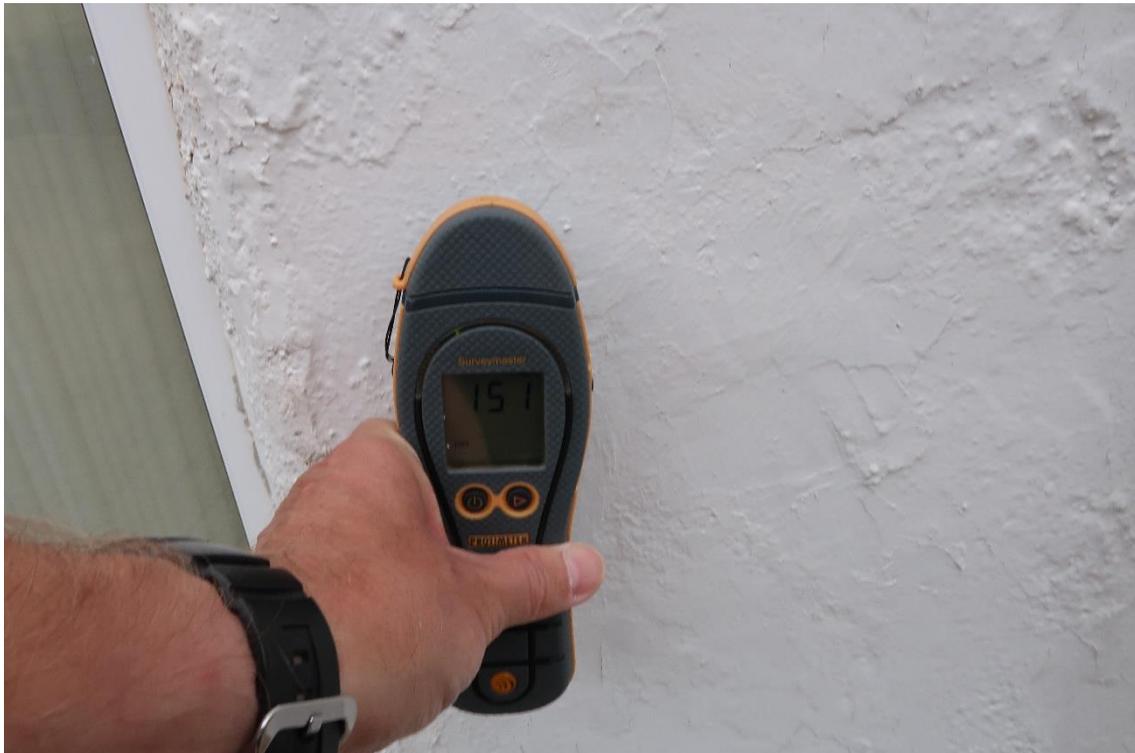
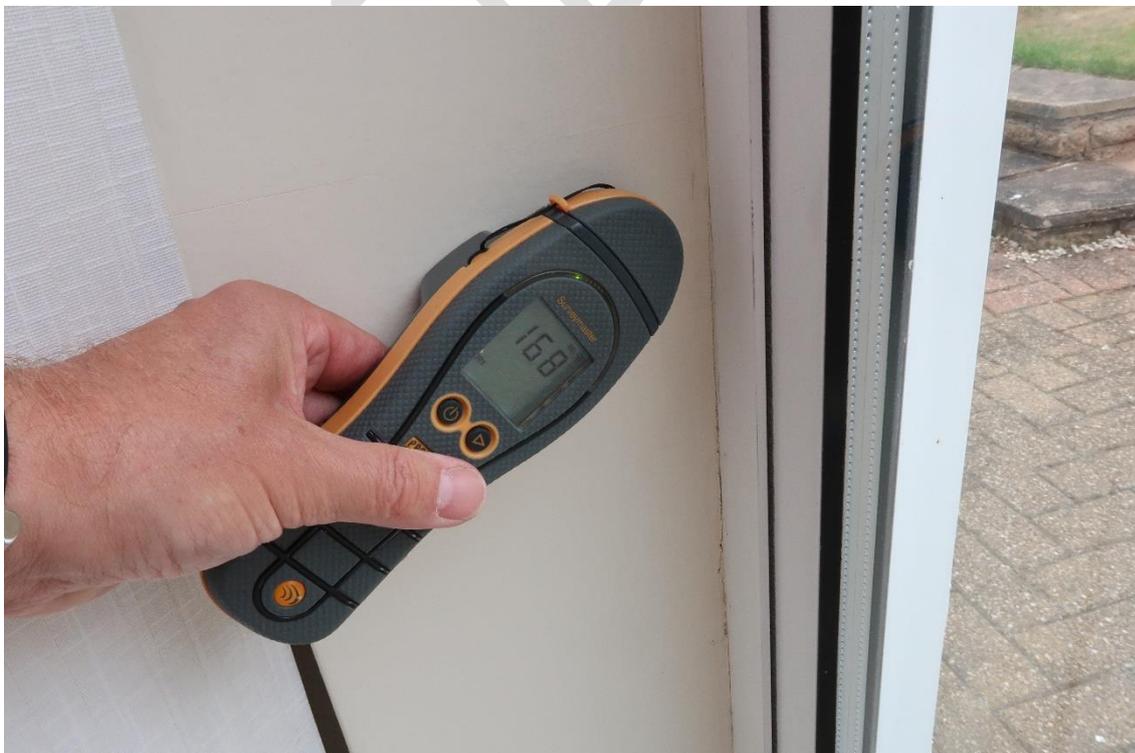
THE WALL IS DRY.

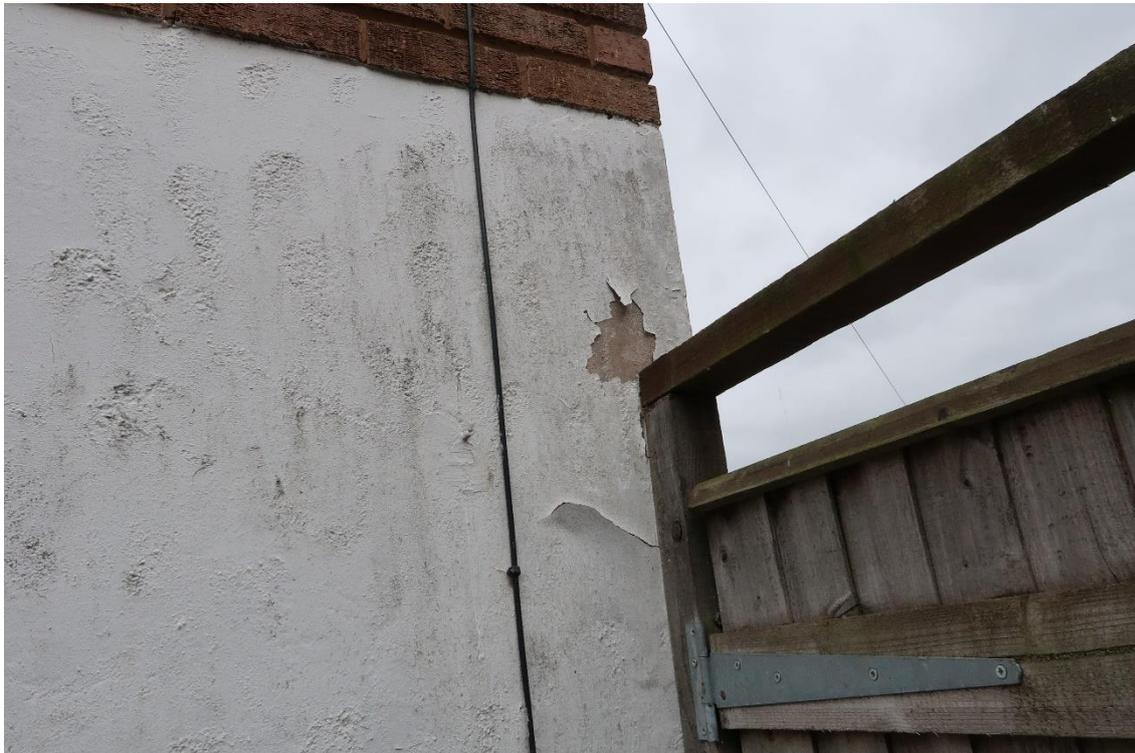
DAMAGED PAINT TO THE LEFT-HAND SIDE.

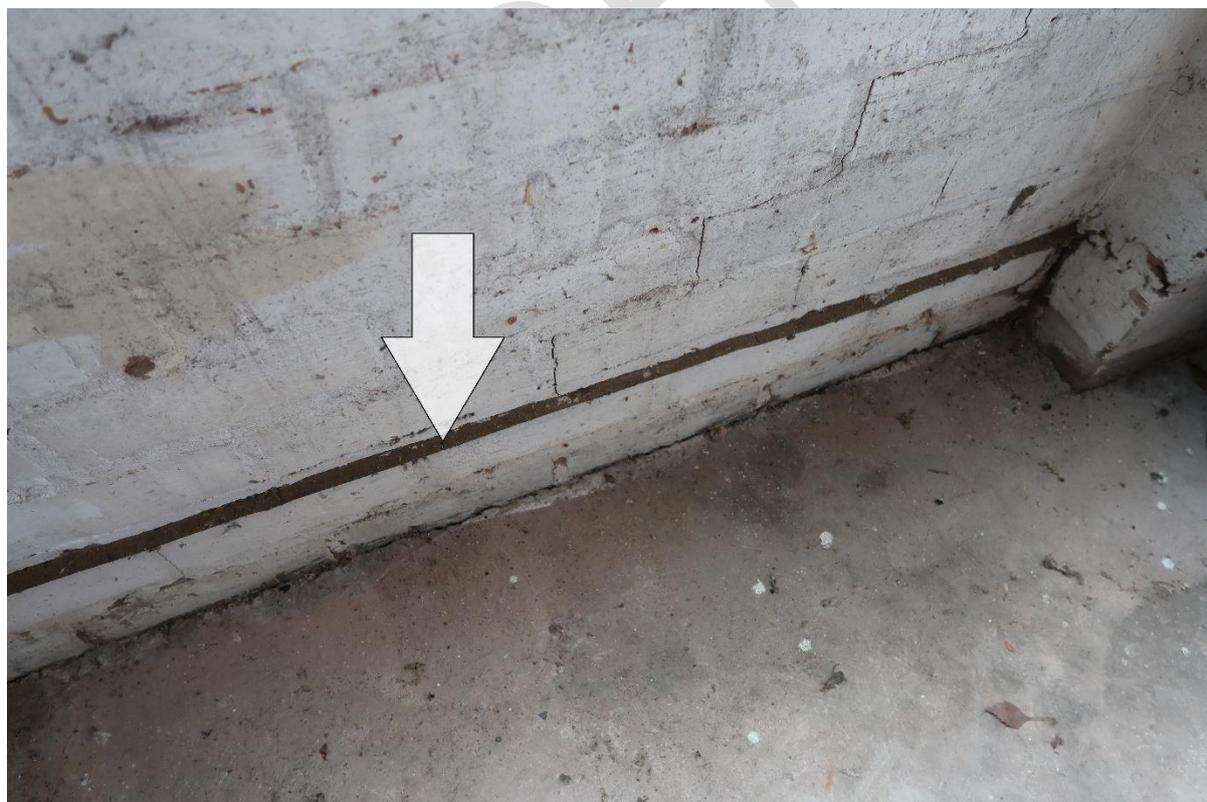
11.04 This bitumen DPC could contain asbestos. There is no danger to health where it is encapsulated within the brickwork, but to the garage, it is exposed and if it is damaged, it could release asbestos fibres. We have discussed this with you and recommended a full house inspection for asbestos.

EXPOSED DPC TO THE GARAGE.

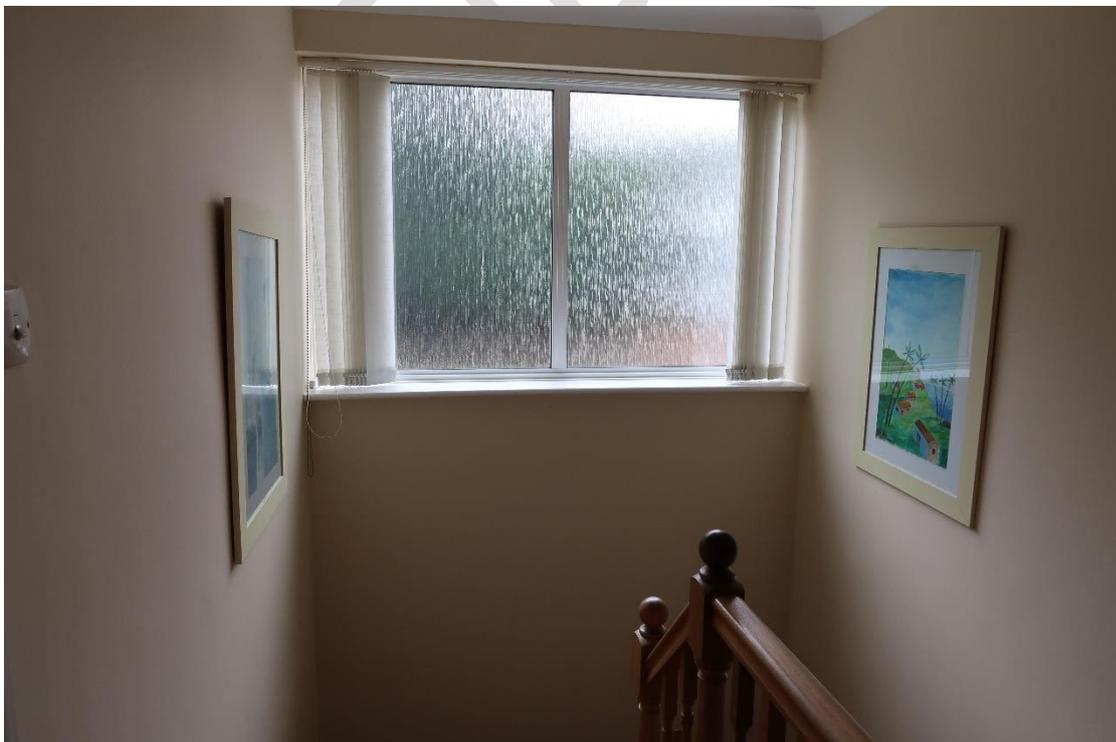
THE LANDING WINDOW IS POSITIONED WHERE YOU COULD FALL AGAINST IT.

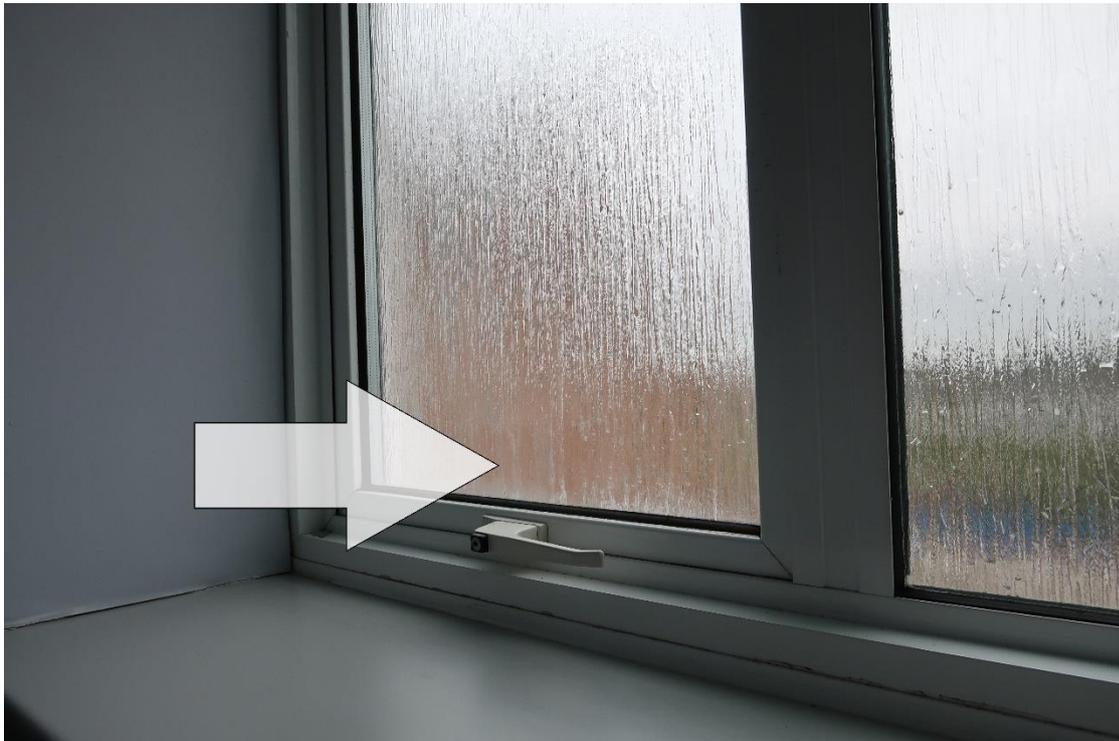
FAILED BATHROOM UNIT.

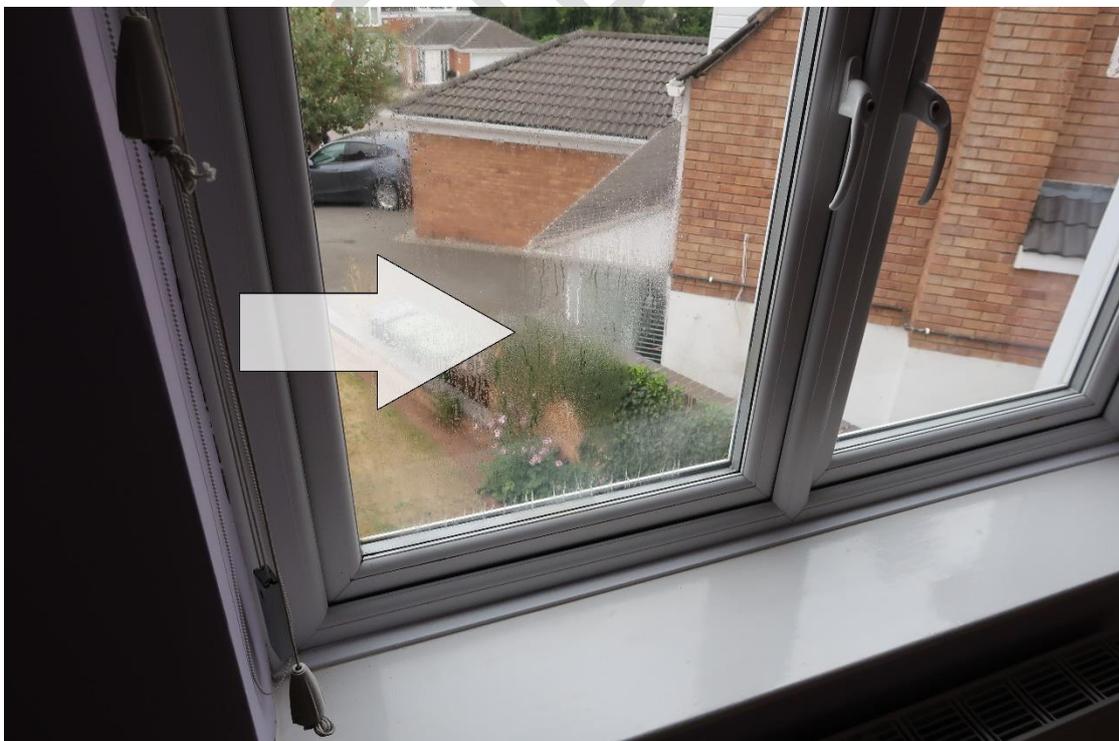
FAILED BEDROOM UNIT.

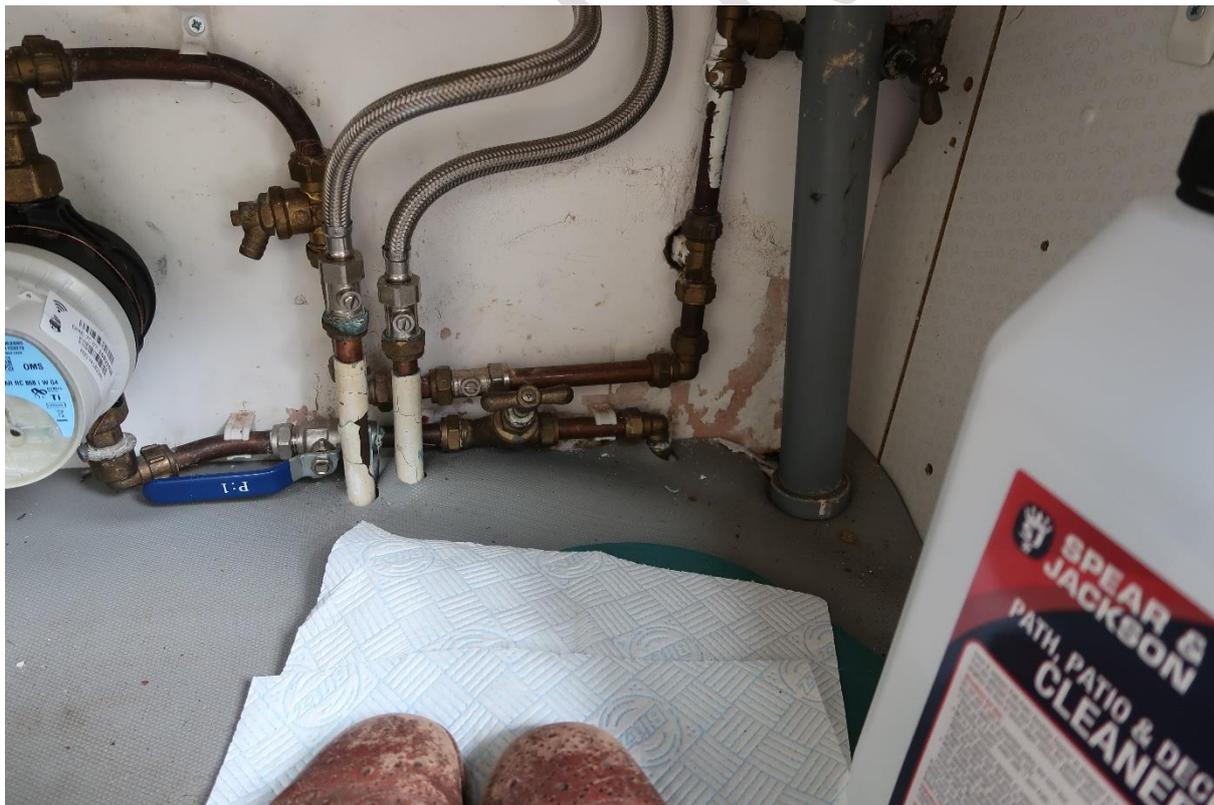
19.04 We did note what looked like damp damage within the utility sink unit. It tested dry with a damp meter.

THIS LOOKS LIKE DAMP DAMAGE BUT IT IS DRY.

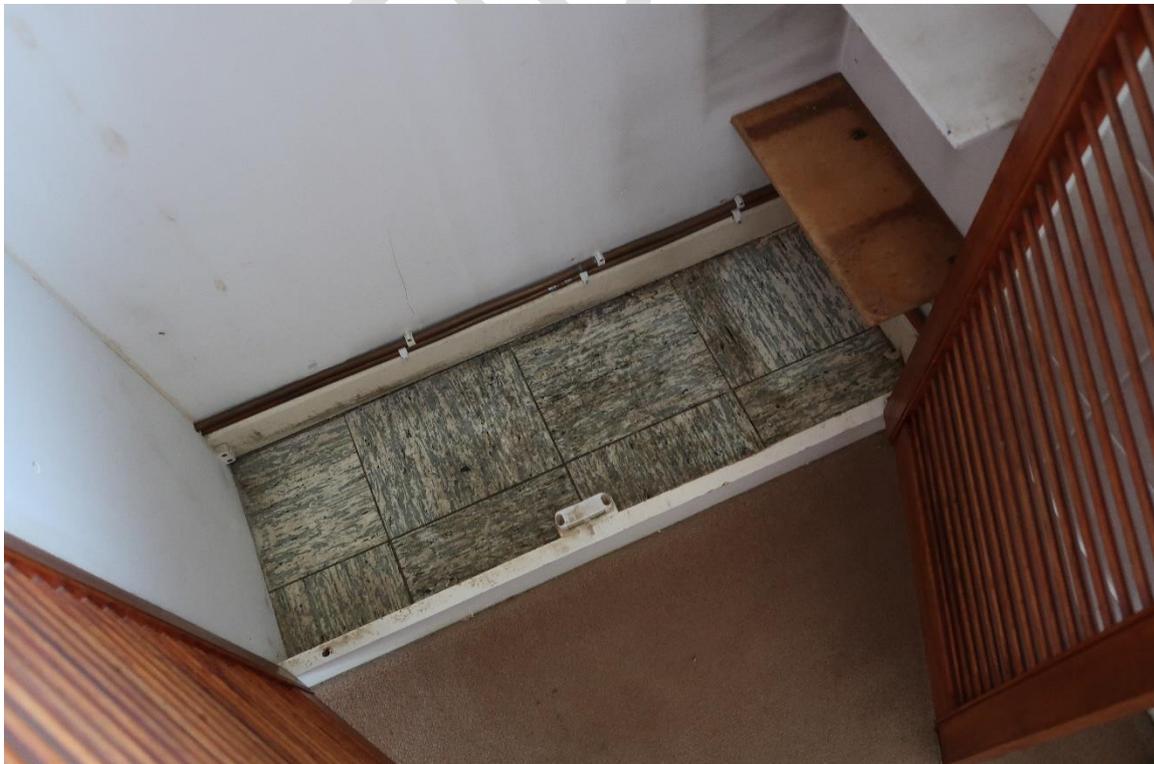
ORIGINAL VINYL TILES.

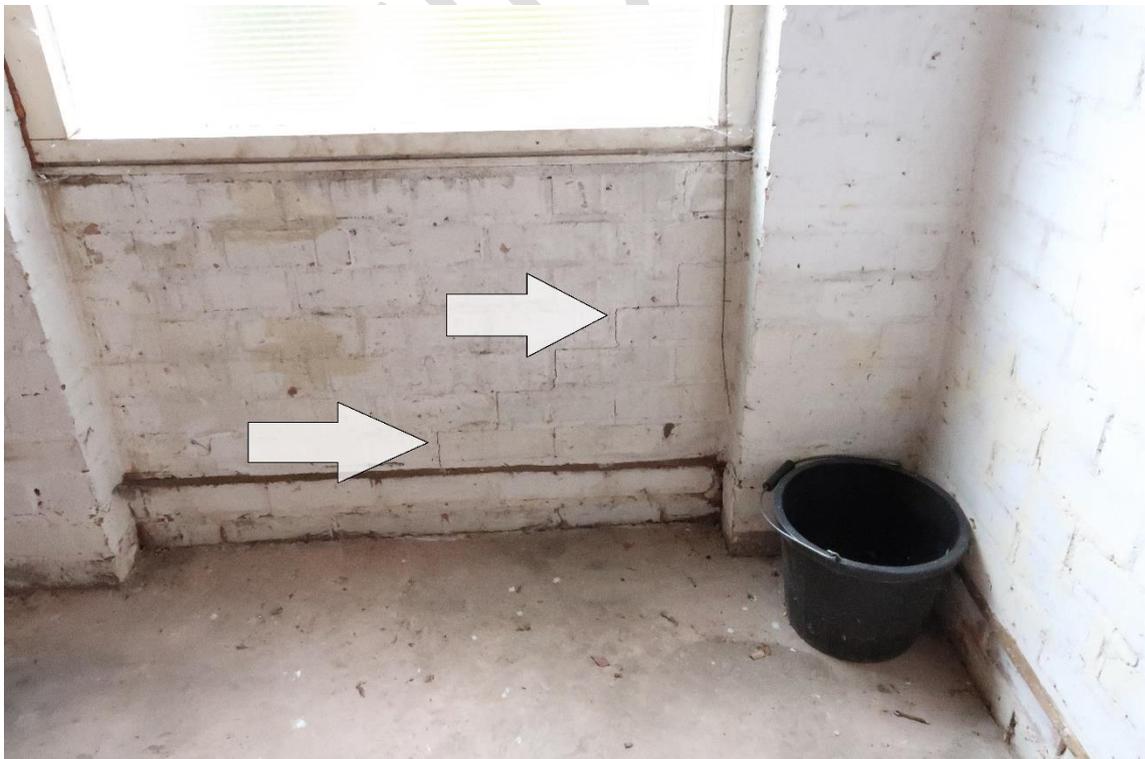
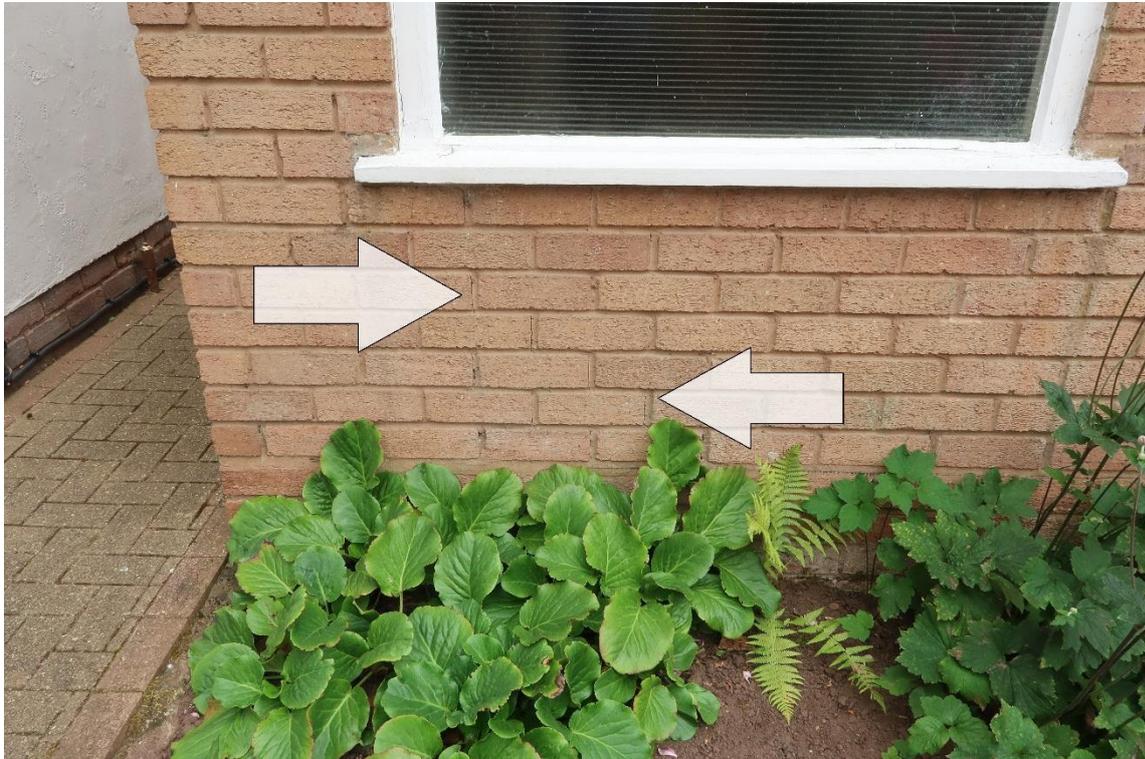
RAKING CRACK TO GARAGE.

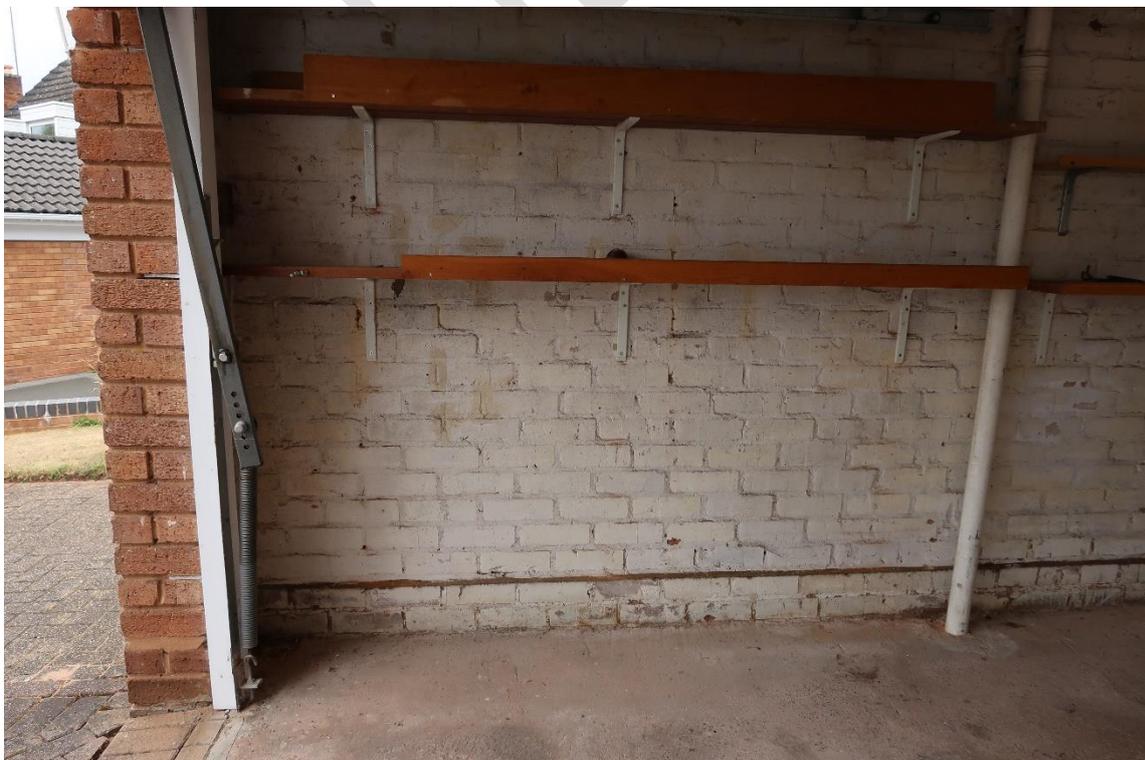
THIS WALL LOOKS LIKE SEVERAL CRACKS HAVE BEEN REPOINTED.

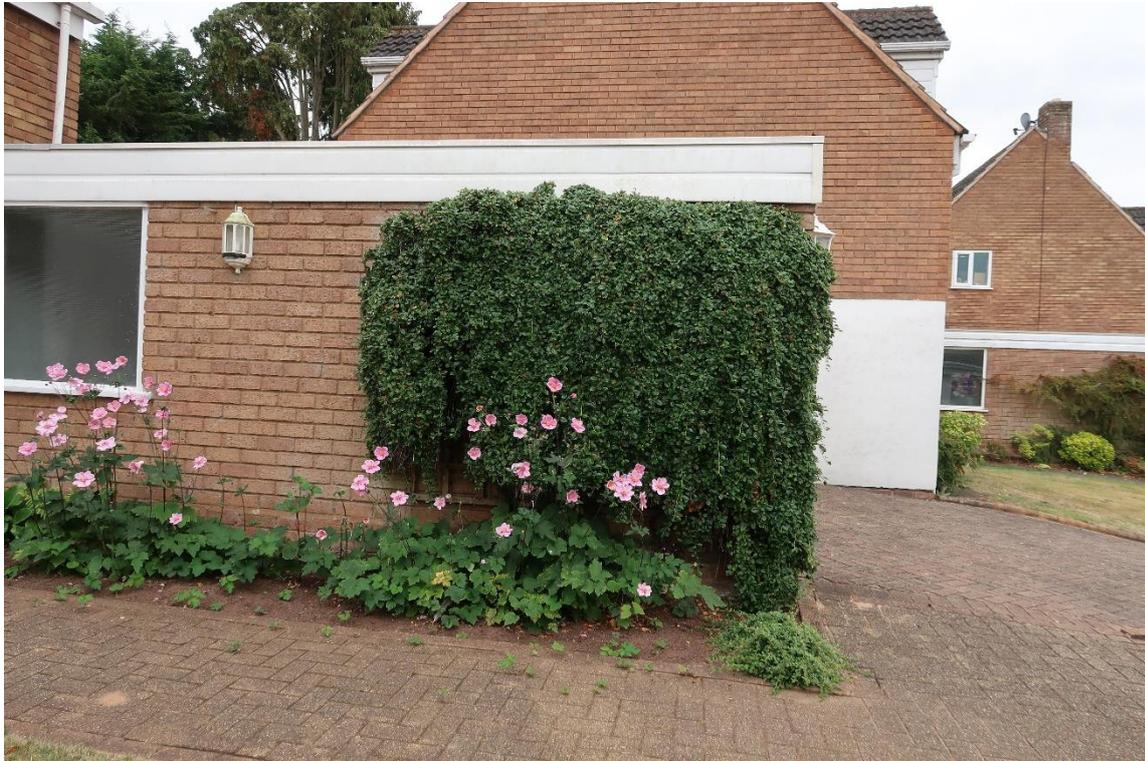
PLANTING COVERED THE OUTSIDE OF THE WALL.

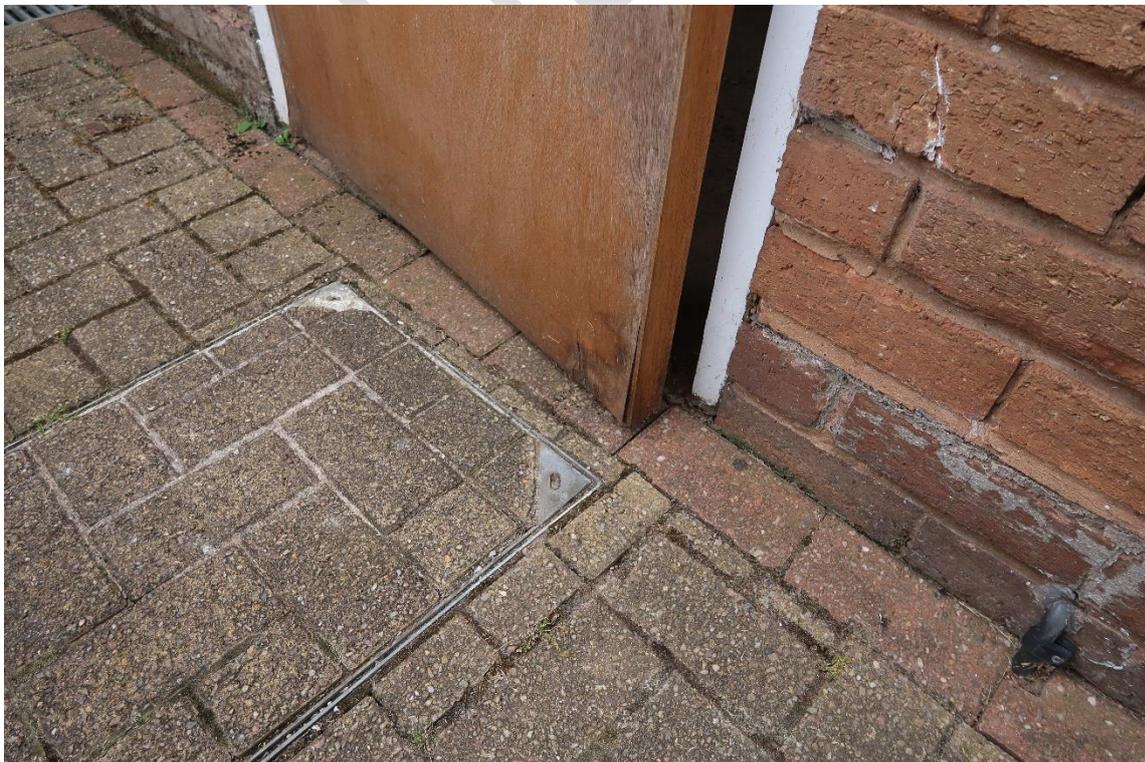
BASE OF DOOR IS ROTTING.

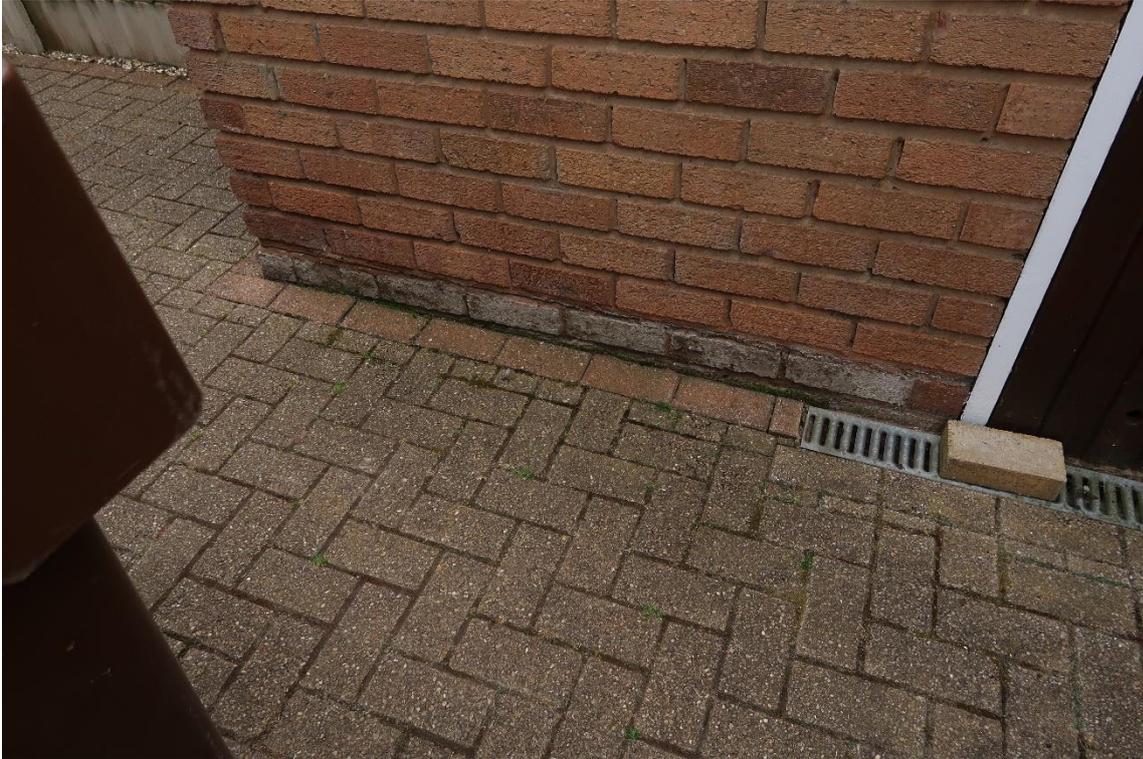
DAMP DAMAGE TO THE BASE OF THE STORE WALL.

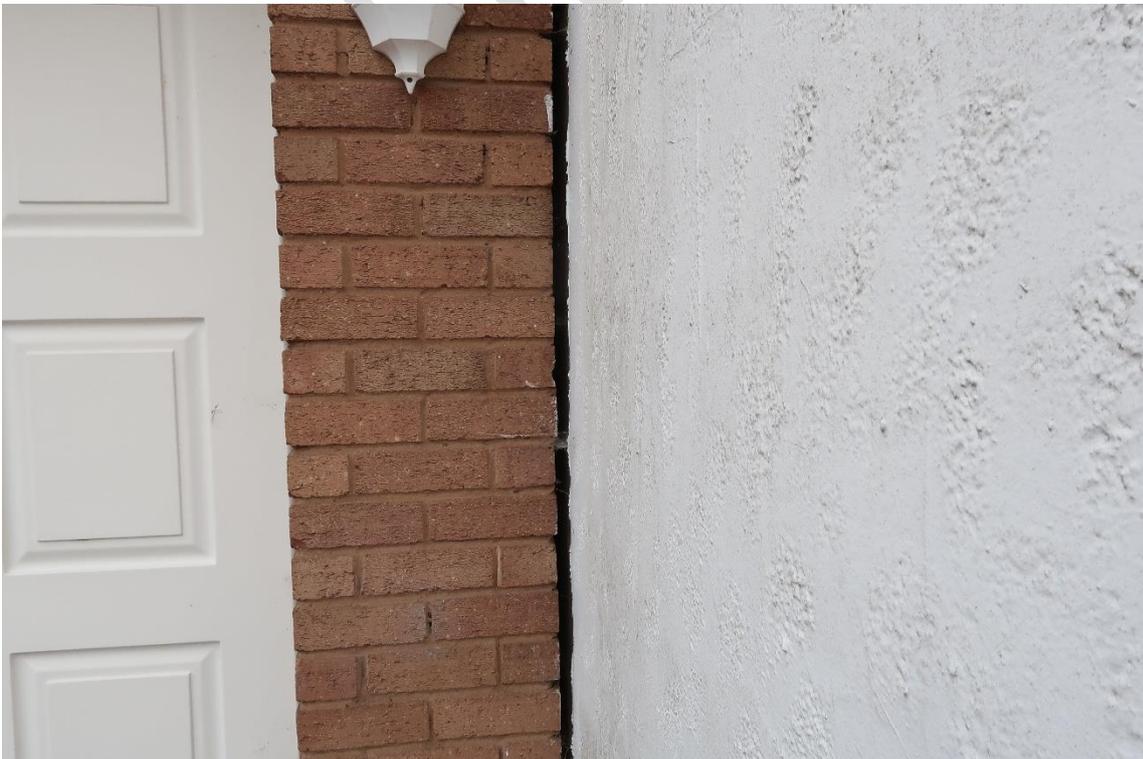
THERE IS A SMALL GAP BETWEEN THE GARAGE AND THE NEIGHBOUR'S HOUSE.

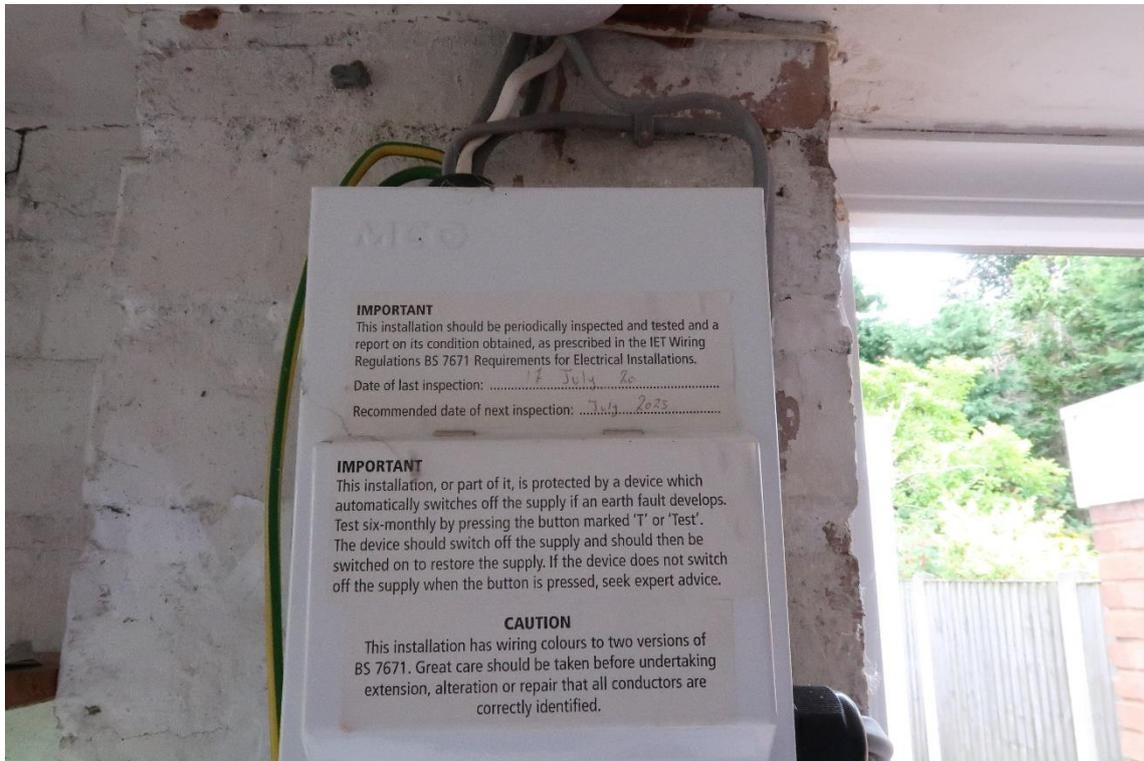
THE GARAGE ELECTRICS ARE DUE FOR REINSPECTION.
