# BUILDING SURVEY

BUILDING SURVEY FOR \*\*\*\*\*

Date of Survey: \*\*\*\*\*

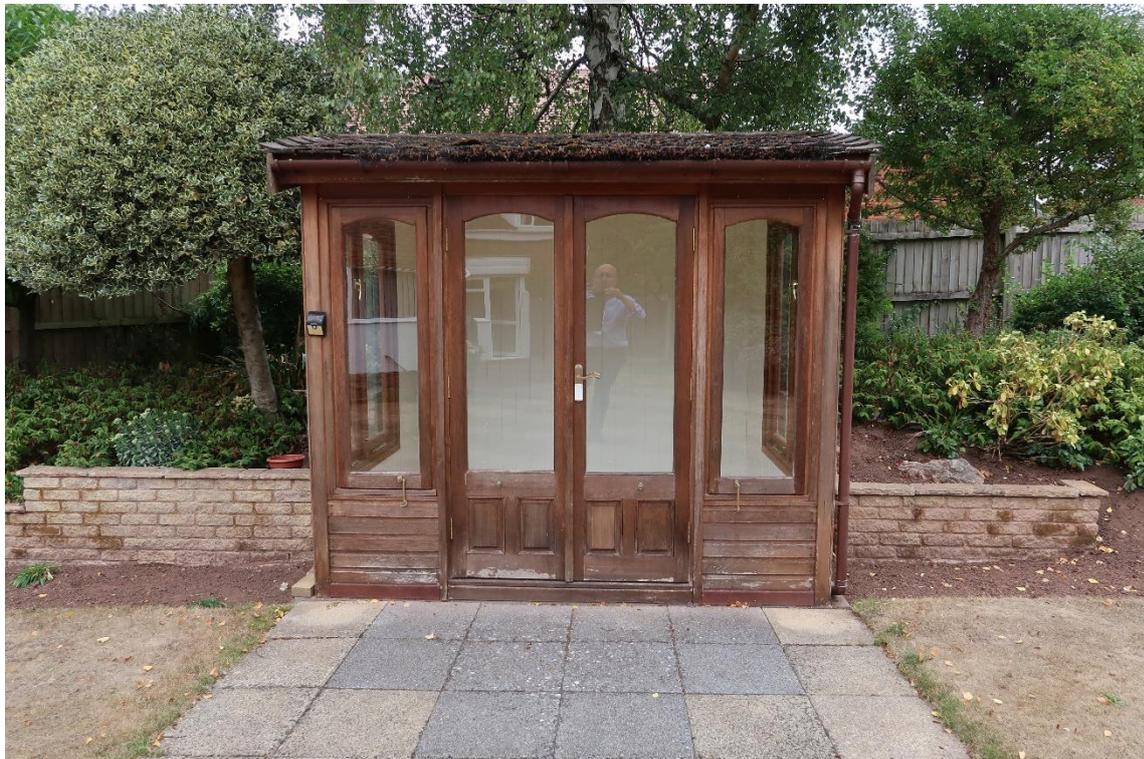
ROOF IS VERY OLD TO THE SUMMER HOUSE.

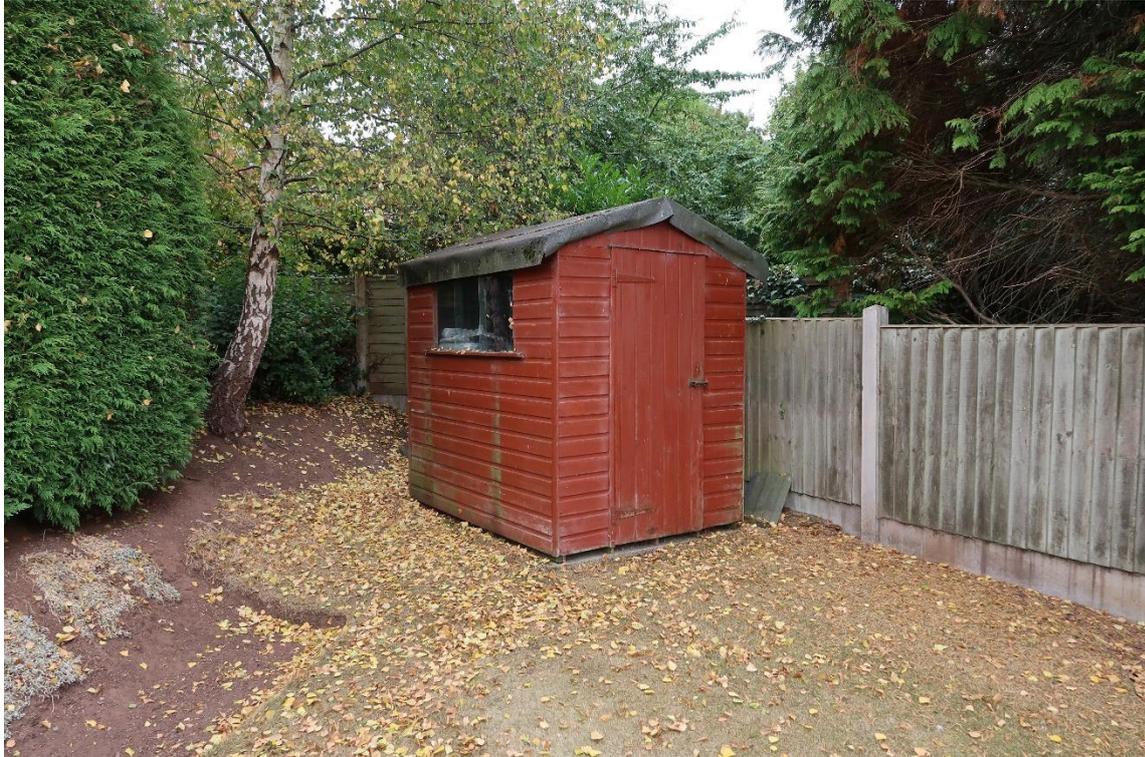
ROOF FELT IS LOOSE.
