BUILDING SURVEY

BUILDING SURVEY FOR *****

*****,
*****,
*****,
Birmingham,
*****.

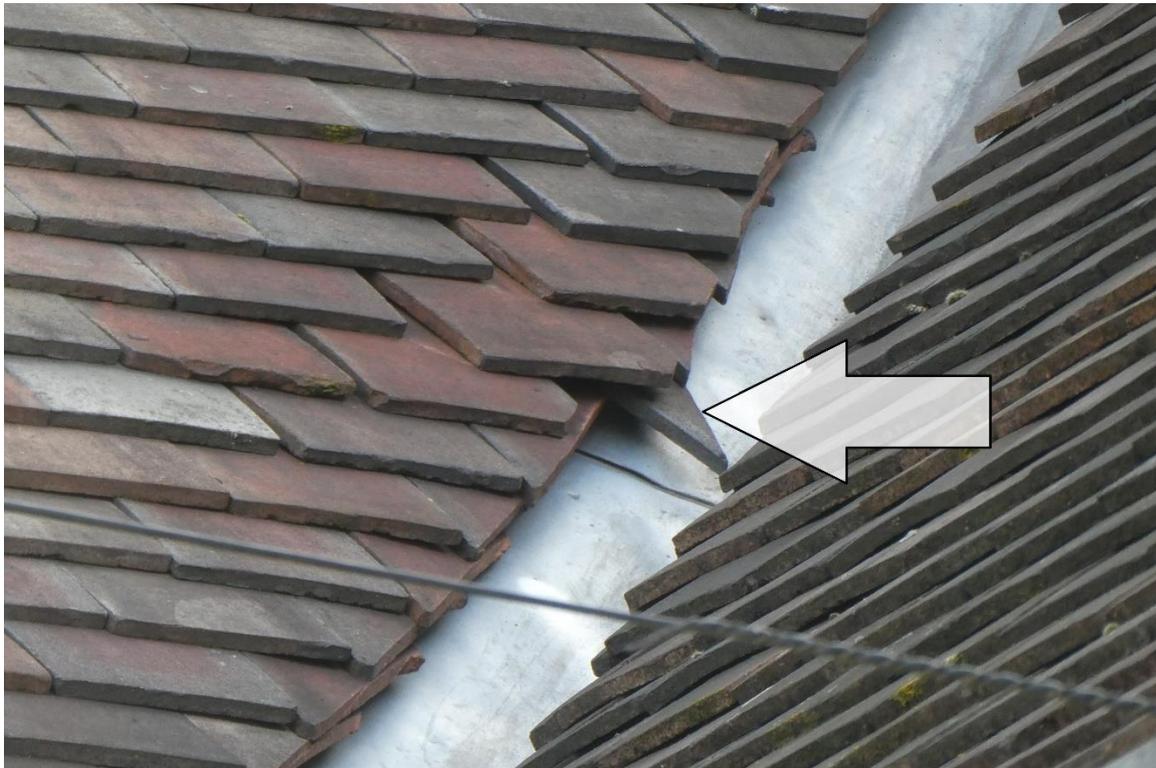
1. One cut valley tile looks like it has slipped to the front valley.
2. We could not see mortar to the valleys. Traditionally, mortar is used to the edge of the lead lined valleys to weather-proof them although other means to can be used to stop rainwater getting into the valley edges. The valleys should be inspected.
3. One tile is missing to the front of the extension.
4. Three broken tiles and one slipped tile to the right-hand side of the lower and second-storey extension.
5. To the rear eaves, the tiles look uneven, and this can be caused by the lower of the double-laid tiles deteriorating.
6. The lead flashing has been missed to the front return above the porch. This needs to be installed.

SLIPPED CUT VALLEY TILE. NOTE THAT YOU CANNOT SEE MORTAR TO THE EDGE OF THE VALLEYS.

3.06 We recommend that the roof is inspected by a roofing contractor, and they replace all of the missing or broken tiles and the missing lead flashing. They should also check the condition of the mortar to hips, ridges, and valleys. They can also give you a quotation to lift and refix all ridge and hip tiles in a ventilated dry-fix system. They should also allow for a ventilated eaves system:

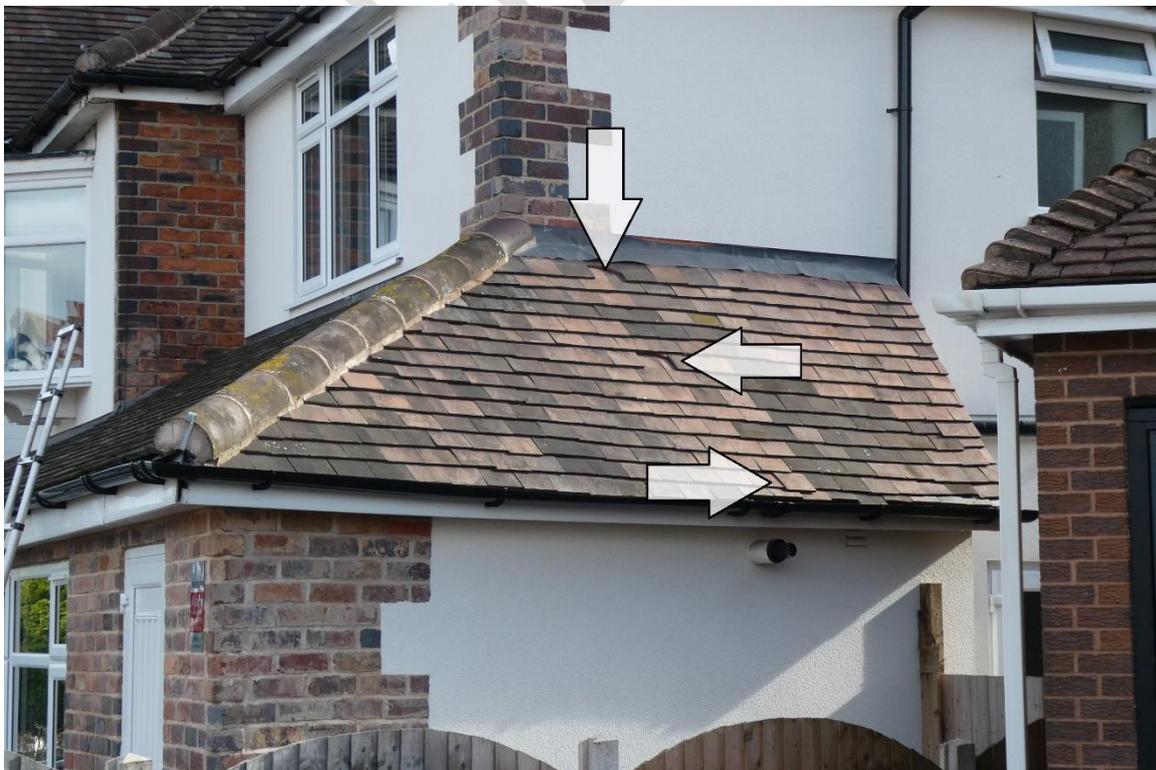
BROKEN AND SLIPPED TILES.

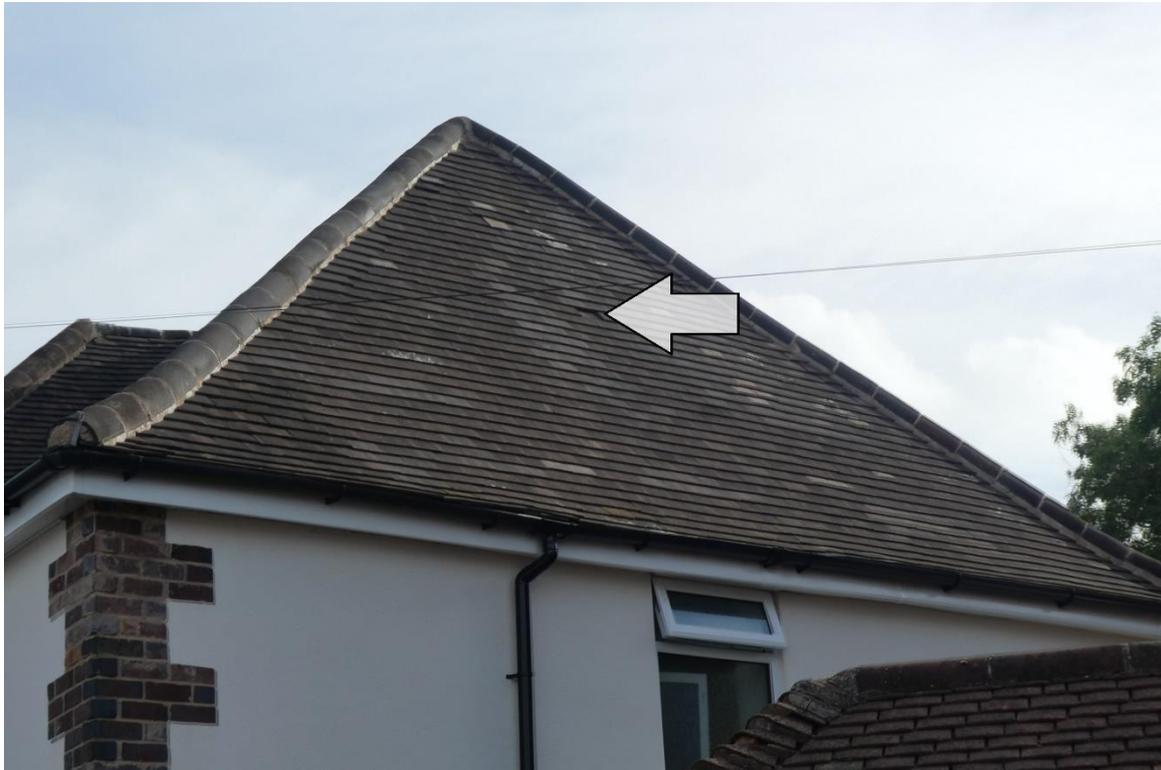
BROKEN TILE.

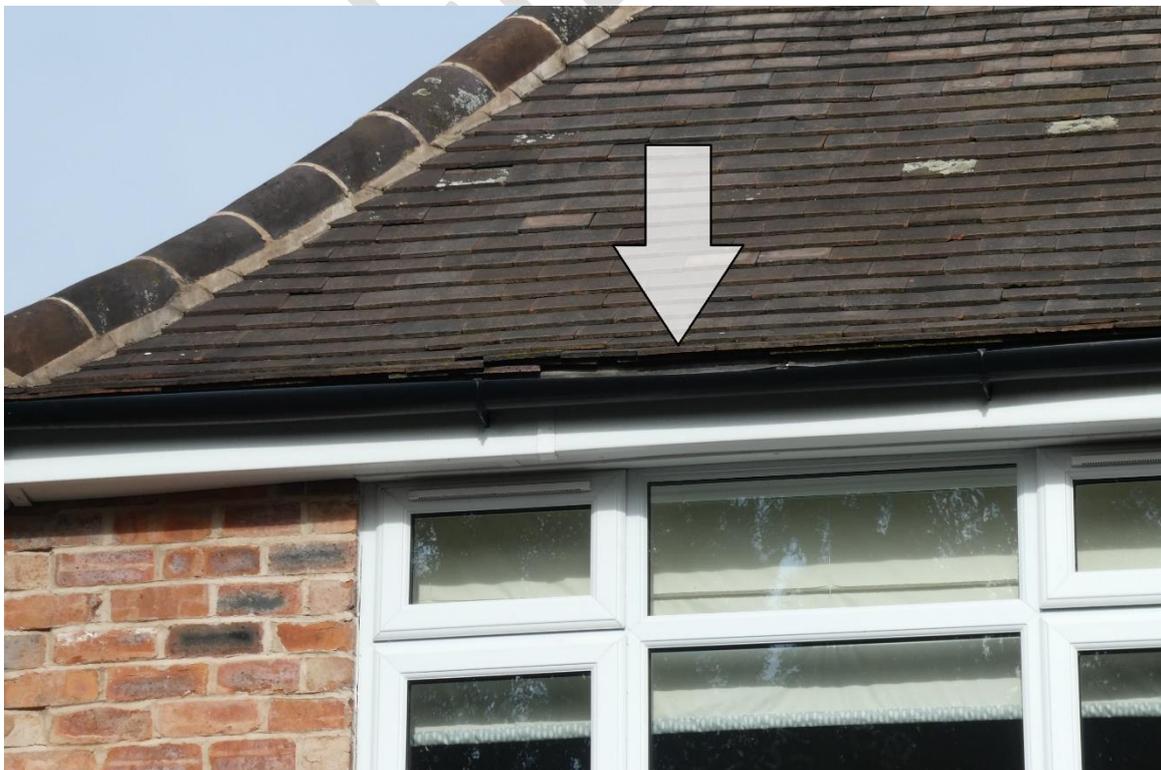
UNEVEN EAVES NEEDS TO BE CHECKED.

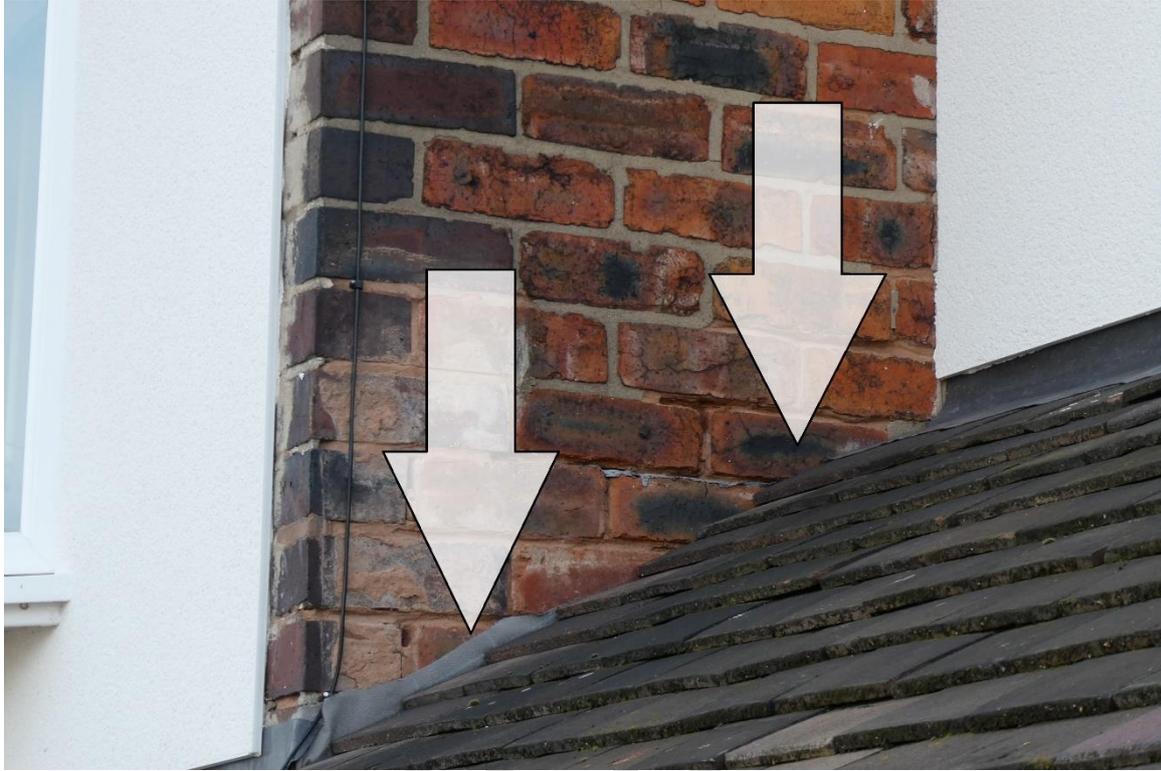
LEAD FLASHING IS MISSING.

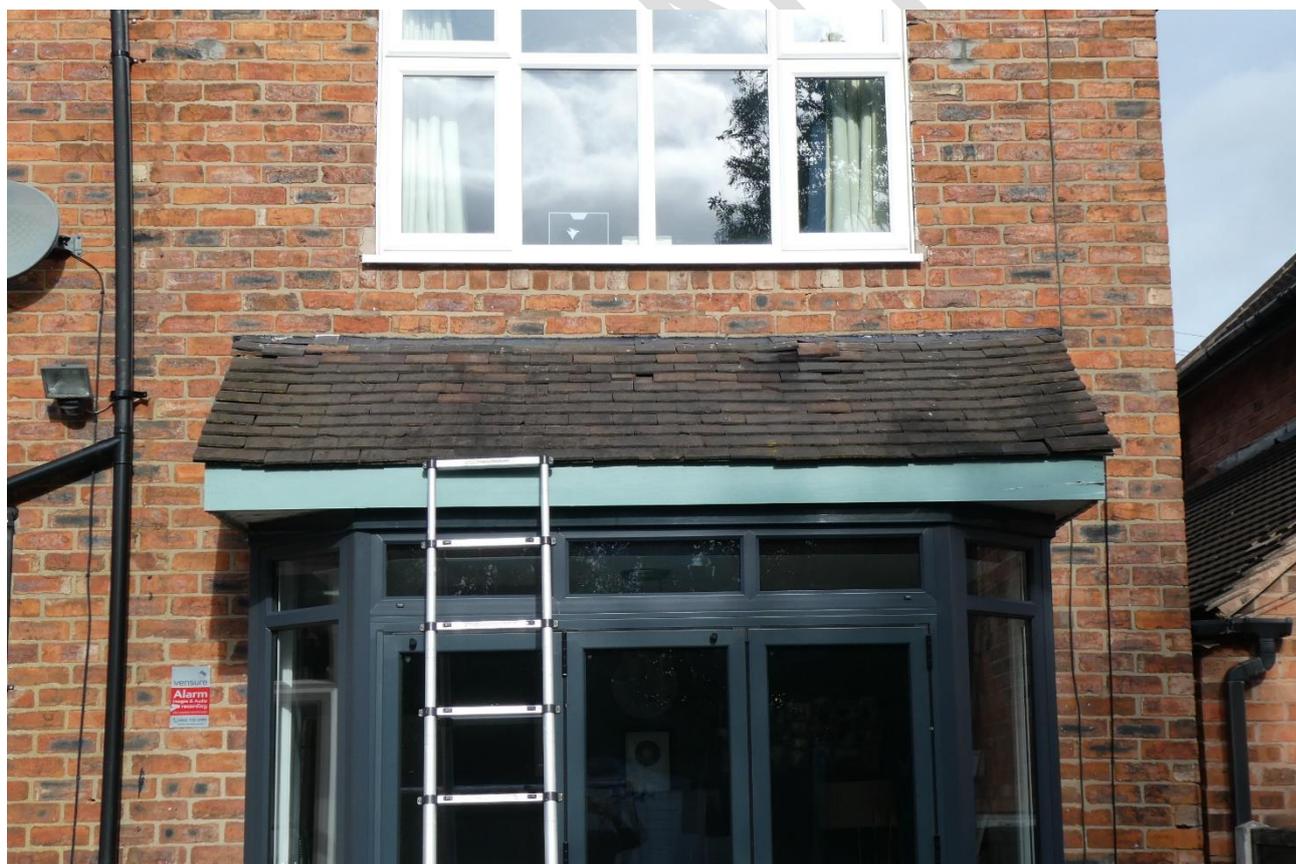
3.09 This small roof is covered in original clay plain tiles. The tiles look older than those used to the other roofs and there are broken tiles.

THIS ROOF REQUIRES RENEWAL.

3.11 The roof finish should be replaced with new membrane, battens, and tiles to BS5534. The flashing to the house wall should also be replaced with lead roll.

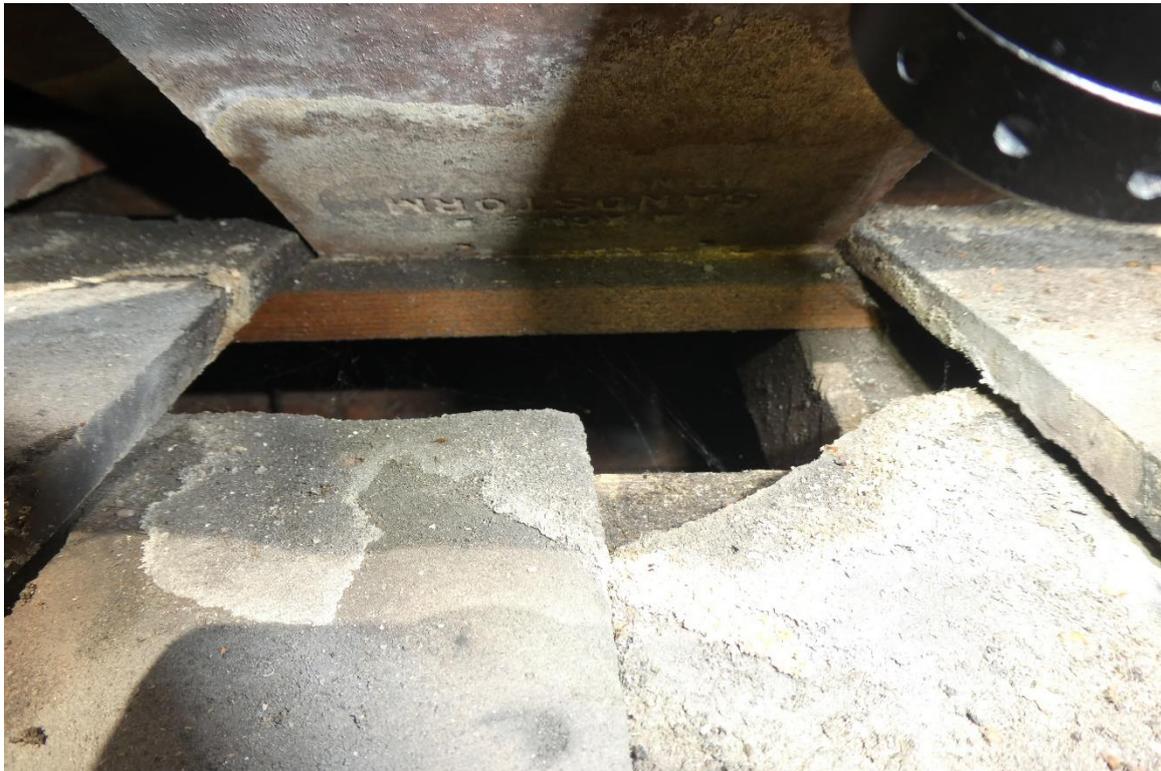
LOOKING UNDER THE TILES. THE ROOF IS UNLINED.

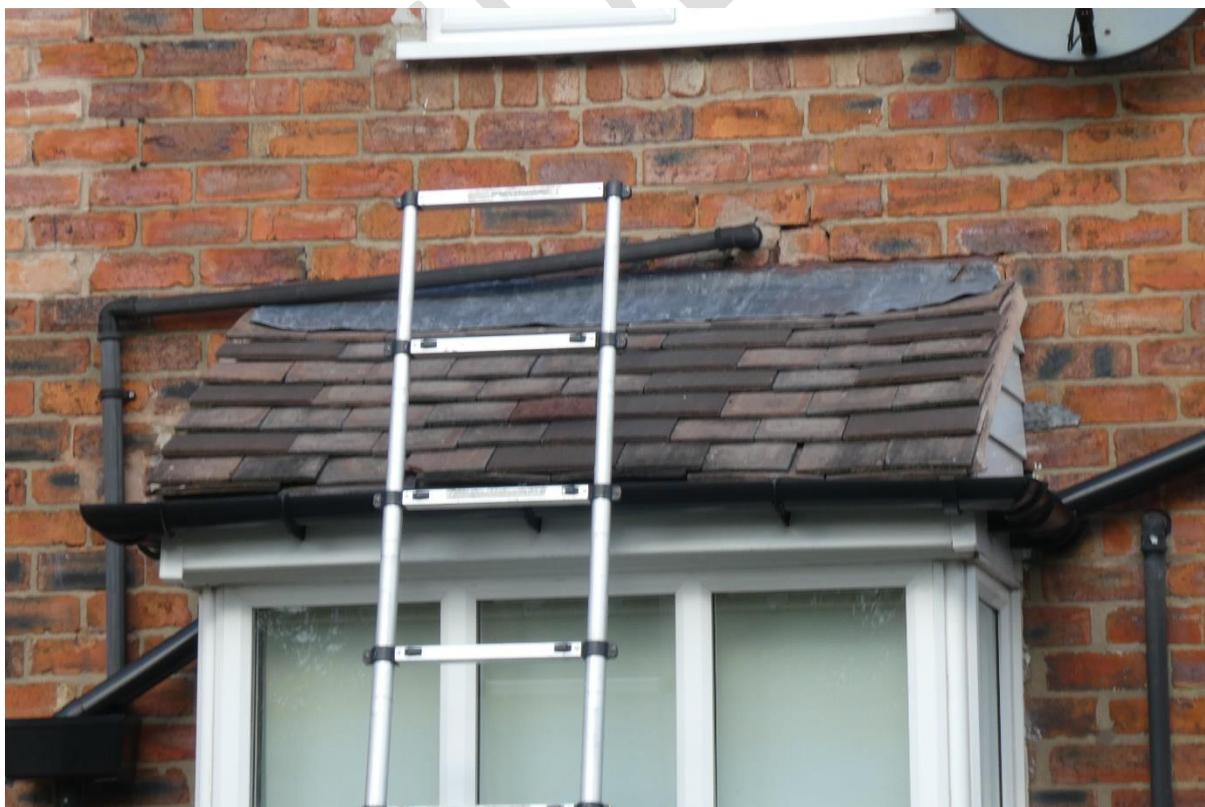
THIS ROOF IS NOT ON THE PLANNING DRAWINGS.

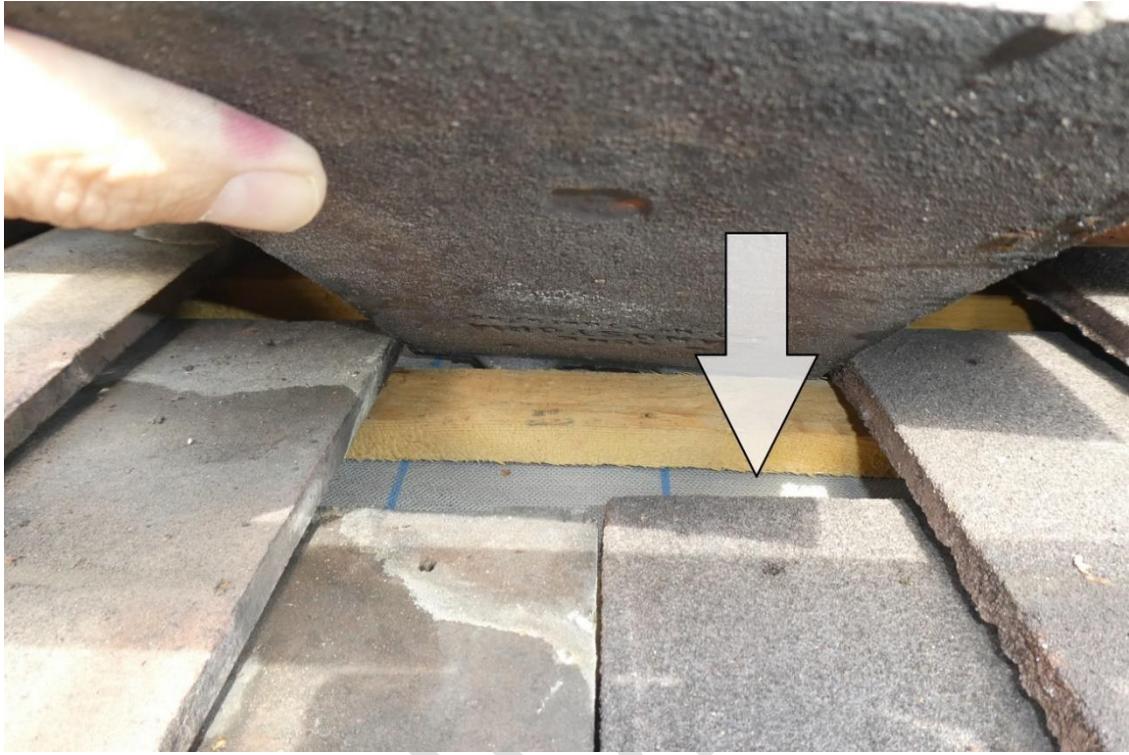
MEMBRANE CAN BE SEEN UNDER THE BATTEN. THE BATTEN LOOKS LIKE UNTREATED TIMBER WHICH IS A CONCERN.

4.02 There is a geotextile membrane to the underside of both roofs. The battens are above this membrane, so we could not see the battens. To the kitchen bay roof, we could see what looked like untreated battens. This is a concern, because if the battens used throughout are untreated, they will be subject to the dampness leaching through old tiles and will eventually rot/deteriorate. We cannot comment further.

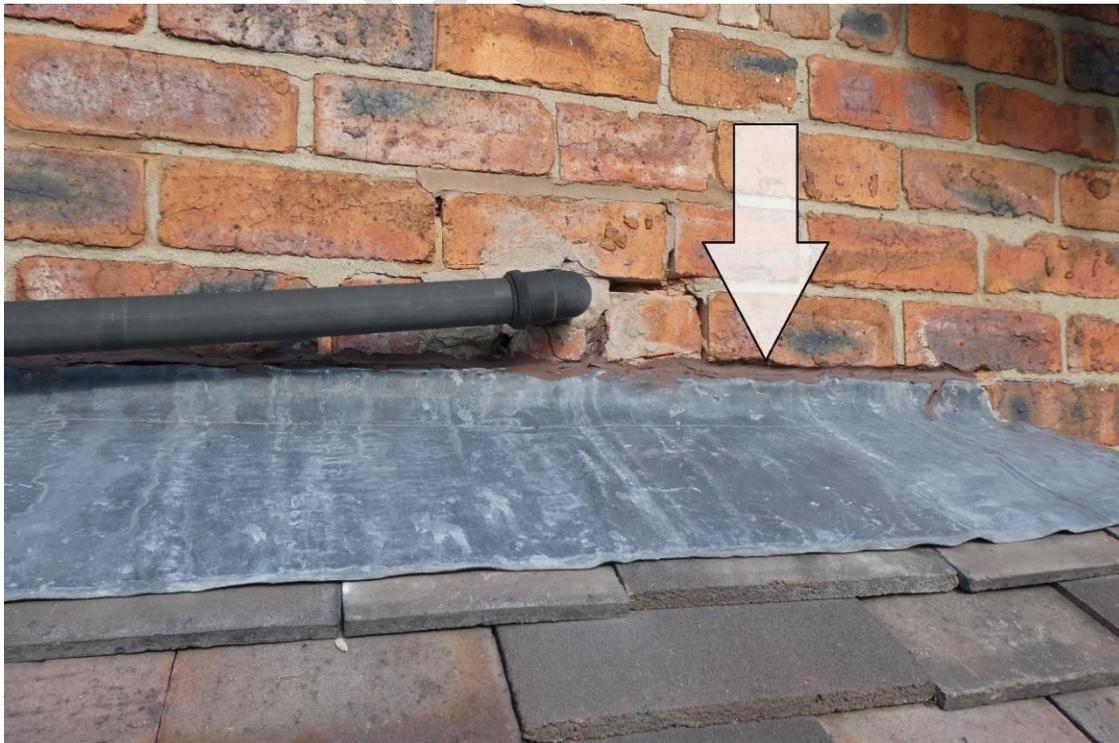
BRICK SILICONE USED TO REPOINT THE FLASHING. IT IS UNTIDY.

3.16 The flashing should be replaced with lead roll which covers the whole of the joint. It needs to be repointed correctly with silicone sealant.

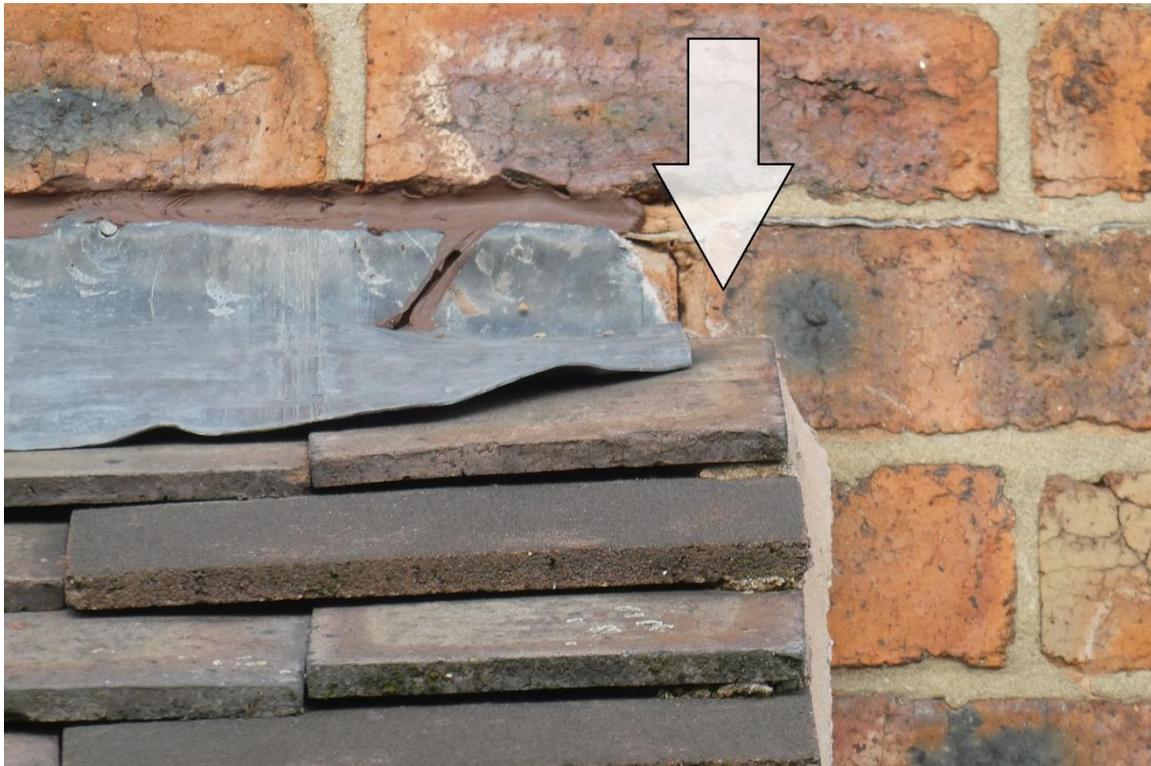
FLASHING IS TOO SHORT.

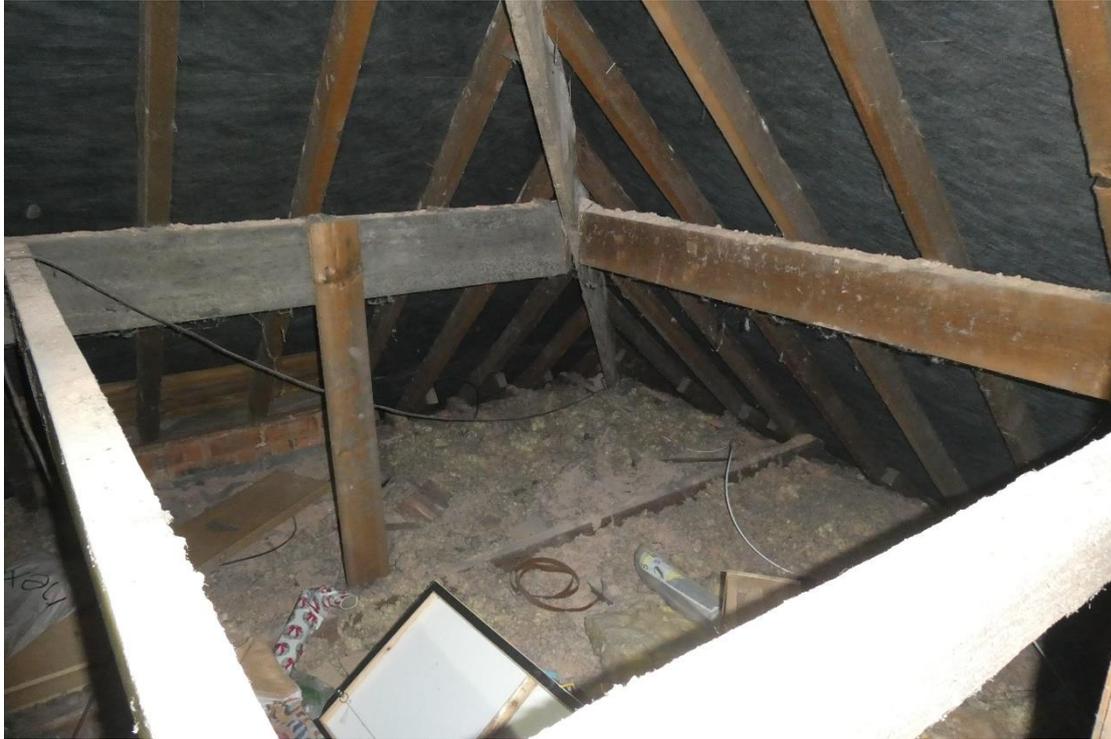
4.07 There is little insulation to both floors, and this is unusual to the extension as it should comply with building regulations. Current recommendations are a minimum of 270mm. The complete loft would benefit from the removal of the boards and a uniform 300mm of insulation.

ORIGINAL REAR LEFT-HAND CORNER. NOTE HOW LITTLE INSULATION IS IN PLACE.

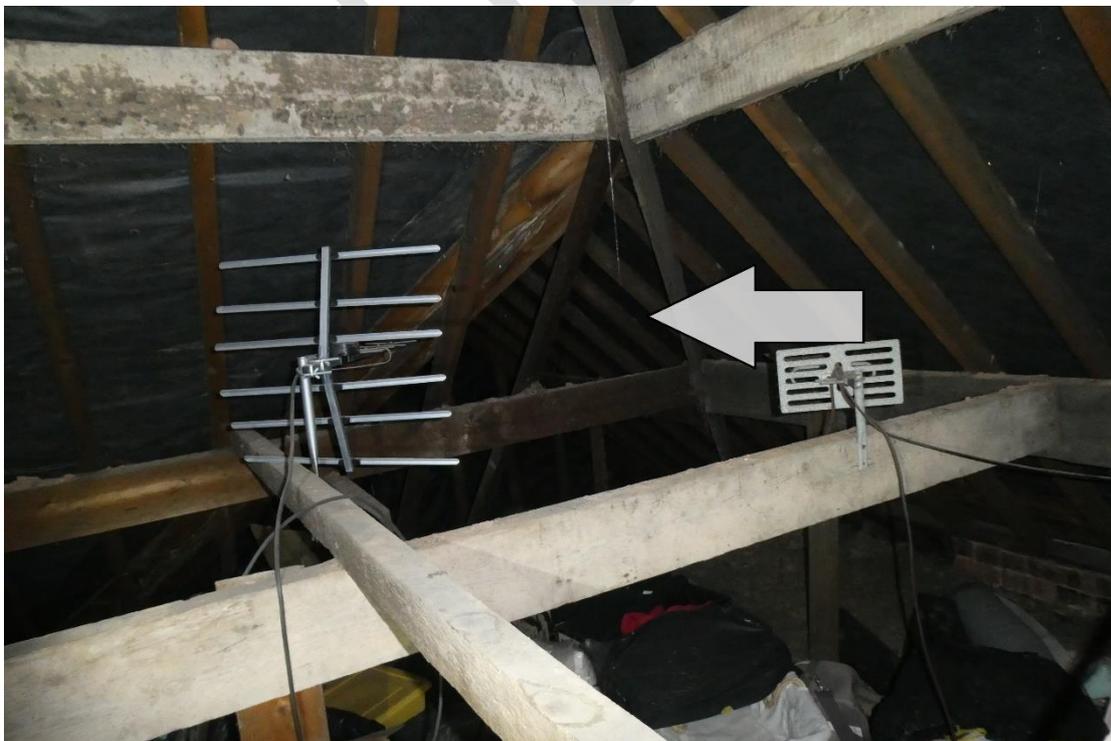
THE FRONT DORMER CAN BE SEEN BUT NOT INSPECTED.

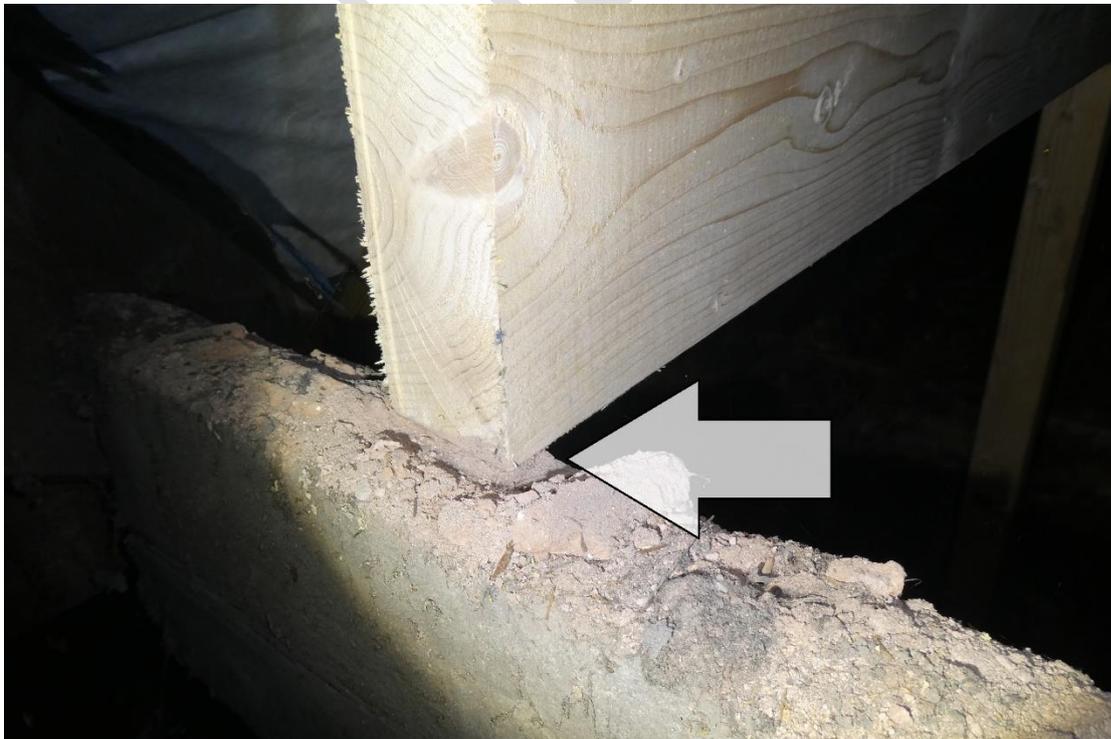
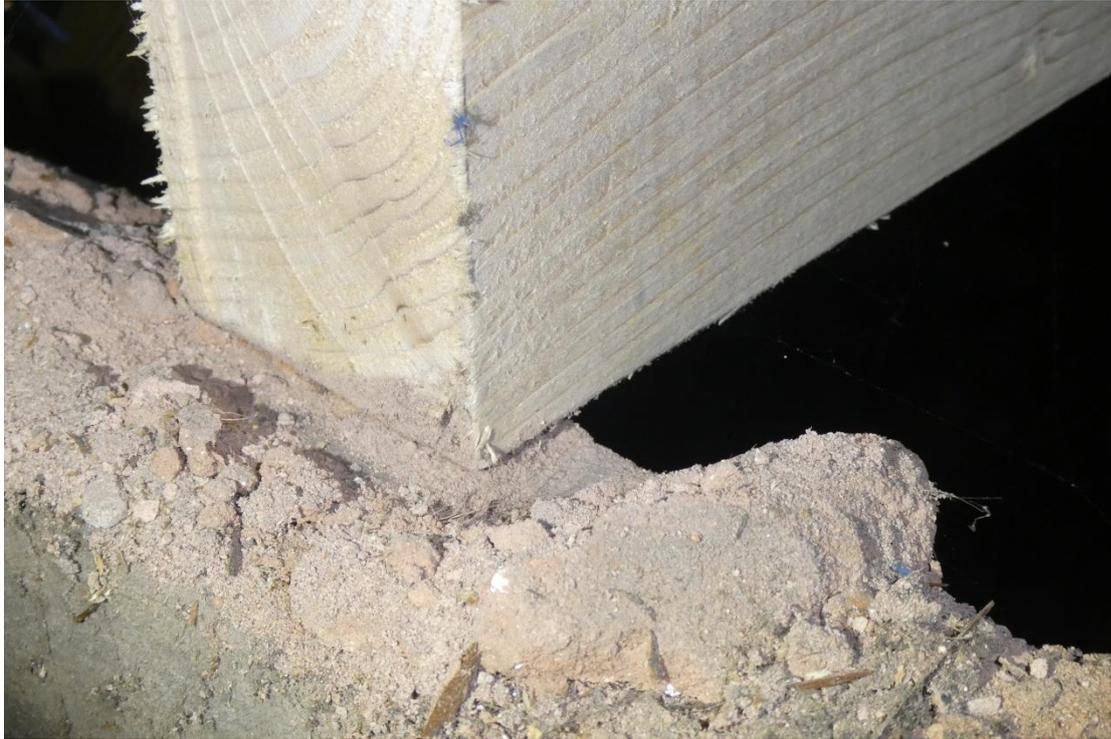
5. The rear purlin is only just resting on the original side purlin. The front purlin is not even resting upon the other end of the original purlin; it is resting up in the air supported by one small prop and another near the hip timber. The roof structure appears below the standard that we would expect to see, and the vendor confirmed that there was not a Structural Engineer involved in either the design or the construction. It is our opinion that the roof structure has not been formed to the standard that it should have been. We recommend:

REAR PURLIN JUST SITS UPON THE ORIGINAL SIDE PURLIN.

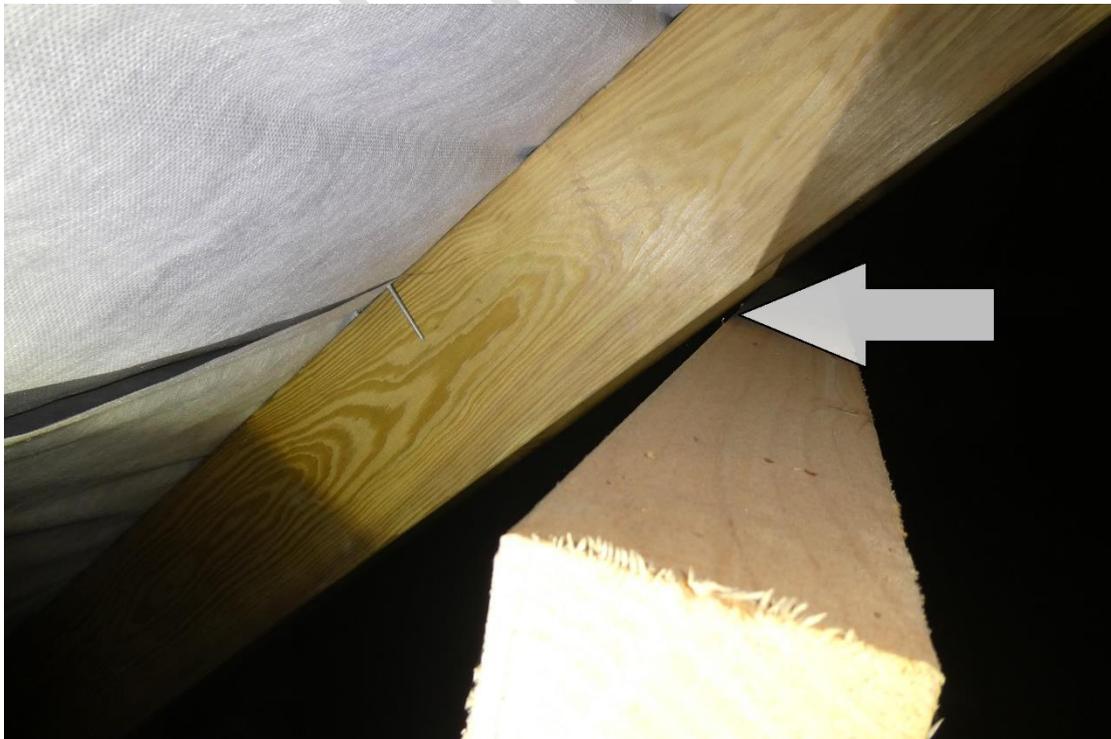
3. The purlins appear to be simply supported on vertical props without any form of restraint/fitting into the hip timbers and the original side purlin. We also noted that at least one rafter does not meet the purlin and there is a gap. This means that the purlins are effectively held in place by the small number of props and may be providing very little support to the rafters and theoretically, the roof could spread.

AIR GAP BETWEEN THE REAR PURLIN AND ONE RAFTER.

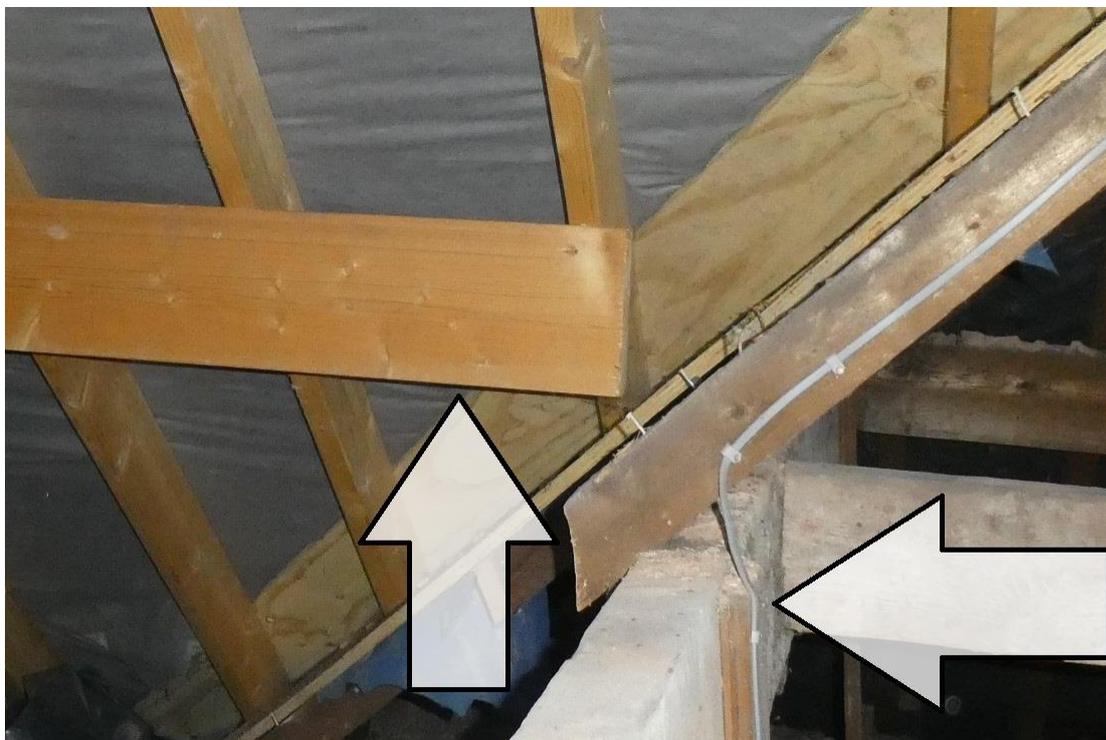
APART FROM TWO SMALL PROPS THE FRONT PURLIN IS HANGING IN THE AIR. IT SHOULD BE RESTING ON THE ORIGINAL SIDE PURLIN.

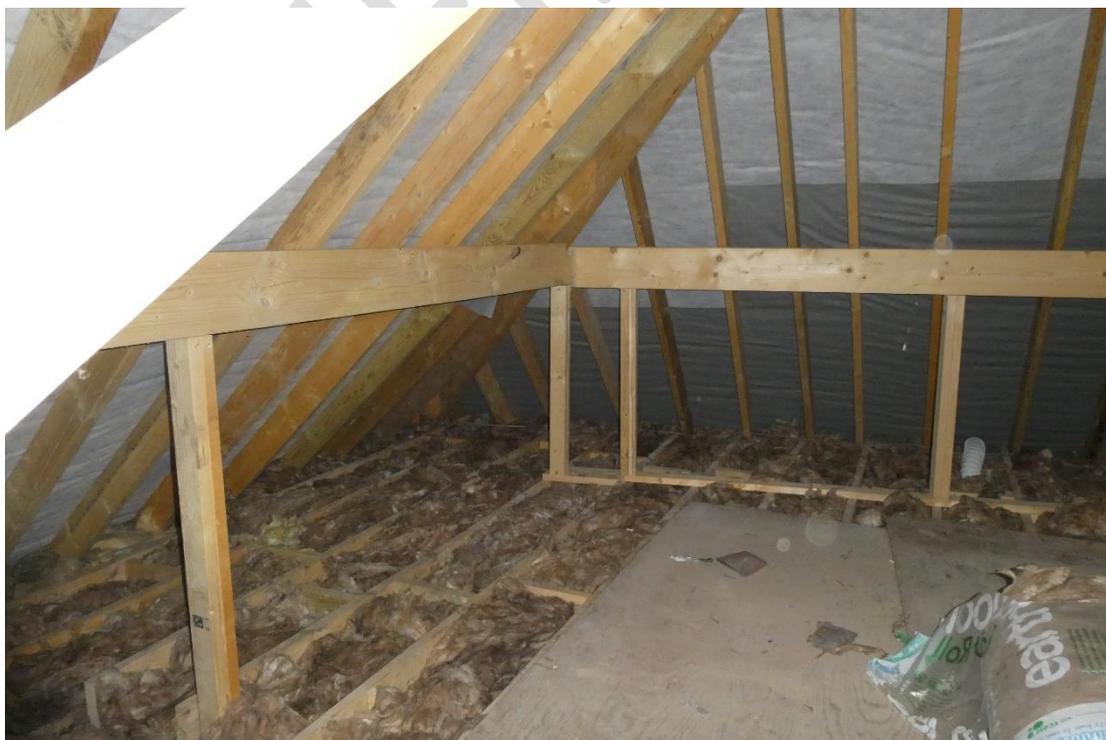
LOOKING ACROSS TO THE SIDE OF THE EXTENSION. NOTE HOW LITTLE INSULATION IS ON THE FLOOR. THE VERTICAL PROPS APPEAR TO BE ALL THAT ARE HOLDING THE PURLINS IN PLACE.

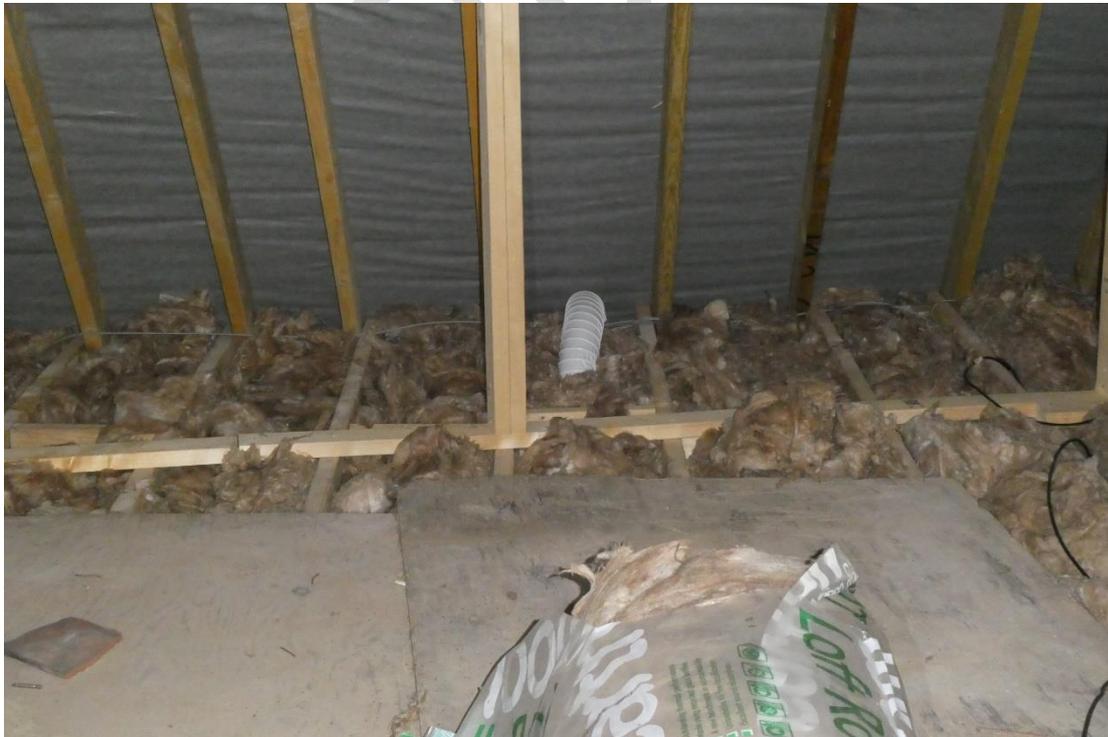
ENSUITE EXTRACTOR FAN DISCHARGING INTO THE EAVES.

4.08 We noted extractor fans discharging into the roof space and the eaves. The extractor ducts must discharge to outside air. These should be fitted to proprietary roof tiles.

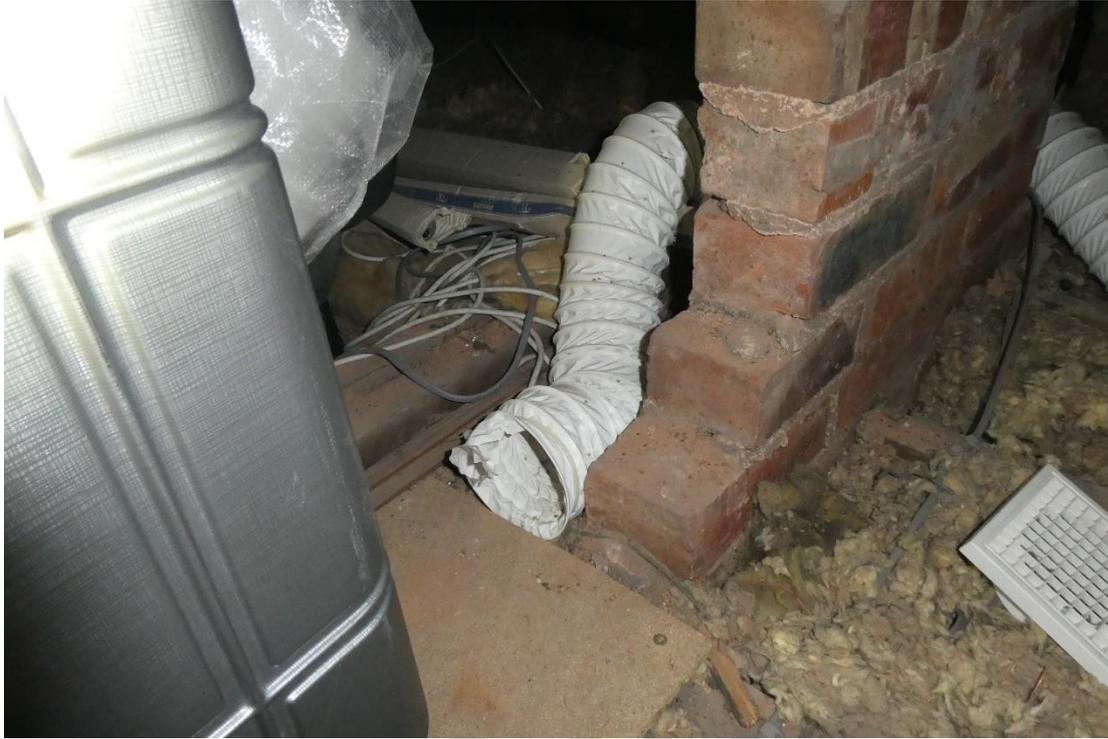
BATHROOM EXTRACTOR FAN DISCHARGING INTO THE ROOF SPACE.

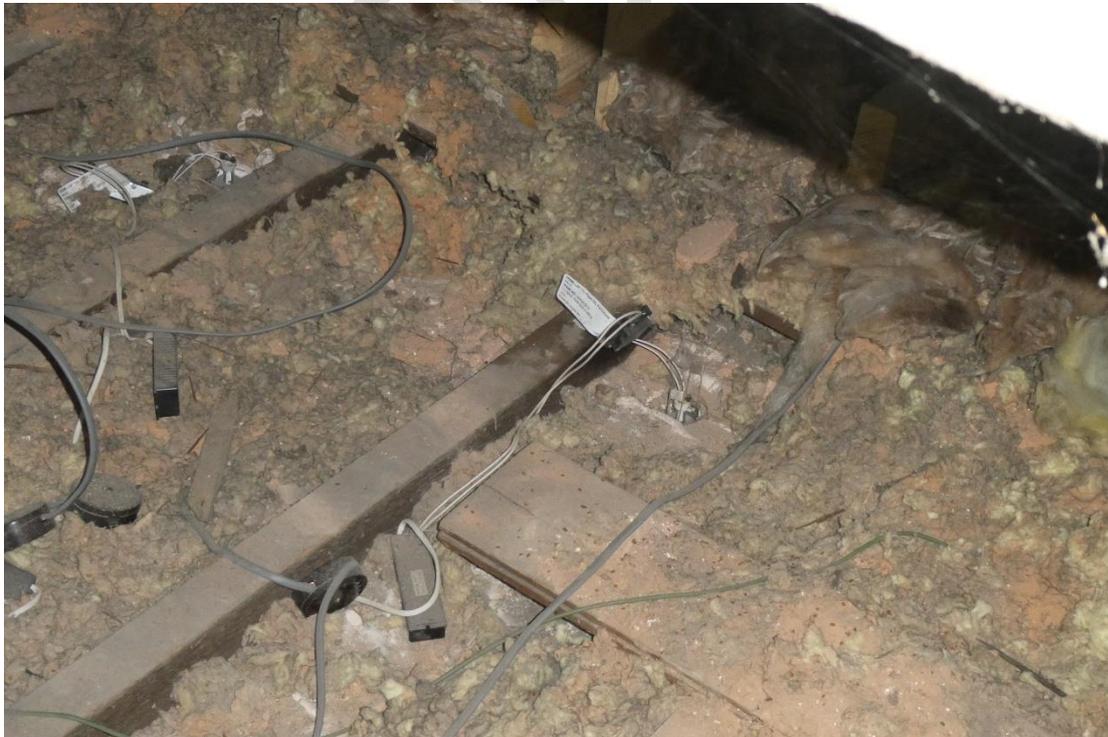
NON-FIRE RATED DOWNLIGHTERS ABOVE THE BATHROOM. THE ELECTRIC CABLES LOOK OLD.

4.10 Downlighter to the bathroom are not fire-rated. All downlighters should be checked and replaced with fire-rated units to ensure the fire integrity of each ceiling.

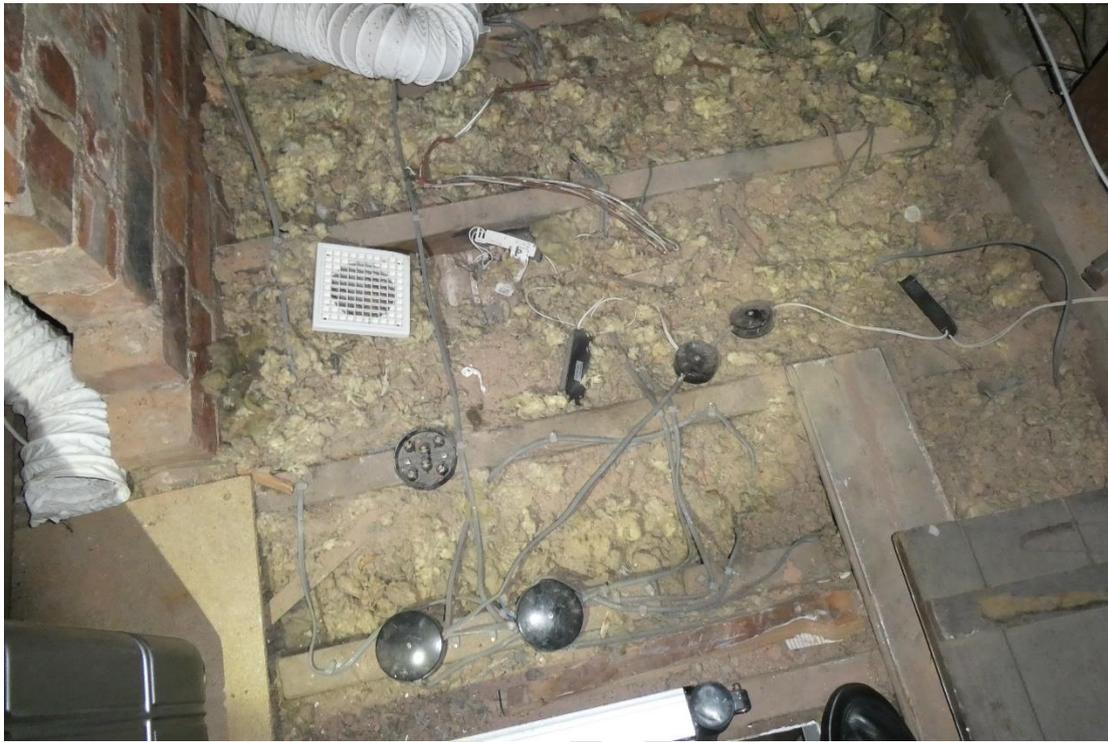
THE ELECTRIC CABLES LOOK OLD.

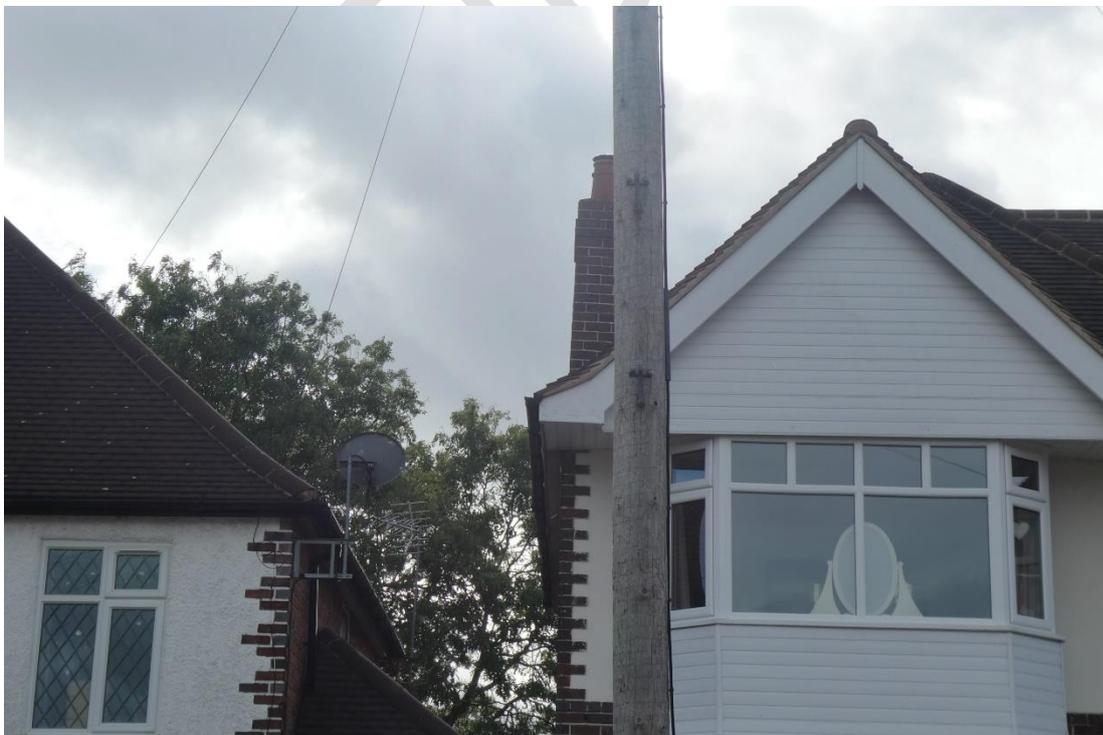
LEAN TO FRONT SIDE CHIMNEY STACK AGAINST THE REASONABLY VERTICAL TELEGRAPH POLE.

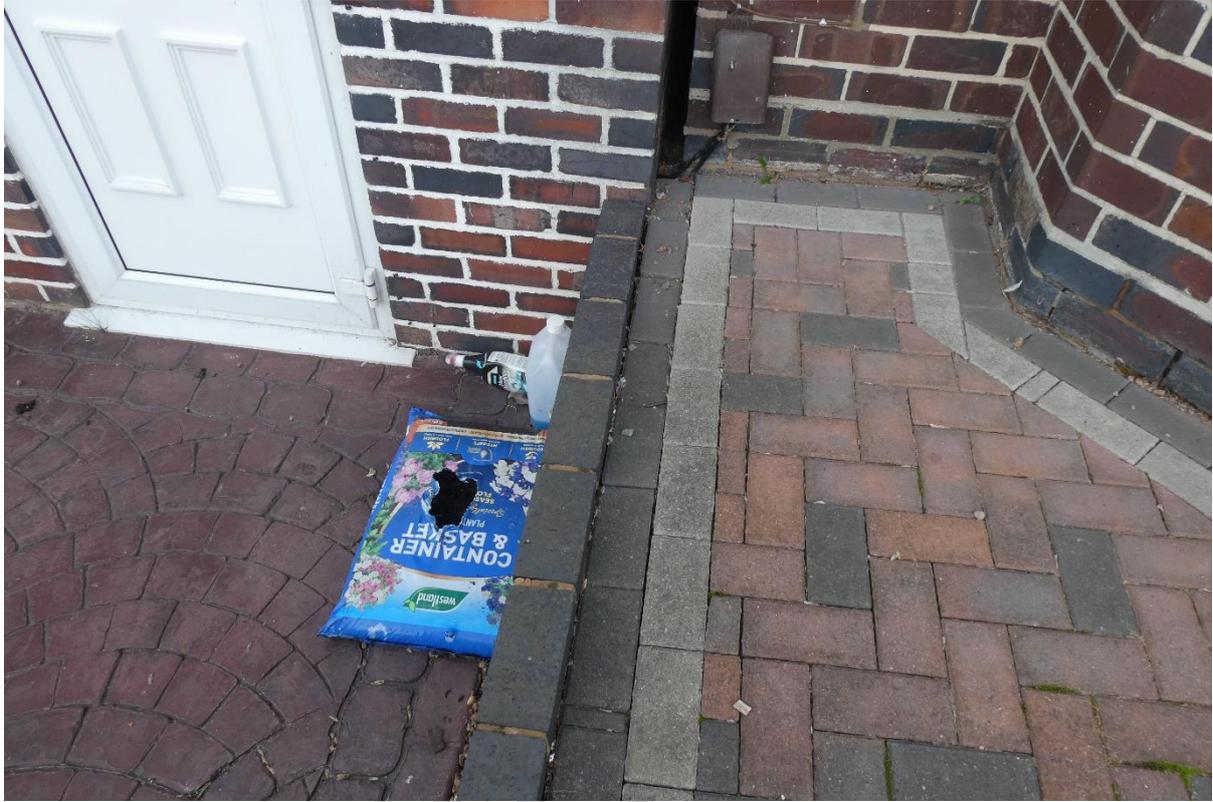
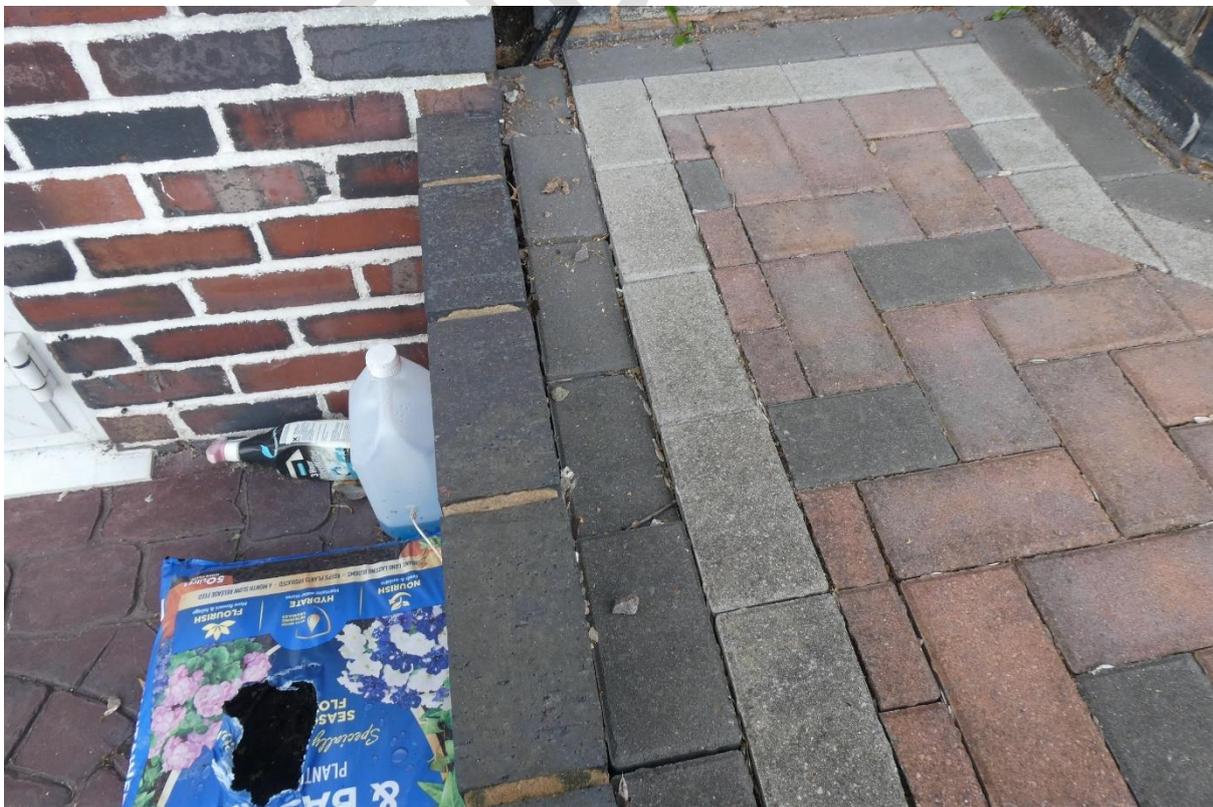
BLOCKS HAVE SUNK HERE AND THERE IS A GAP AGAINST THE WALL.
