BUILDING SURVEY

BUILDING SURVEY FOR *****

*****,
*****,
*****,
Birmingham,
*****.

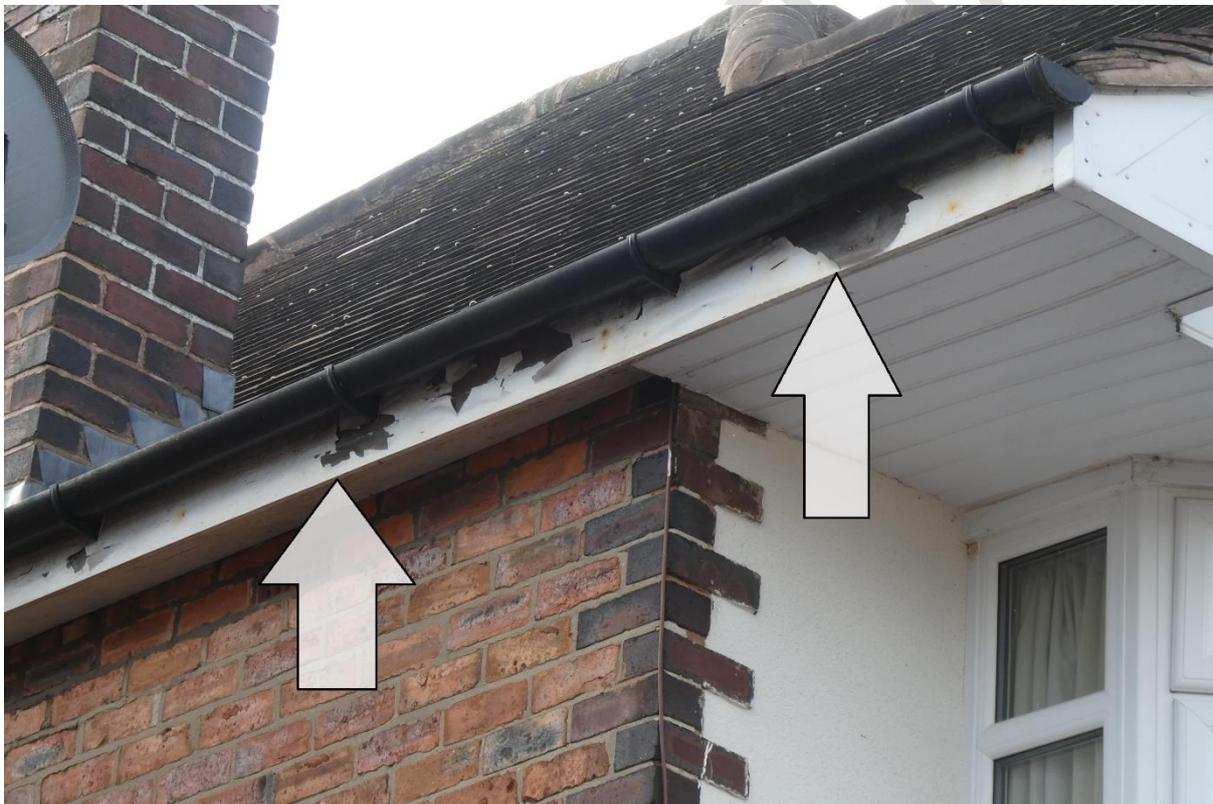
7.01 To the original house, the fascia and soffit boards are a mixture of original softwood and UPVC board without a vent. The softwood boards have not been maintained/painted for many years and all sections require attention prior to redecoration. This will require scaffold/tower access

ORIGINAL FASCIA/SOFFIT IN DISREPAIR.

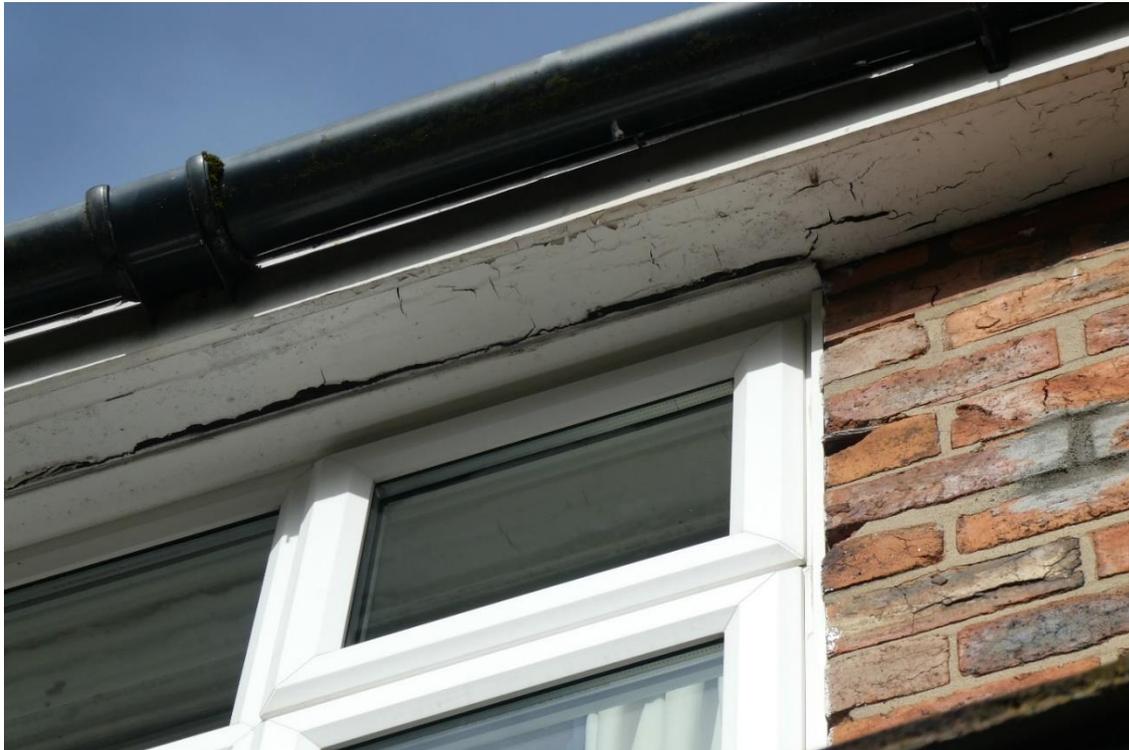
SOFFIT BOARD IN POOR CONDITION.

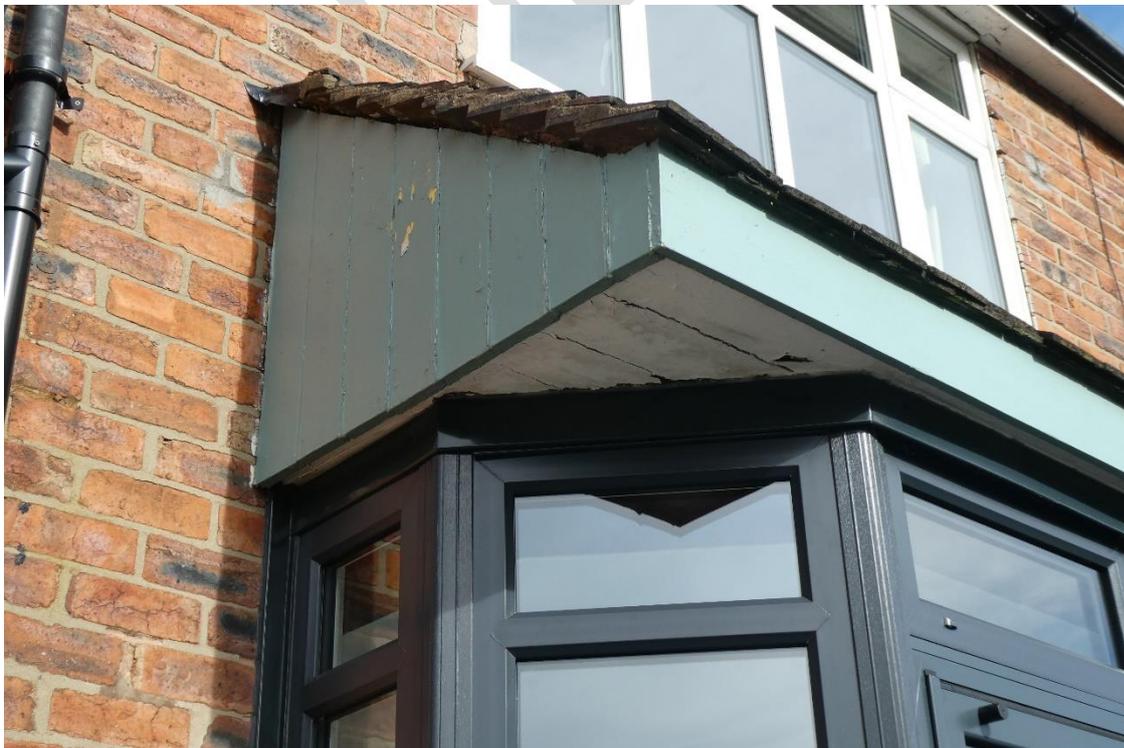
SOFFIT BOARD AND GABLE BOARD REQUIRE ATTENTION/REDECORATION.

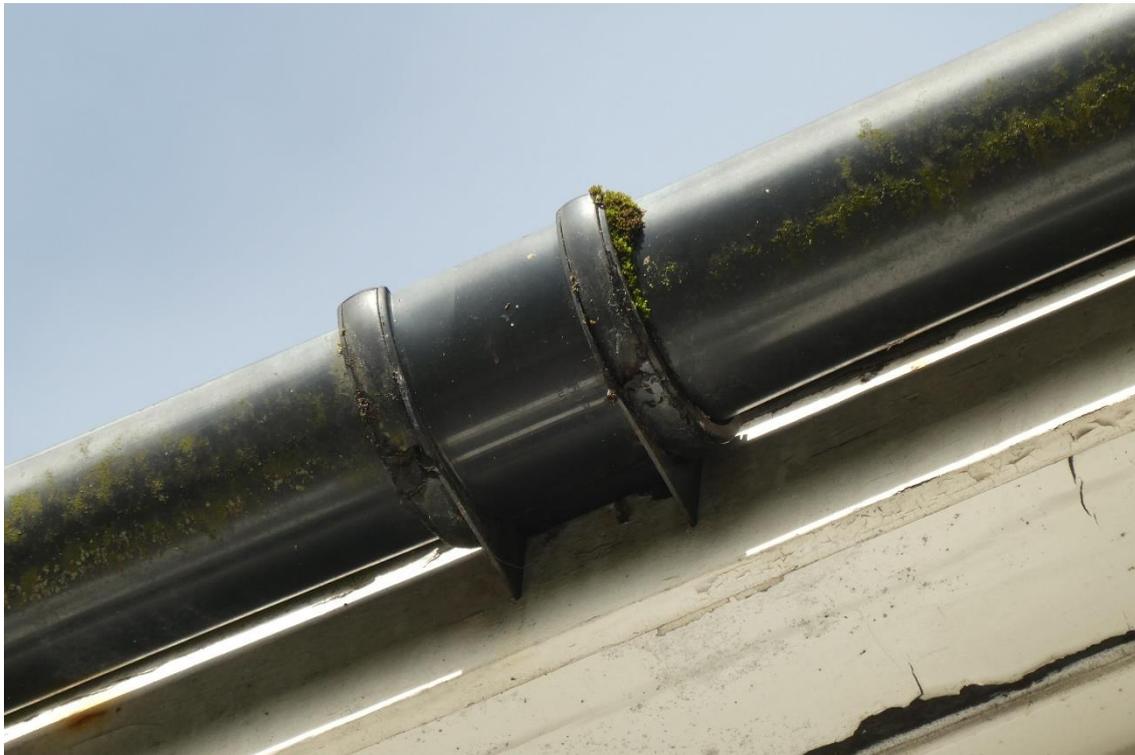
MOSS CAN BE SEEN TO THE LEAKING JOINT TO ORIGINAL SECTION AT THE REAR.

1. The original installation was not renewed with the extension. We noted leaking joints to the rear and left-hand side. All leaking joints should be replaced.

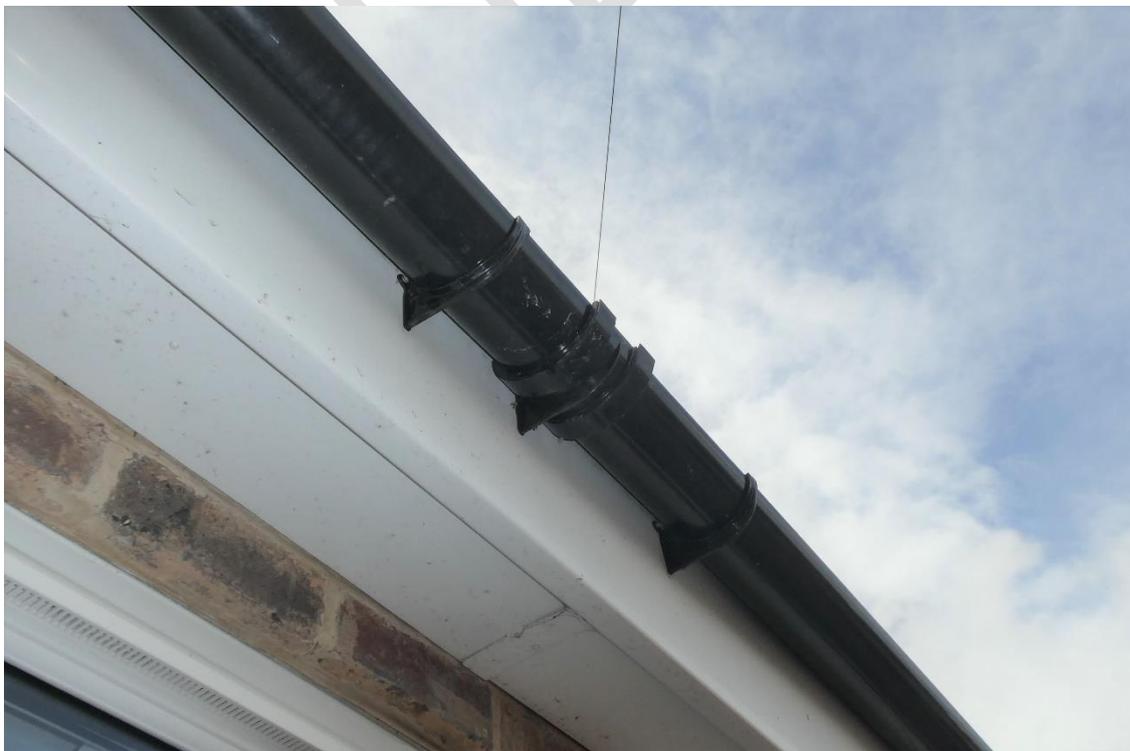
2. There is leakage on the joint above the family room window. This is dampening the brickwork and should be replaced.
3. Stormwater discharge should be checked to the front channel. The channel was full of detritus/leaf litter. It needs to be cleared.

LEAKING JOINT ABOVE FAMILY ROOM.

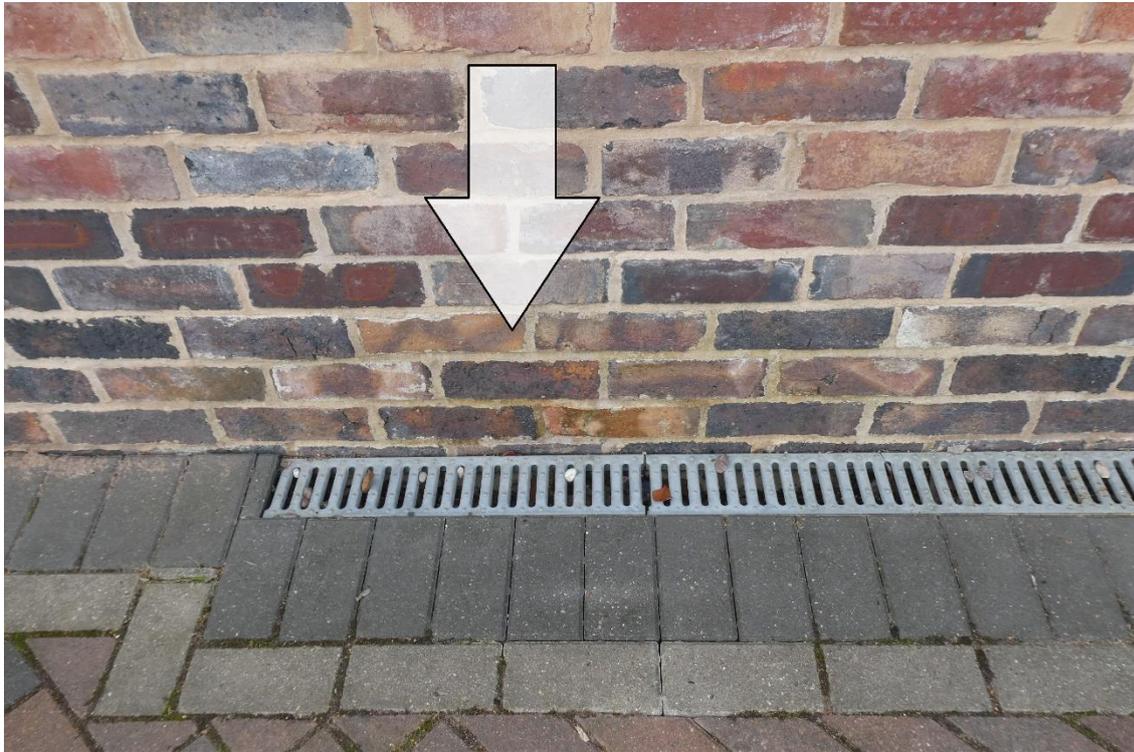
DAMP BRICKWORK.

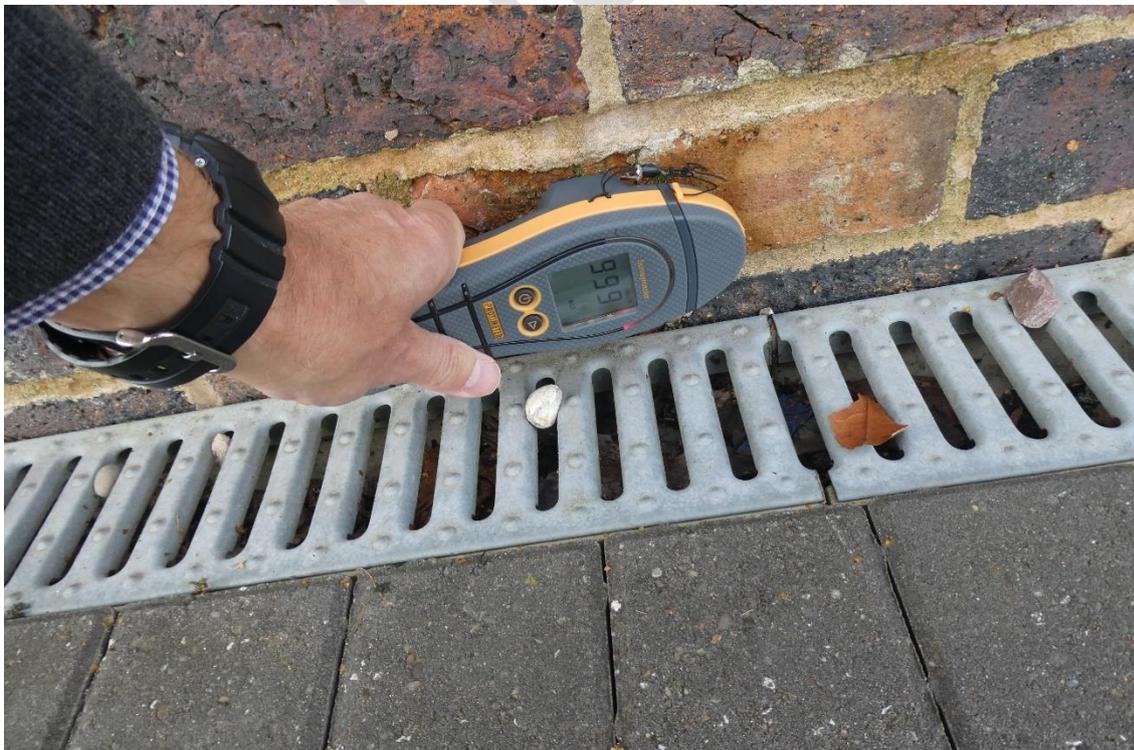
999 IS THE MAXIMUM DAMP READING.

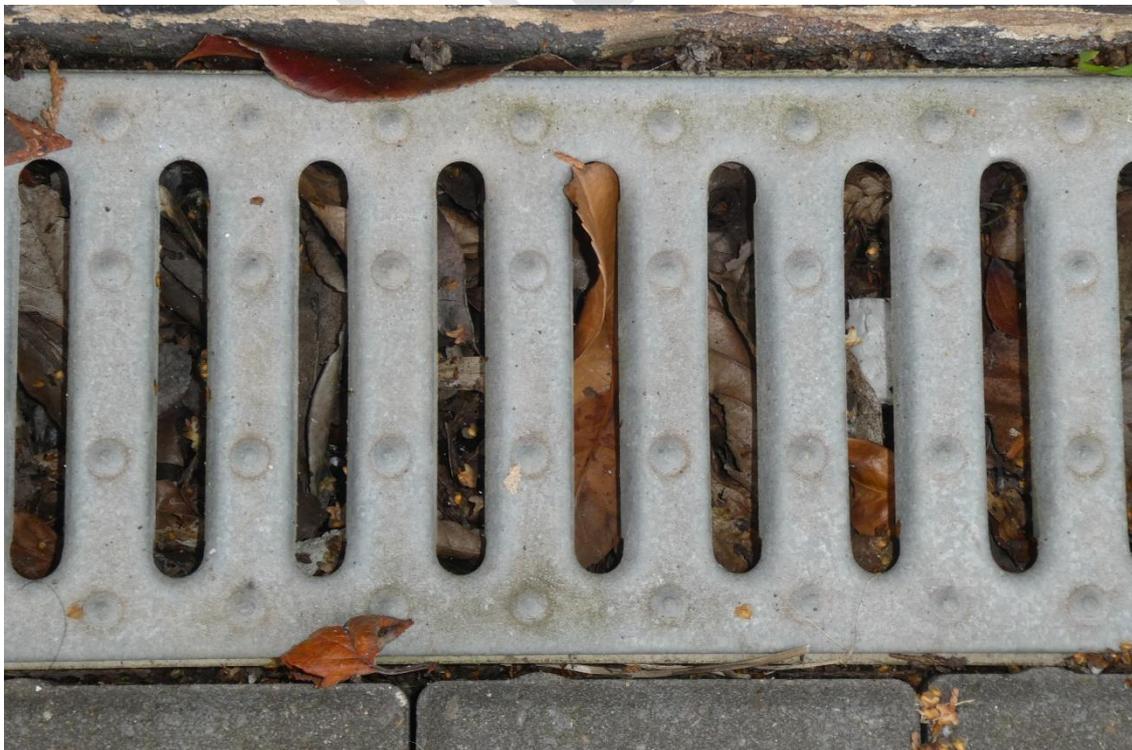
CHANNEL NEEDS TO BE CLEARED.

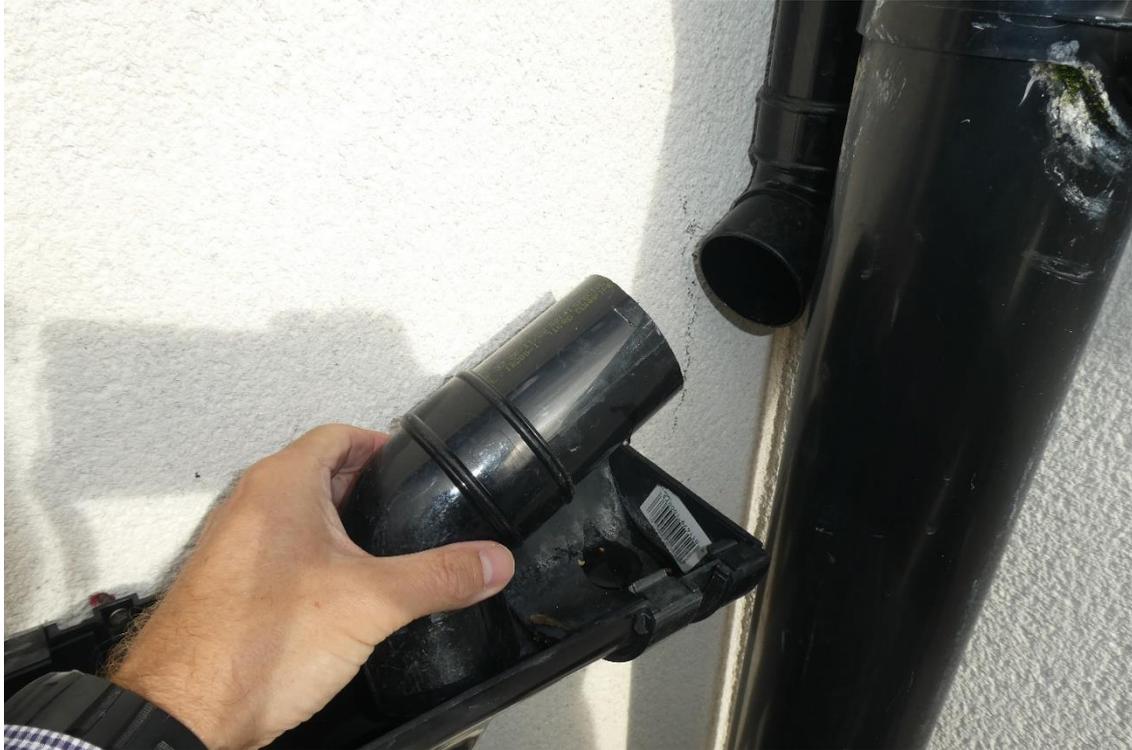
DOWNPIPE SHOE IS LOOSE.

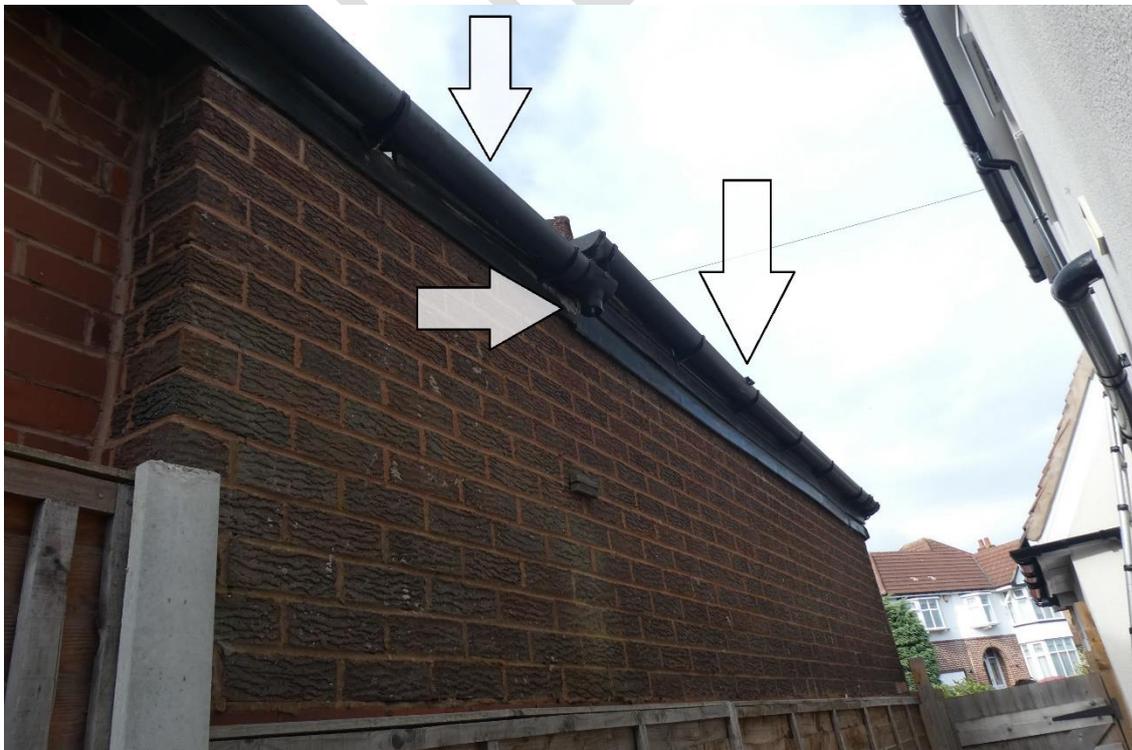
NEIGHBOUR'S OVERSAILING GUTTER AND OUTLET WITHOUT A DOWNPIPE.

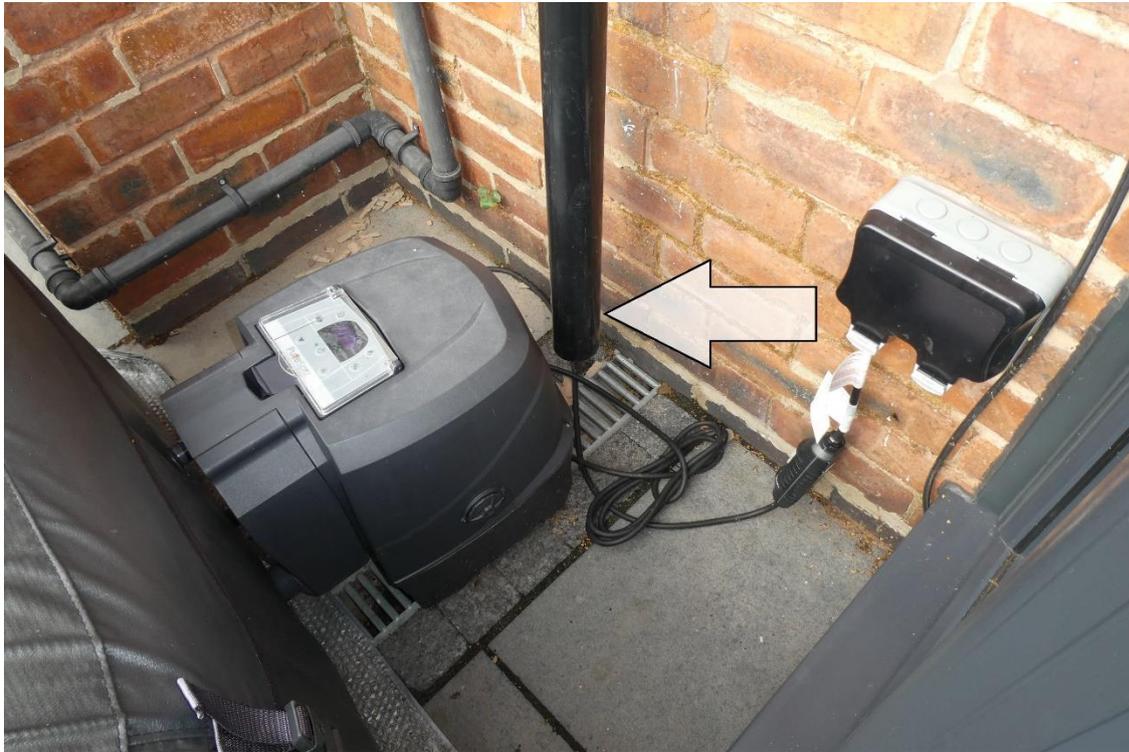
DOWNPIPE CUT SHORT AND DISCHARGING ABOVE THE CHANNEL. SPA IS ON TOP OF THE CHANNEL.

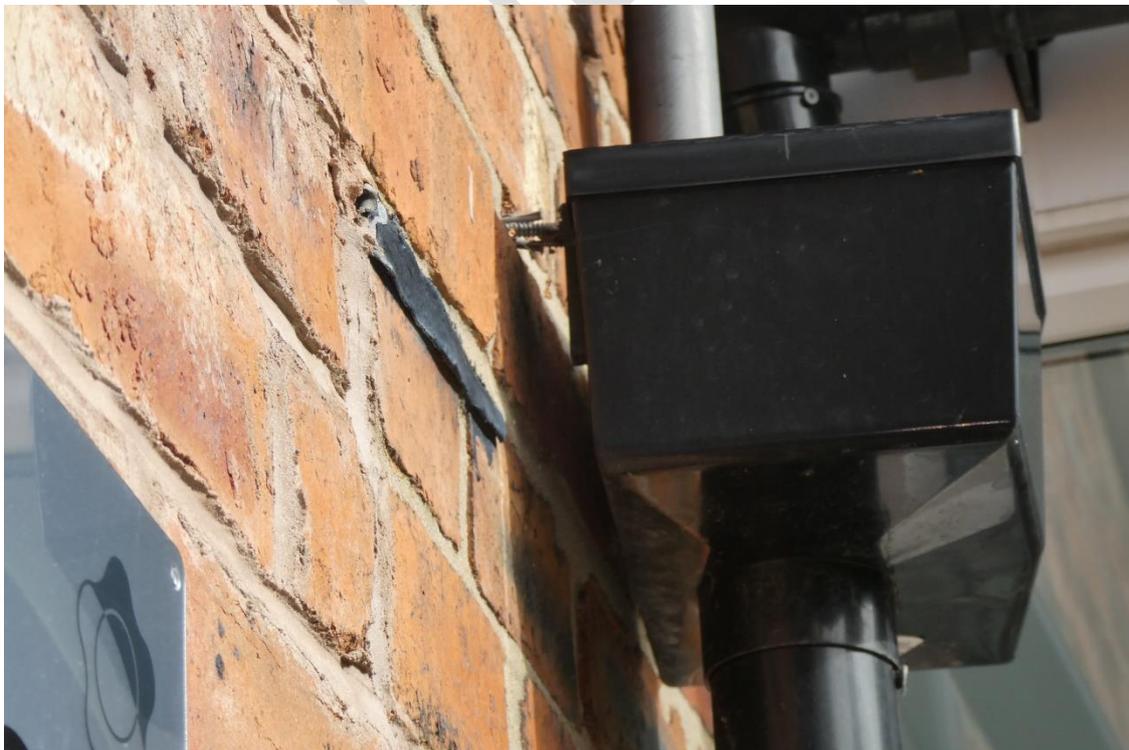
8. There is leakage on the kitchen gutter stop-end. This should be replaced.
9. The hopper and downpipe collecting the kitchen rainwater has not been fixed correctly. It looked like it could be pulled off the wall.

HOPPER AND DOWNPIPE NOT FIXED SECURELY.

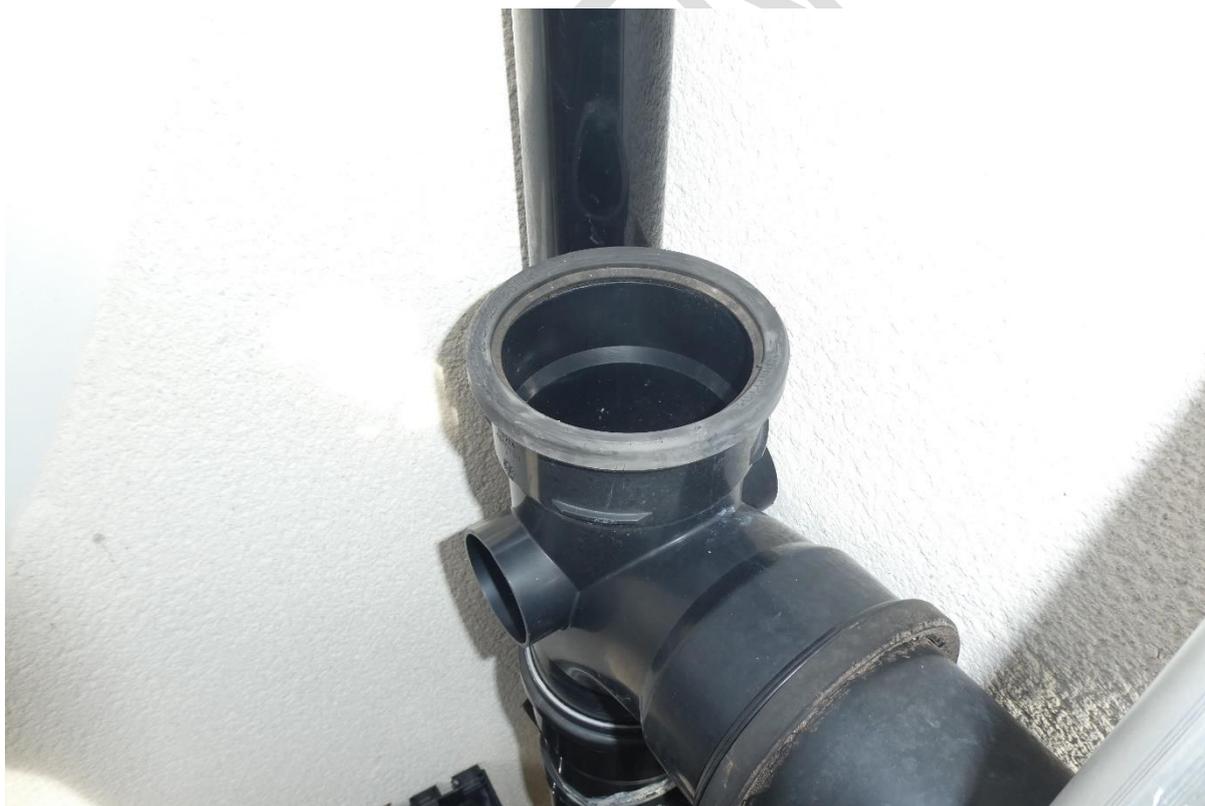
1. The top discharges just above head height and not above the roof eaves. The top is open which could allow sewer smells to the side of the house. The pipe should be extended, and an external air admittance valve installed.
2. There looks like there is leakage from one incoming waste connection. It should be repaired.
3. There is no maintenance access panel at the base.

OPEN TOP TO THE SOIL AND VENT PIPE. SEWER SMELLS WILL COME FROM THIS PIPE.

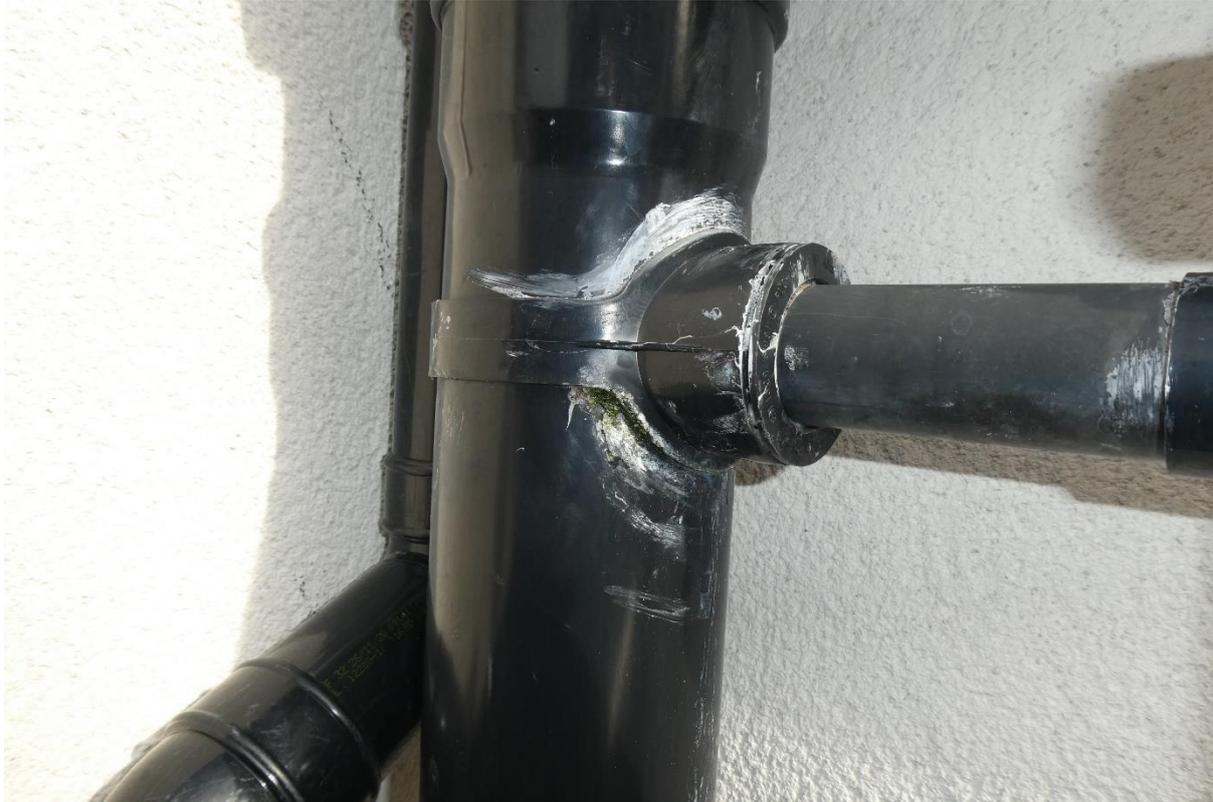
LEAKAGE ON INCOMING WASTE.

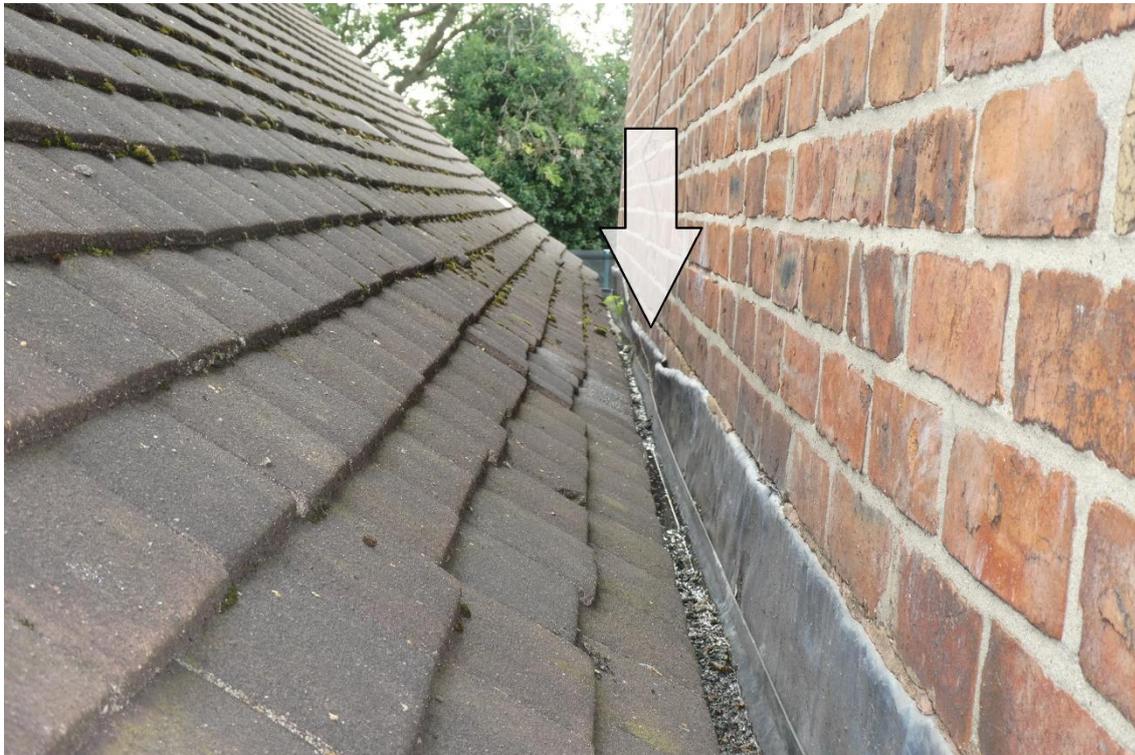
LEAD FLASHING HAS FALLEN OUT OF THE BRICKWORK.

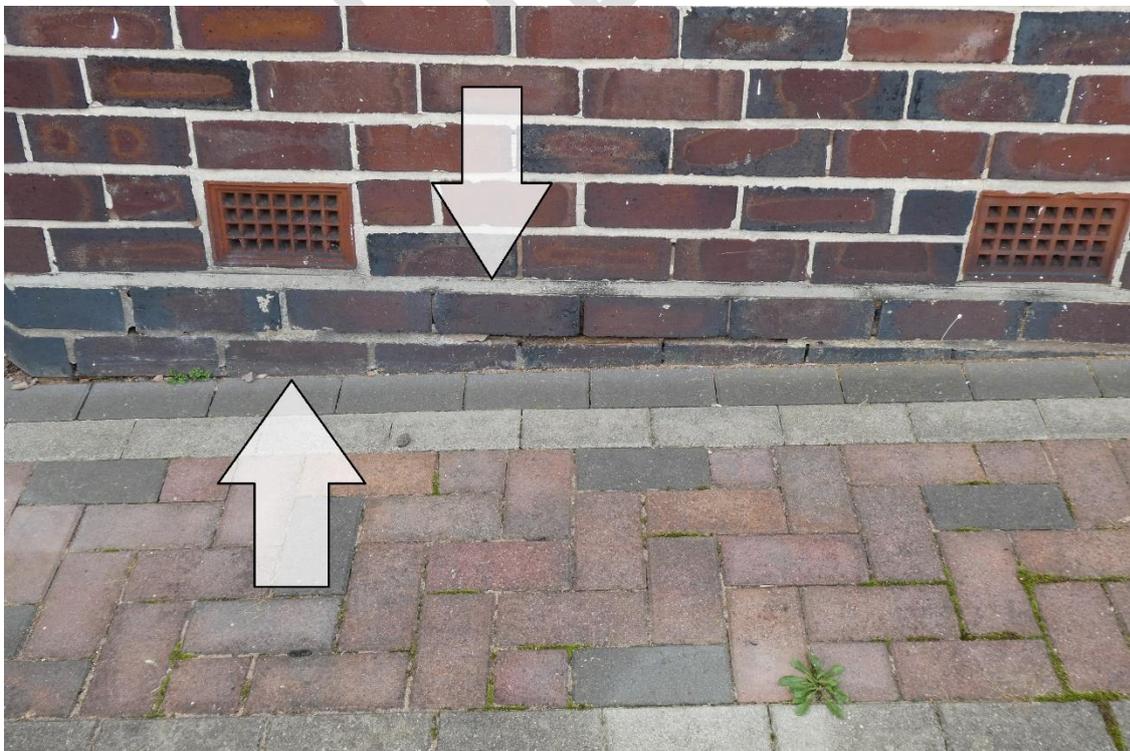
PAVING SHOULD BE 150mm (TWO BRICKS) BELOW THE DPC.

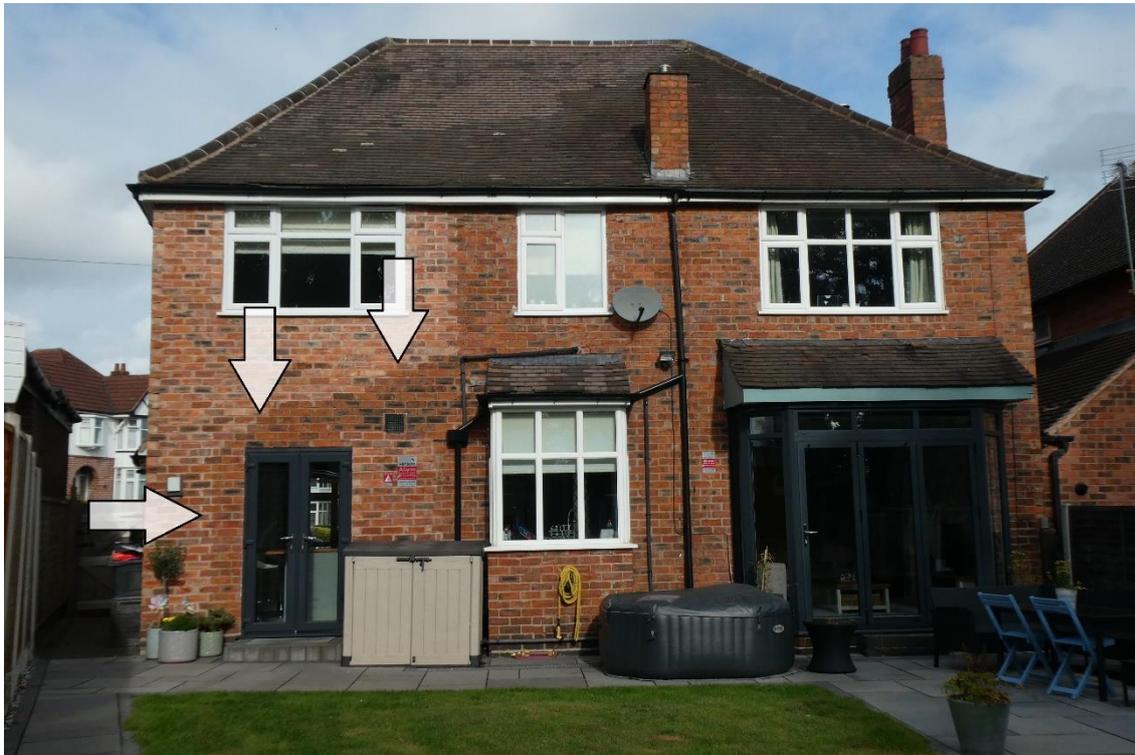
It looks like an original side lean-to or similar was built on top of to form the extension. We cannot confirm that the wall nor foundations were/are suitable. This should have been checked prior to building on top of the existing wall.
In relation to the original DPC, the paving is too high all across the rear. To reduce the risk of the brickwork above the DPC getting wet, a 200mm wide gravel border should be inserted across the rear.
Kitchen steps are partially blocking an air brick. Ideally, another air brick should be inserted.
Areas of brickwork have previously been raked out shallow and repointed. This shallow repointing is now falling out. All recessing joints need to be raked out to 25mm and repointed.
Brickwork behind the SPA is getting wet from the downpipe (see section 8.00).

IT LOOKS LIKE THE REAR OF THE EXTENSION WAS BUILT UPON AN OLD LEAN-TO.

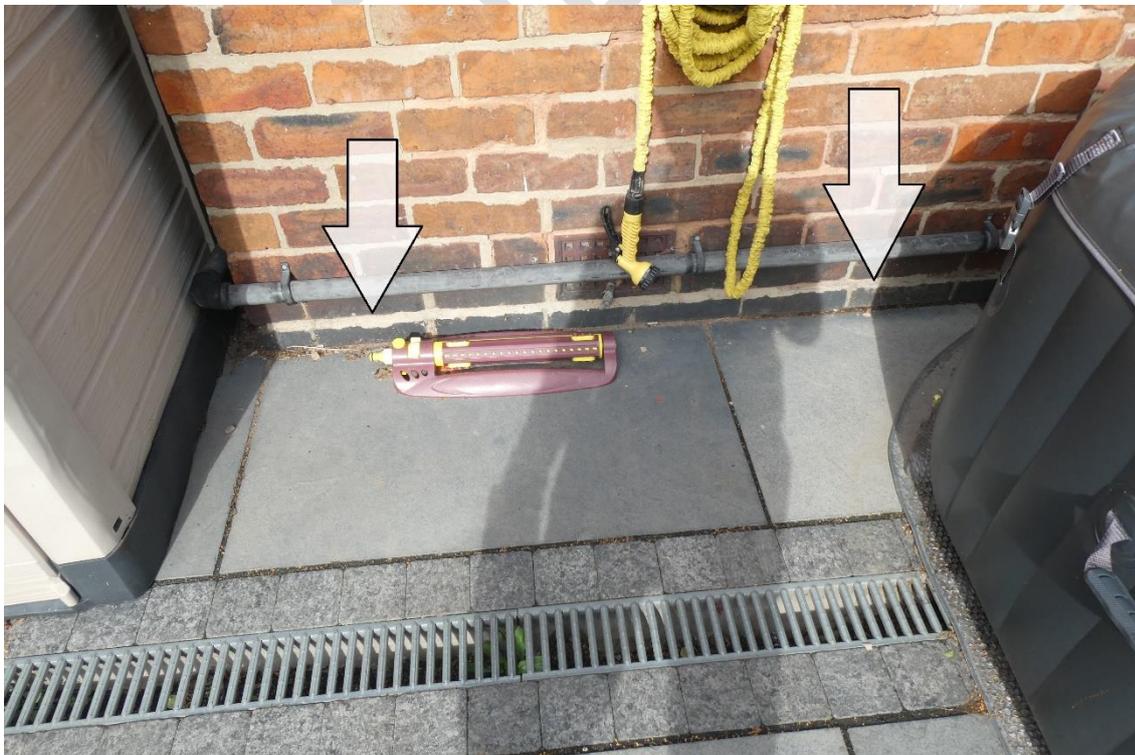
AGAIN, THE PAVING IS TOO HIGH TO THE REAR.

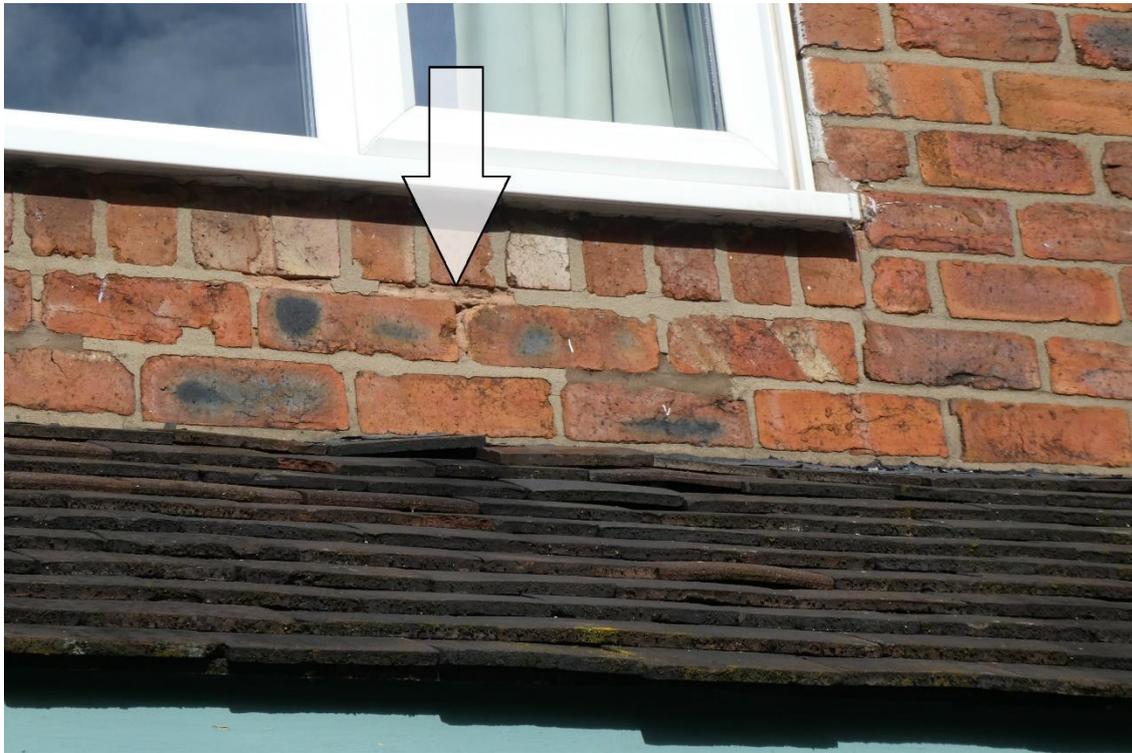
EXAMPLE OF SHALLOW REPOINTING.

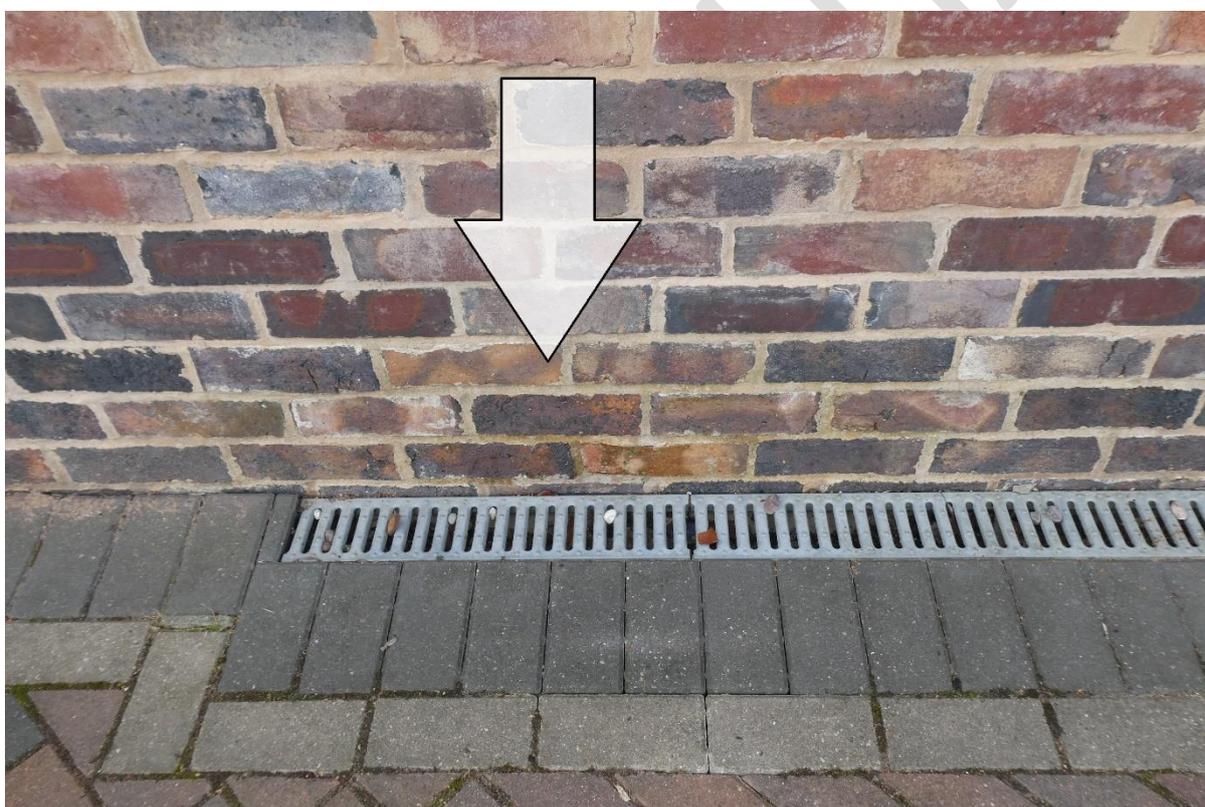
THERE IS NO OBVIOUS DPC NOR CHANGE IN BRICKS BENEATH THE LEVEL OF A HIDDEN DPC.

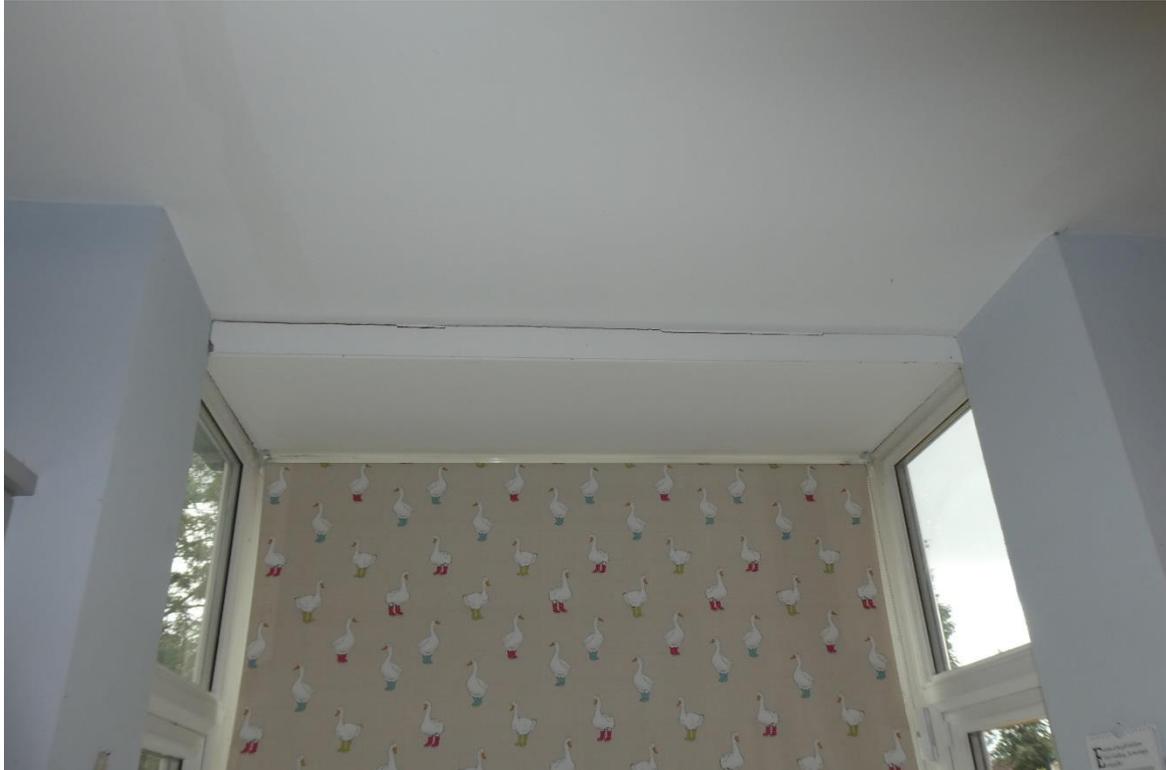
- Kitchen: Slight shading to kitchen ceiling. It was dry with a damp meter, but the ceiling is beneath the bathroom. It needs to be monitored.
Disturbance to the kitchen bay ceiling. This may have been caused by the new roof structure/finish.
Disturbance around the kitchen doors most probably caused by the installation of the door set.
- Small front original bedroom: Staining/water mark to ceiling. Mark was dry with a damp meter. The area above is now part of the covered roof.
- Small rear bedroom (extension): Slight crack over door is shrinkage to stud partition.
- Front large bedroom: Slight cracking to bay and slight slope to bay ceiling. This could be caused by the weight of the roof slightly compressing the UPVC bay. We have recommended gallows brackets.

DISTURBANCE TO KITCHEN BAY CEILING.

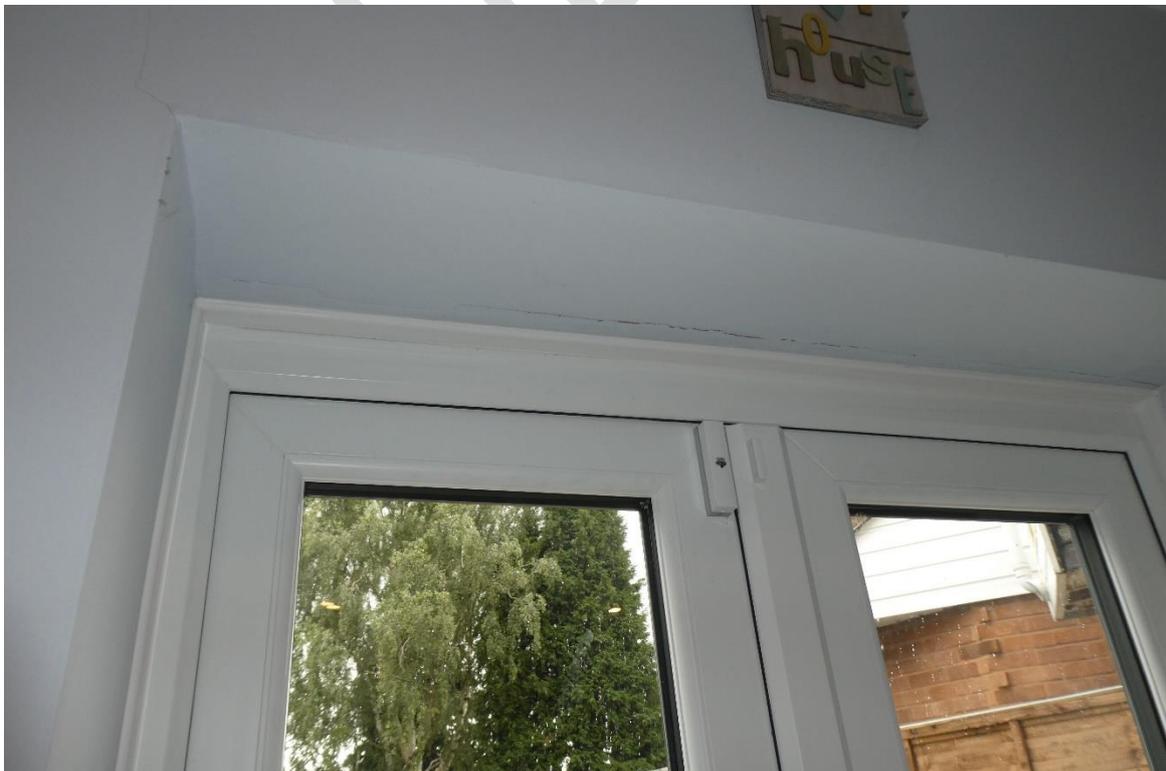
DISTURBANCE TO KITCHEN DOOR SOFFIT.

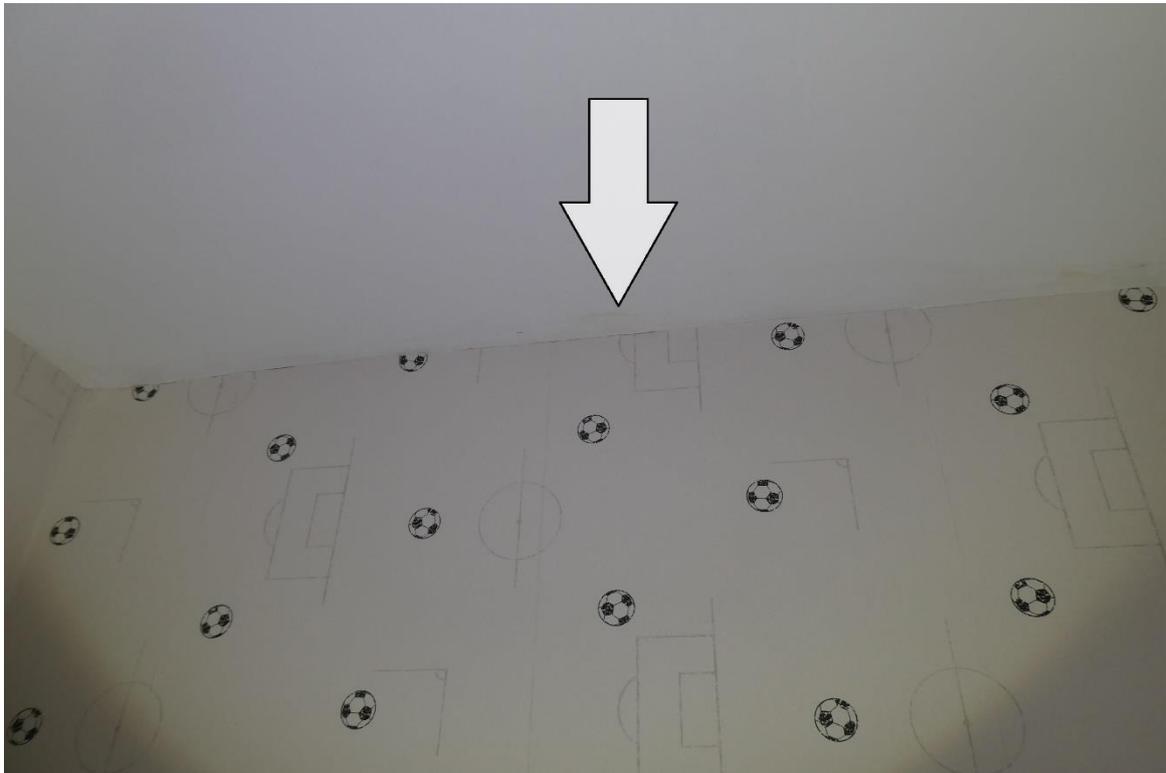
WATER MARK TO BEDROOM CEILING.

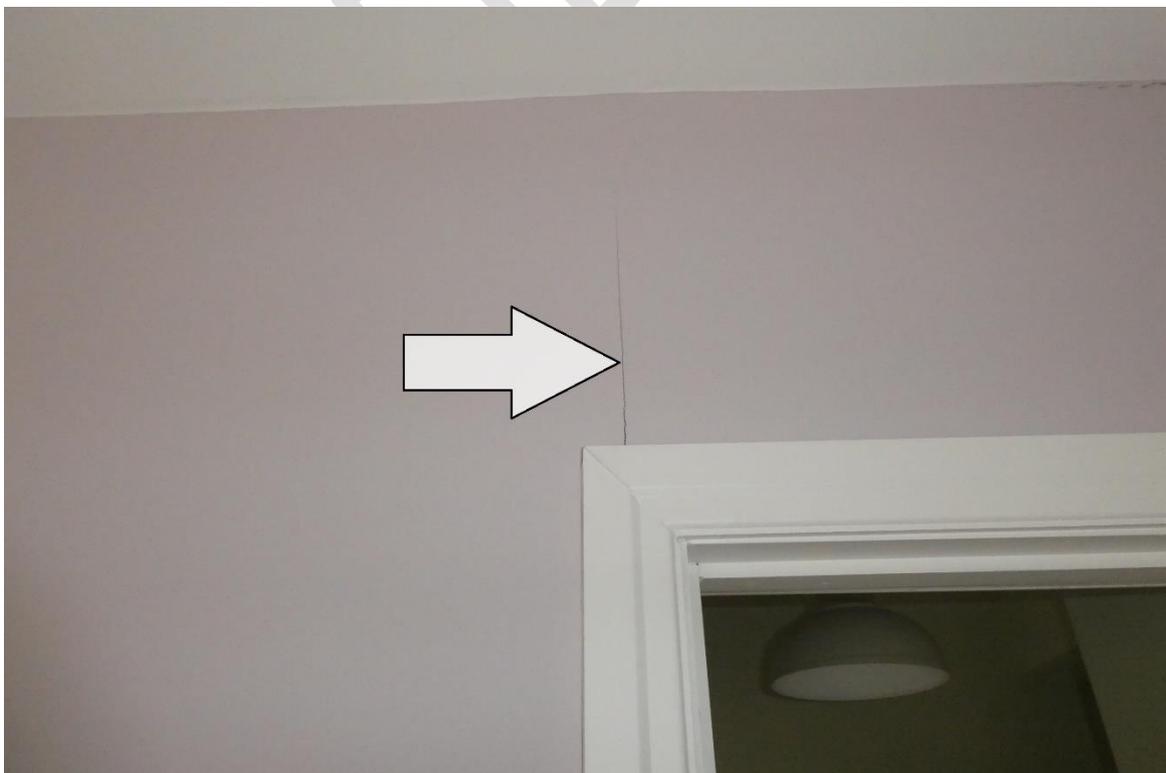
CRACK TO BEDROOM STUD PARTITION.
