BUILDING SURVEY

BUILDING SURVEY FOR *****

Date of Survey: *****

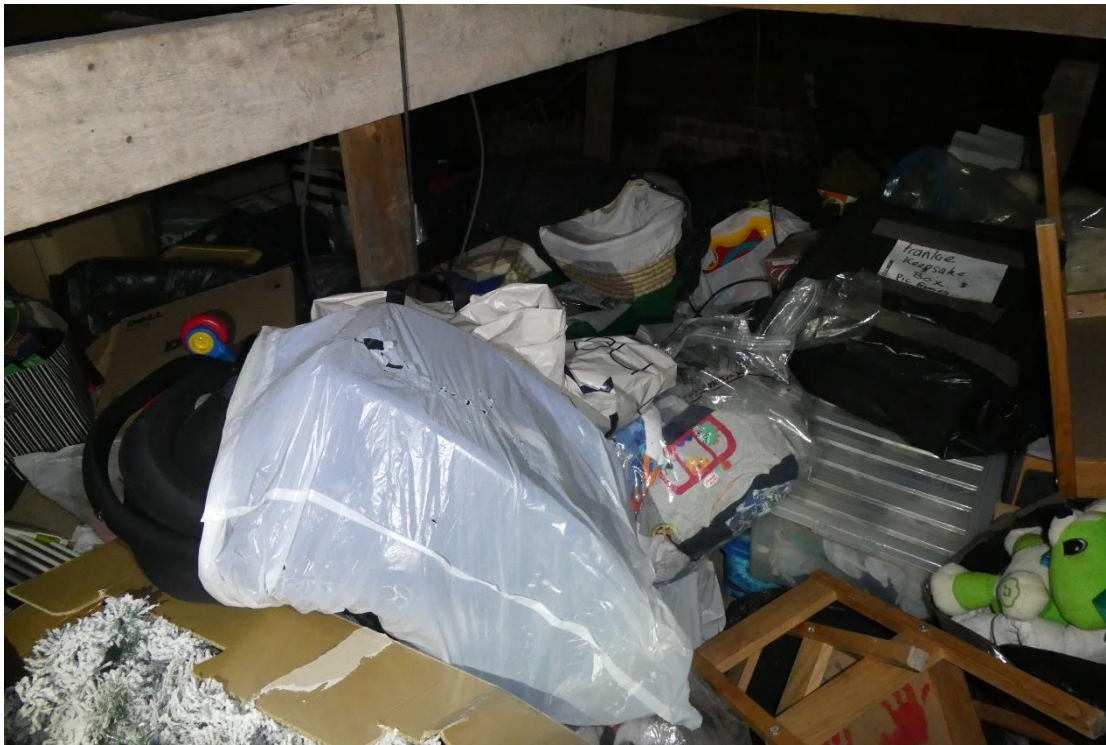
THE BOARDS TO THE ORIGINAL ROOF SPACE ARE COVERED IN STORAGE.

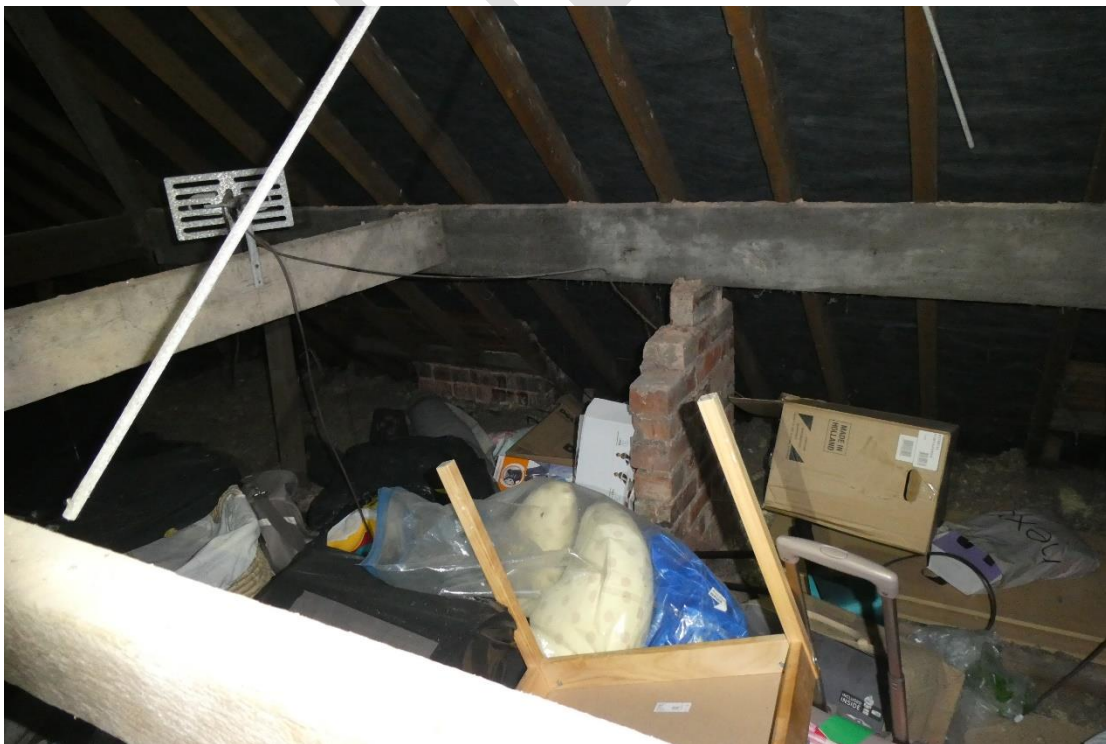
LOOKING TOWARDS THE FRONT LEFT-HAND CORNER OF THE ORIGINAL ROOF SPACE. NOTE BRICK PURLIN SUPPORT WALL.

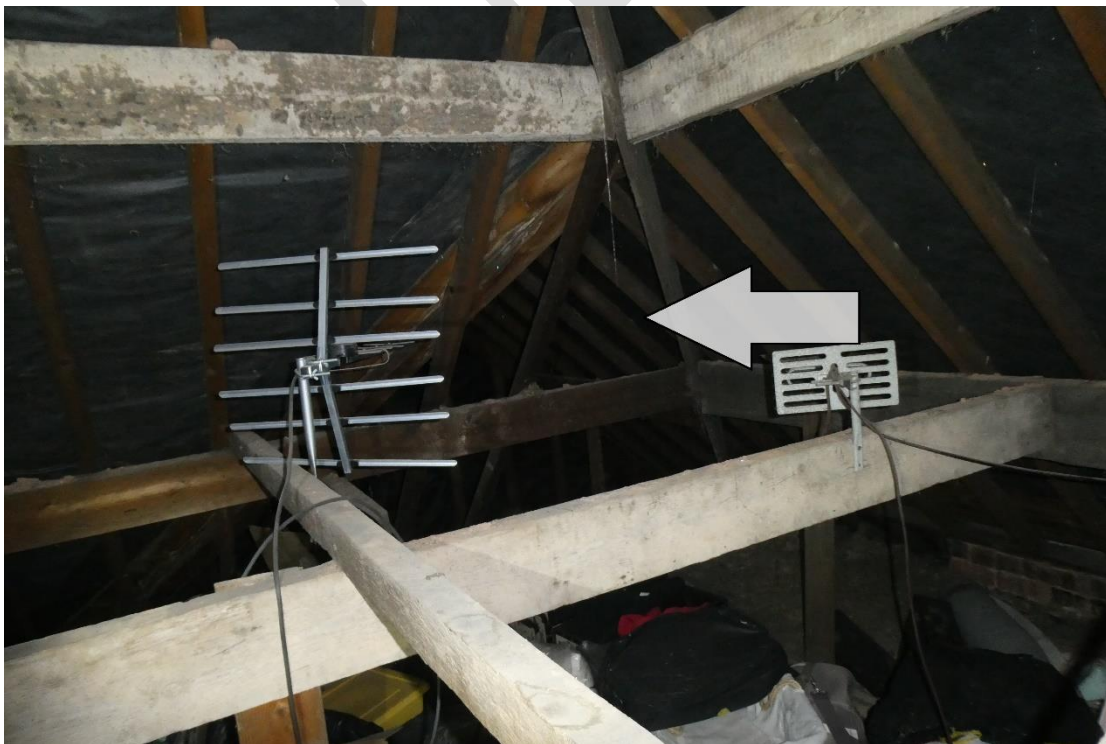
THE FRONT DORMER CAN BE SEEN BUT NOT INSPECTED.

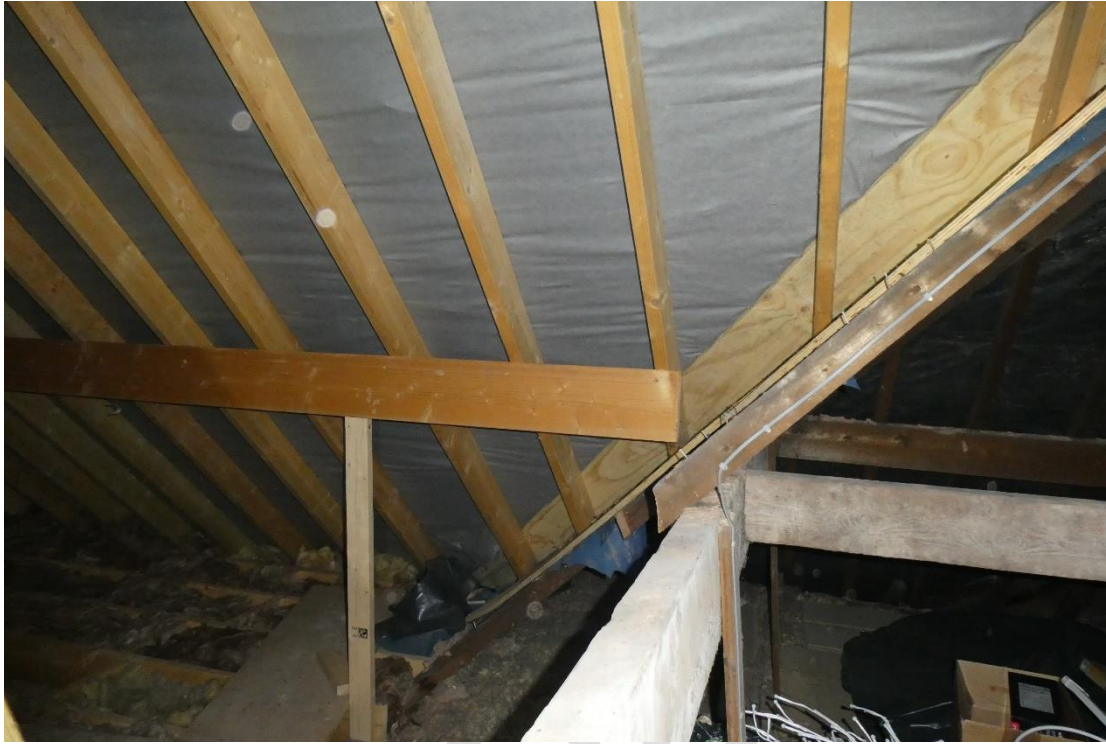
THIS IS THE JUNCTION BETWEEN THE ORIGINAL AND EXTENSION ROOF AREAS.

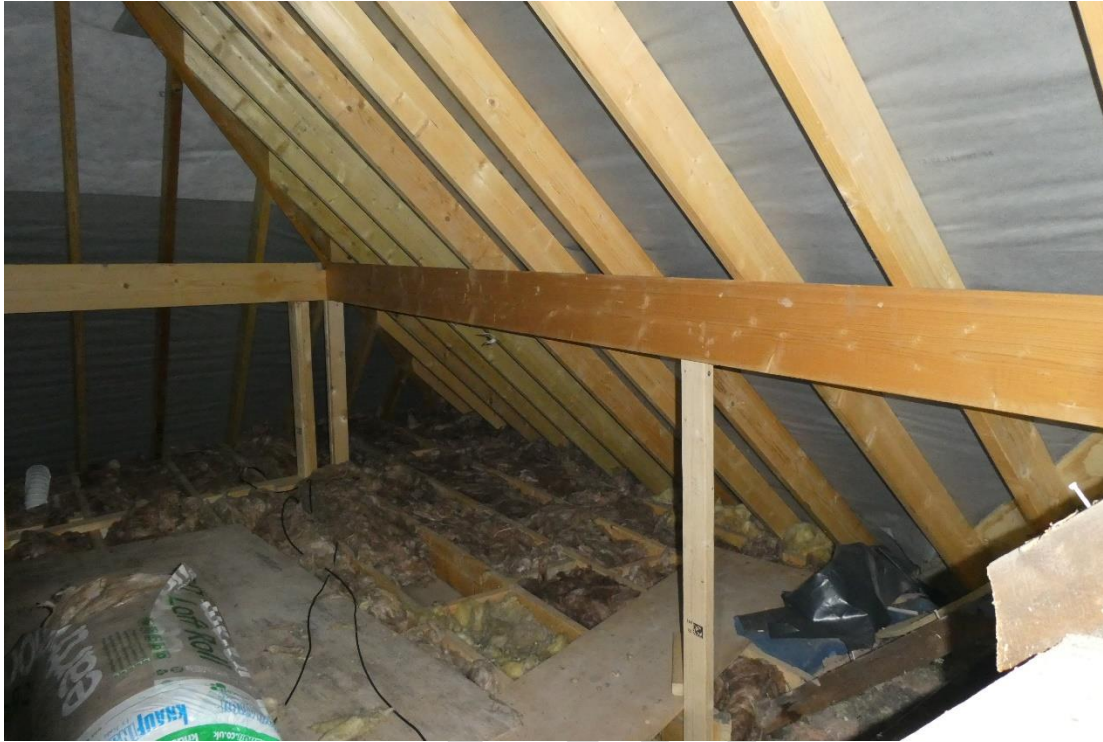
LOOKING ALONG THE FRONT PURLIN.

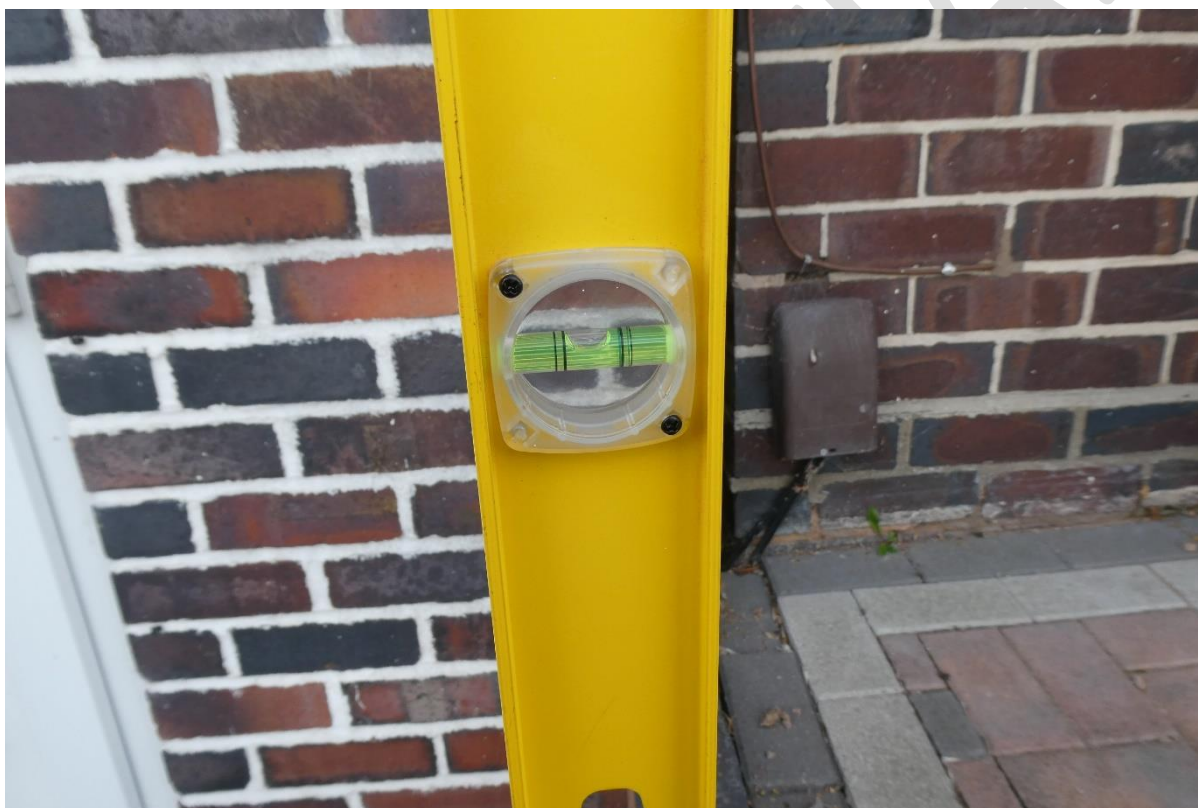
6.01 We assume that the wall which retains this property's drive is your wall as it matches the front wall. This wall is retaining and is only single-skin brickwork. Initially, we thought that it was leaning because blocks have sunk slightly to the front pathway. A level measurement indicated that it is acceptable level.

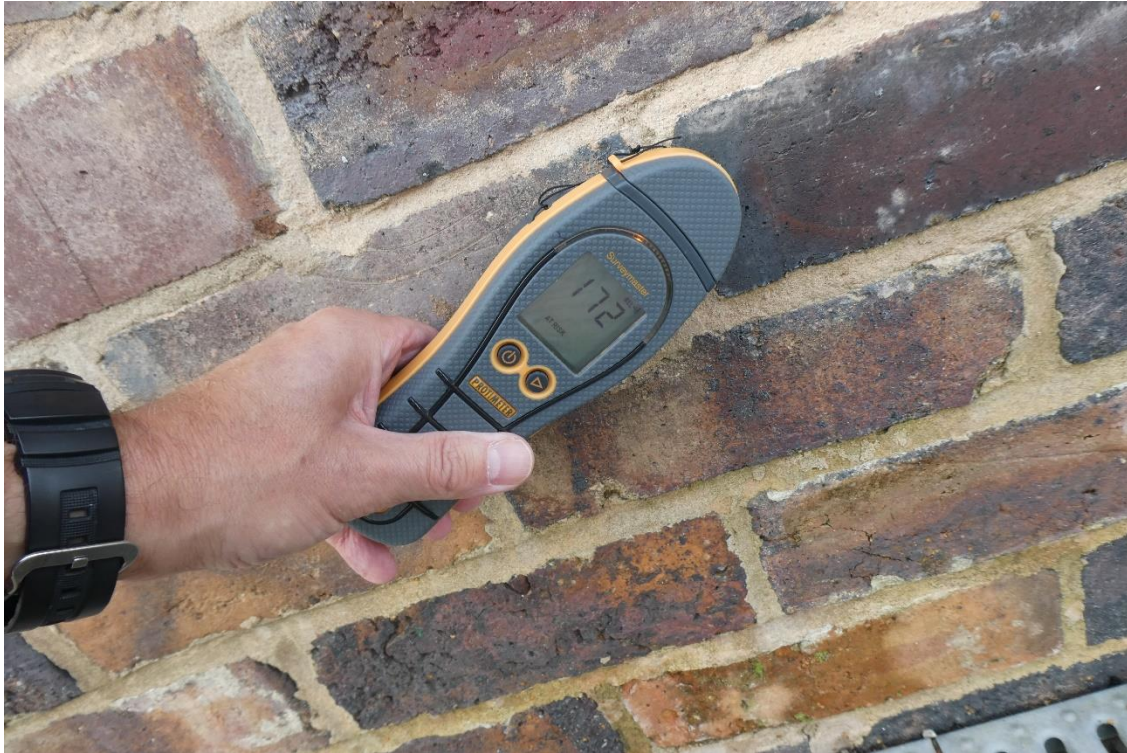
COMPARISON MEASUREMENT TAKEN ABOVE THE DAMP AREA.

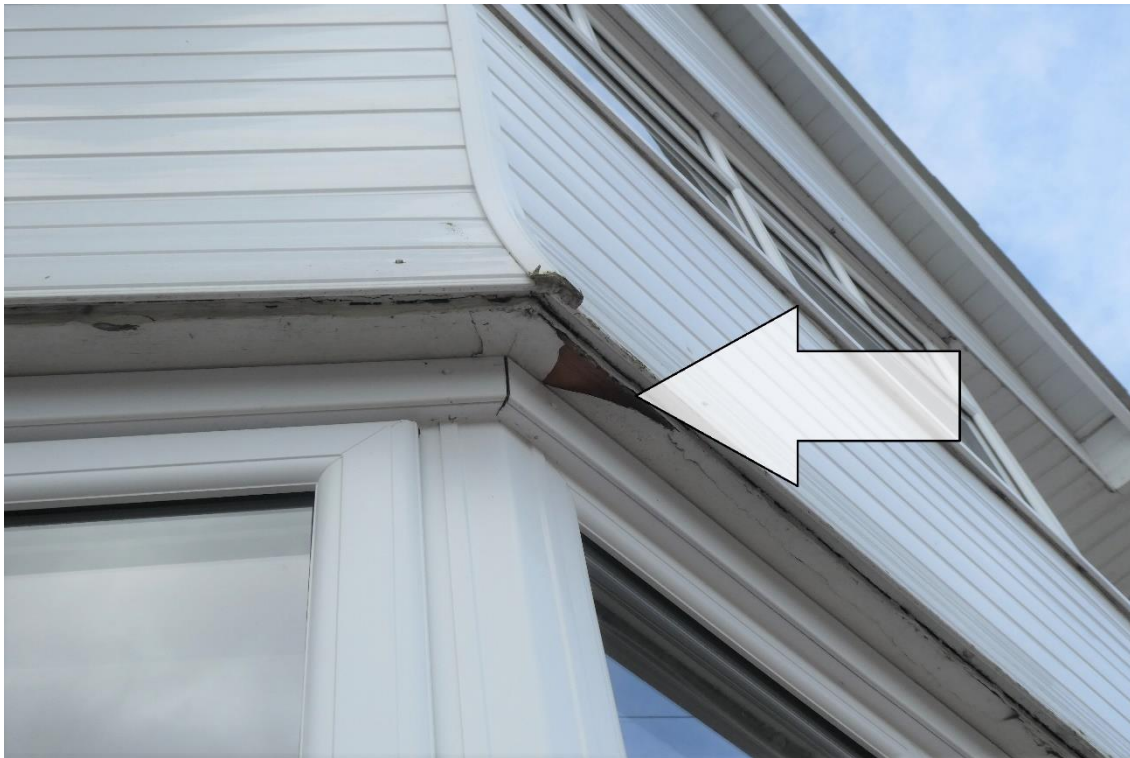
BOARD BENEATH BAY CLADDING.

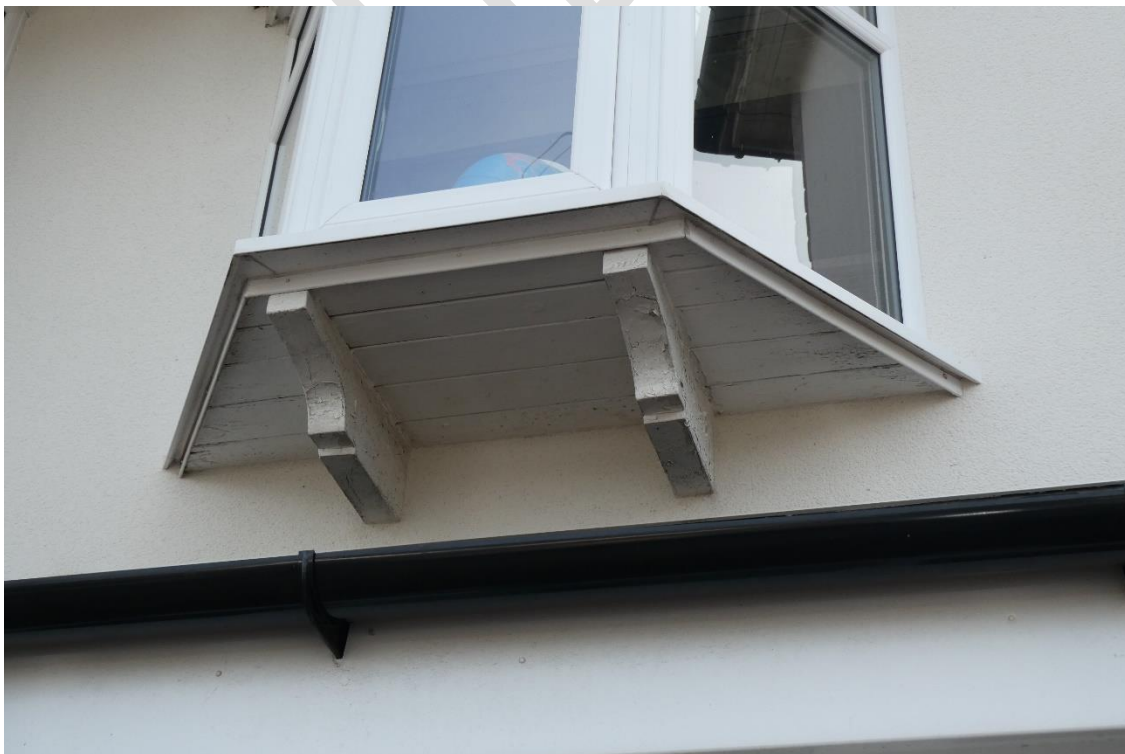
UNDERSIDE OF BAY.

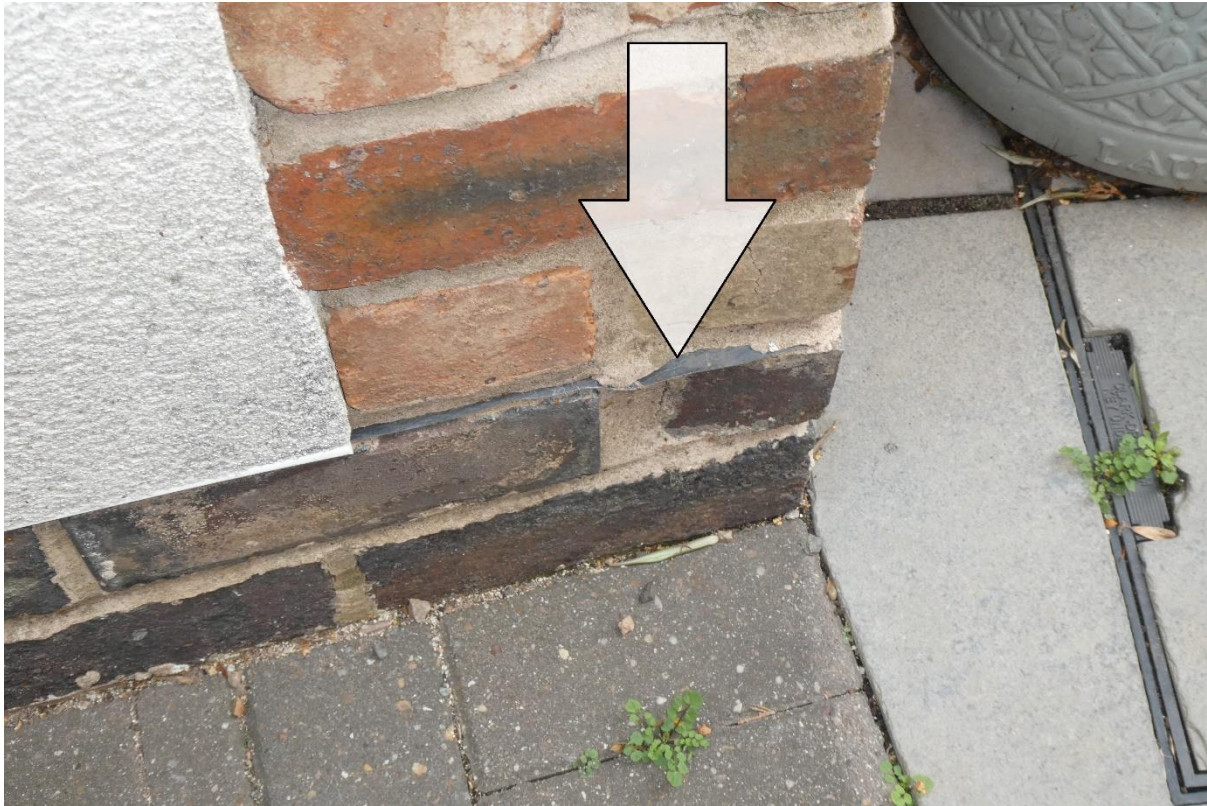
THIS IS THE ONLY SECTION OF DPC THAT WE COULD ACTUALLY SEE. YOU CAN ALSO SEE THE DIFFERENT COLOUR BRICKS BENEATH THE DPC.

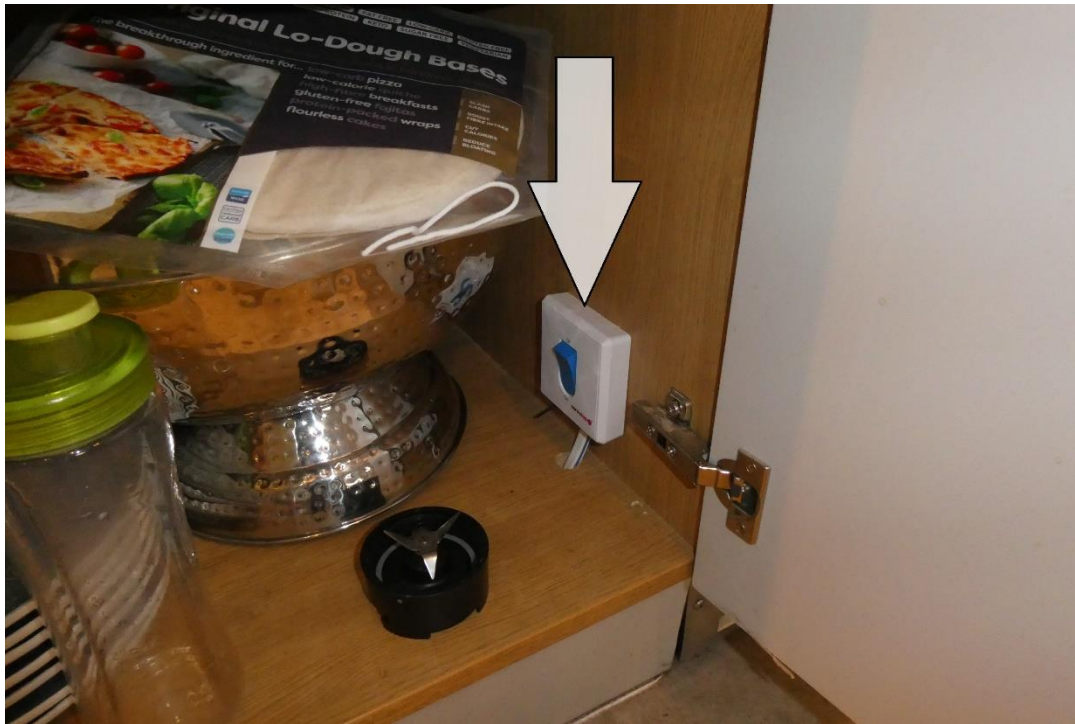
"SURE-STOP" WATER ISOLATOR.

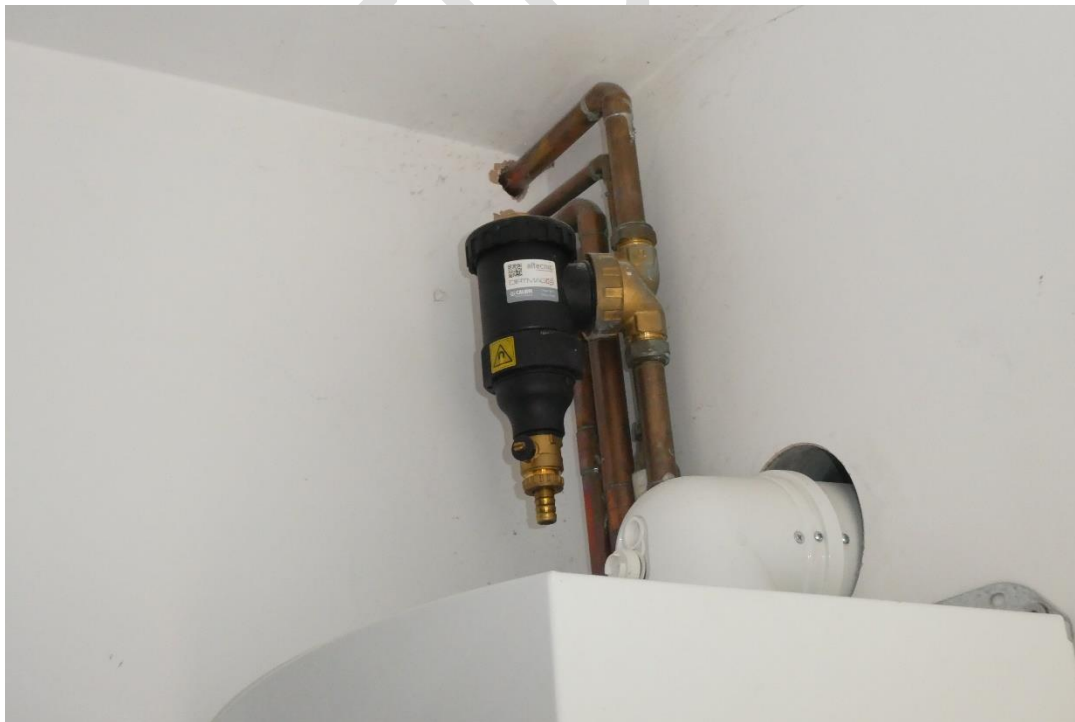
MAGNETIC SYSTEM CLEAN ABOVE THE BOILER.

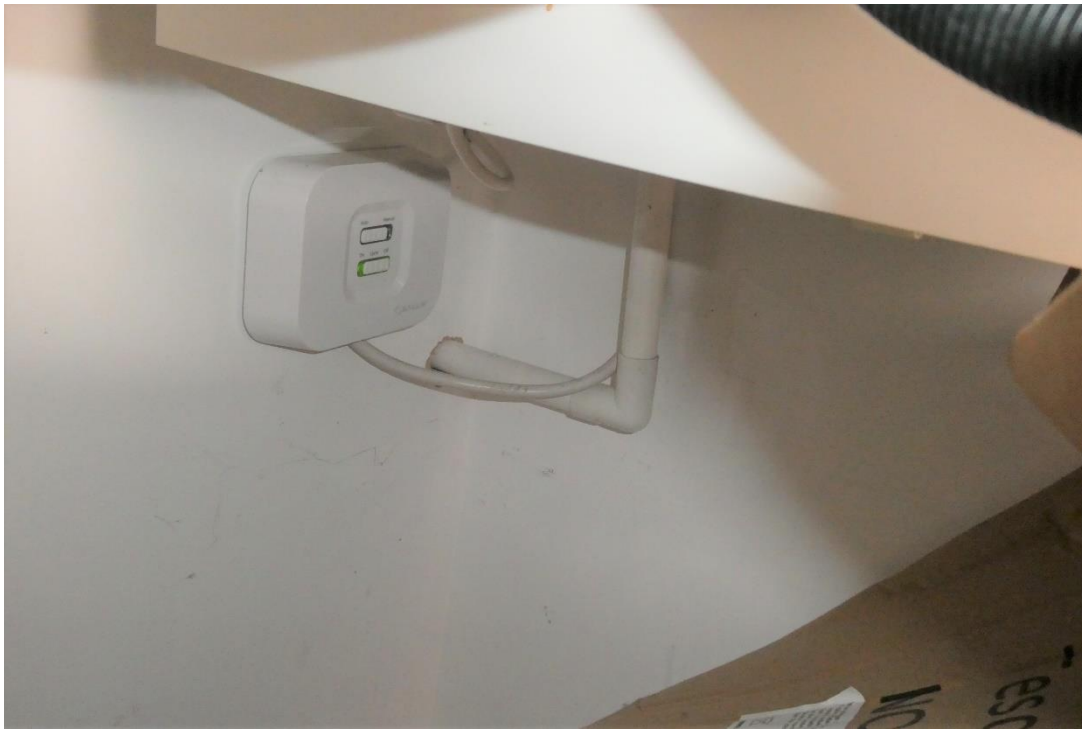
BOILER CONDENSATE PIPE GOING INTO THE UTILITY. YOU CAN ALSO SEE THE THERMOSTAT REMOTE KEY.

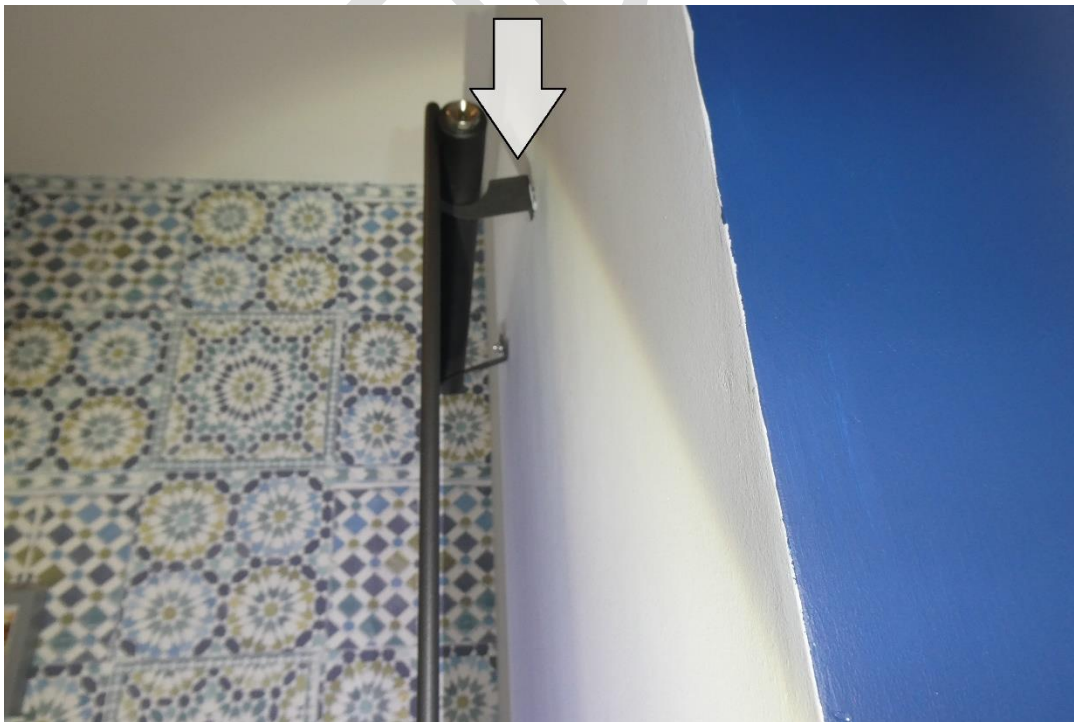
RADIATOR IS NOT FIXED CORRECTLY TO THE WALL.

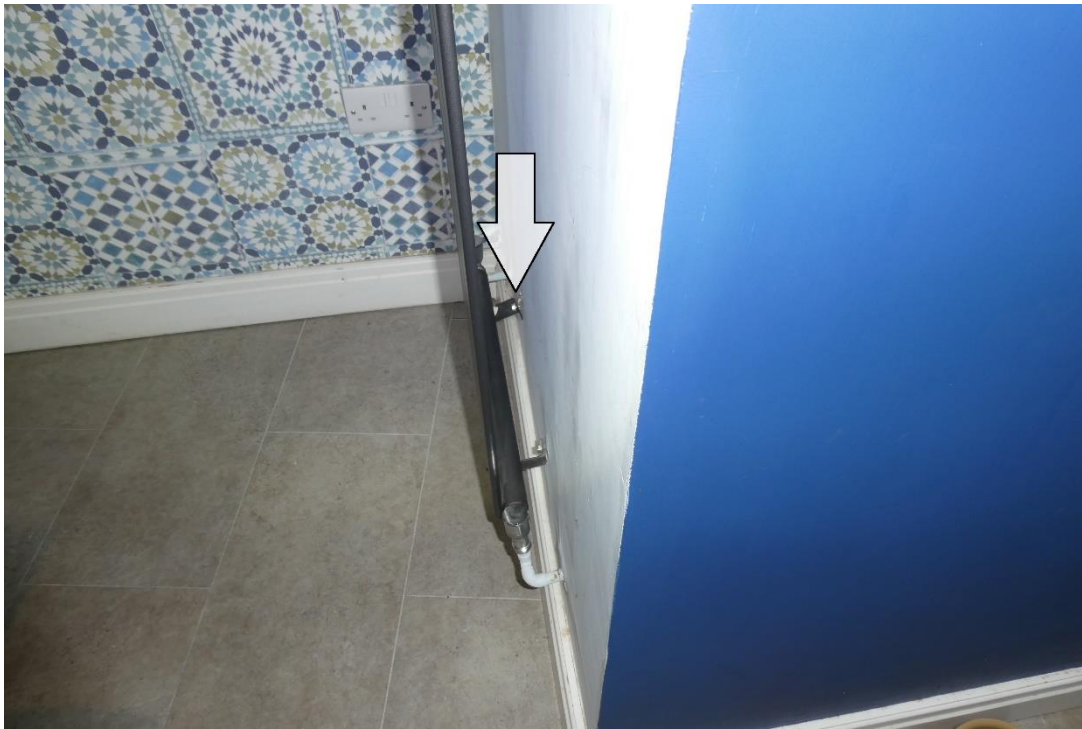
RADIATOR IS NOT FIXED CORRECTLY TO THE WALL.

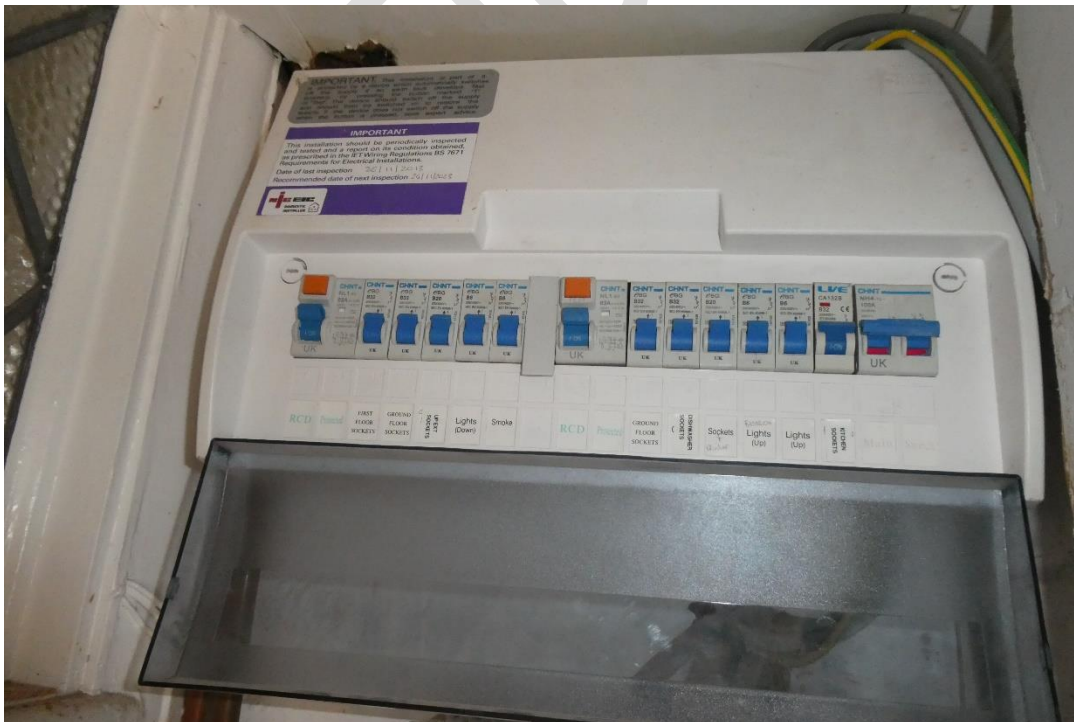
OLDER CONSUMER UNIT.

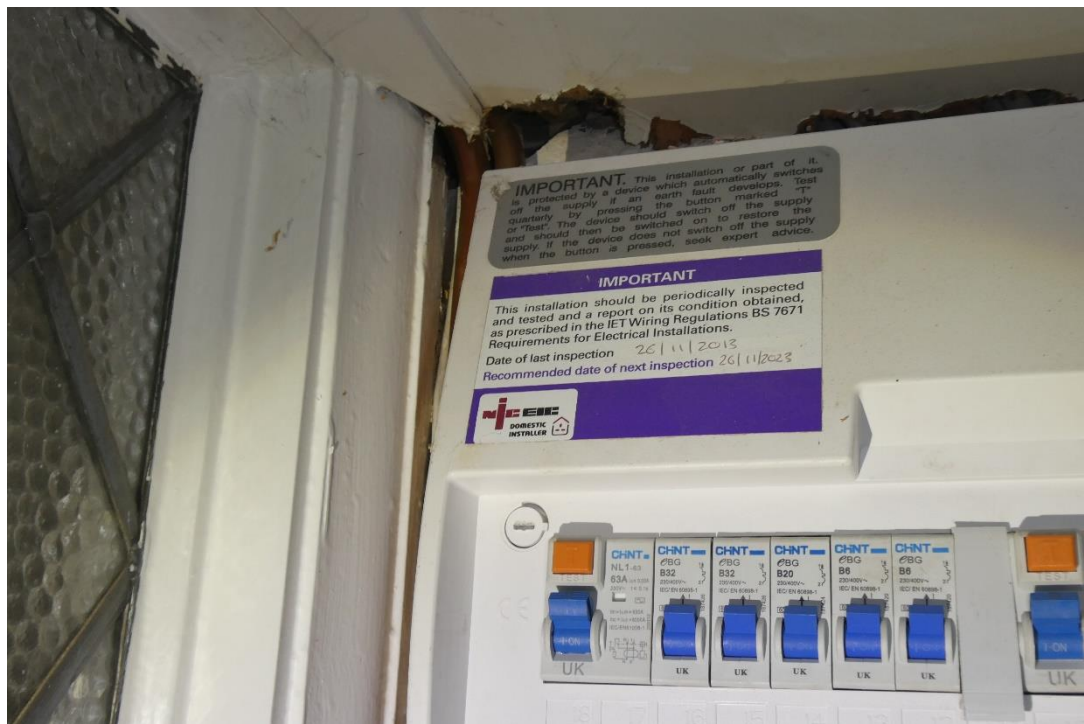
ALTHOUGH THE STICKER STATES "NEXT INSPECTION 2023", THE WHOLE INSTALLATION SHOULD HAVE BEEN CHECKED PRIOR TO EXTENDING IT INTO THE EXTENSION.

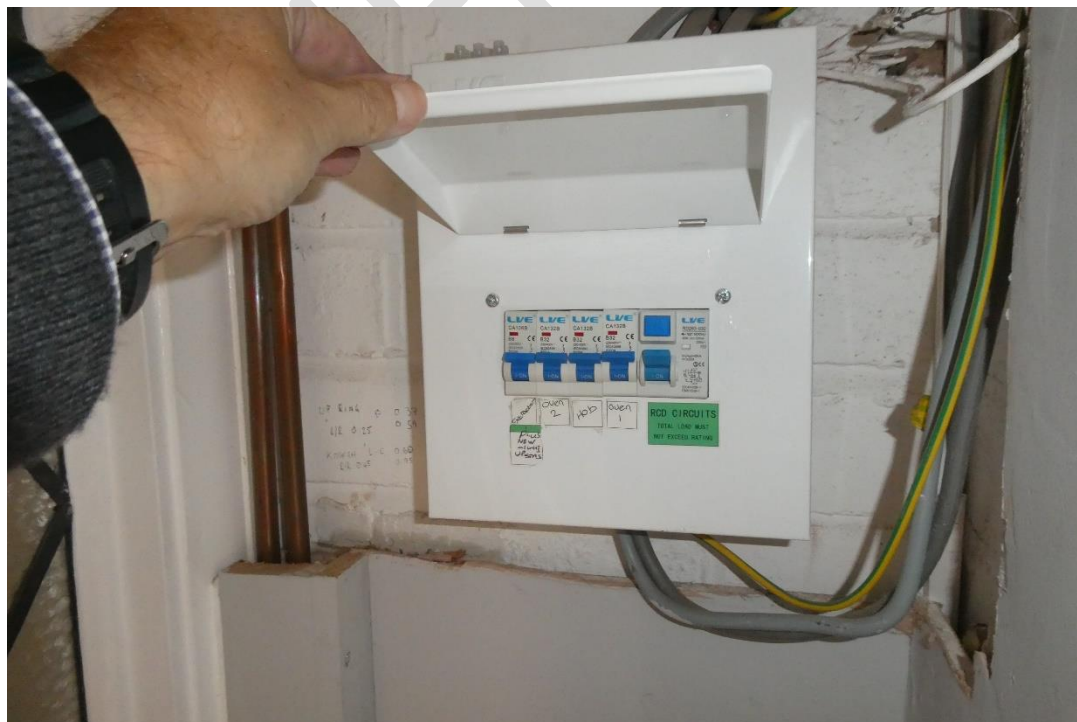
NEW CONSUMER UNIT WHICH ONLY COVERS THE KITCHEN PART OF THE EXTENSION AND SOME LIGHTS UPSTAIRS.
