# BUILDING SURVEY

BUILDING SURVEY FOR \*\*\*\*\*

Date of Survey: \*\*\*\*\*

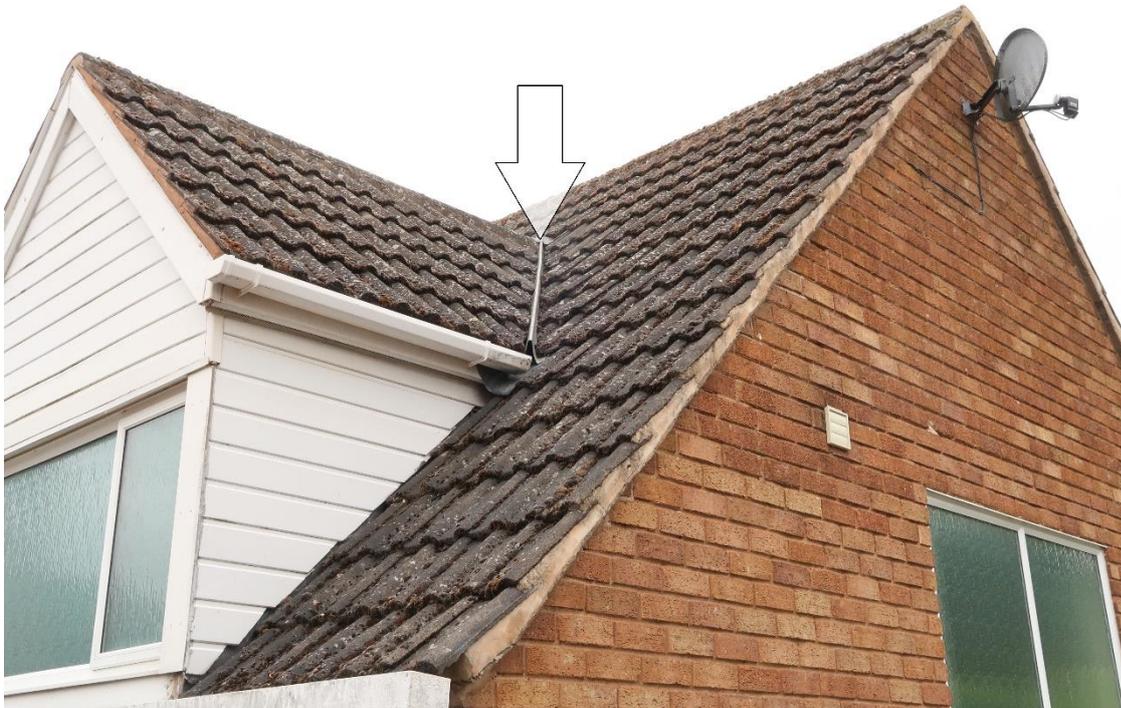
3.03 The valleys to the cottage dormers have been retrospectively fitted with dry-fix valleys. We assume that this is due to the evidence of leakage to the rear bedrooms. We tested the water marks to the boarding to the bedrooms and they were dry, but please bear in mind the dry summer that we have experienced. Another possible cause for the water marks is condensation behind the fitted insulation against the felt lining the tiles. The condensation will roll down and dampen the bedroom ceilings. Please see our comment in 3.08.

DRY-FIX VALLEY.

3.08 If you decide not to follow our recommendation to replace the roof finish, the insulation should be removed from beneath the roof structure and the aforementioned ventilation measures should be installed which can be implemented into the existing roof finish.

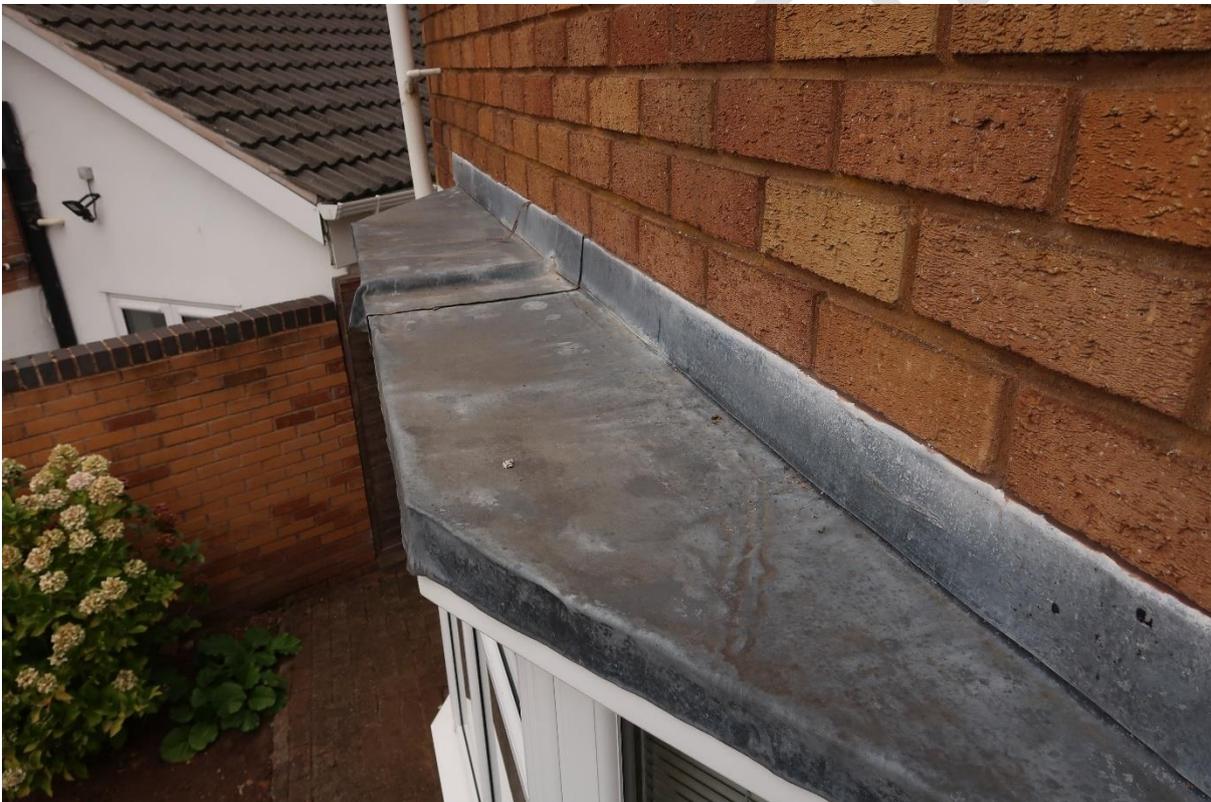
#### Living room bay roof finish.

3.12 No obvious issues were noted but lead does have a lifespan of approximately fifty to seventy years. You should budget accordingly.

Condition Rating 1

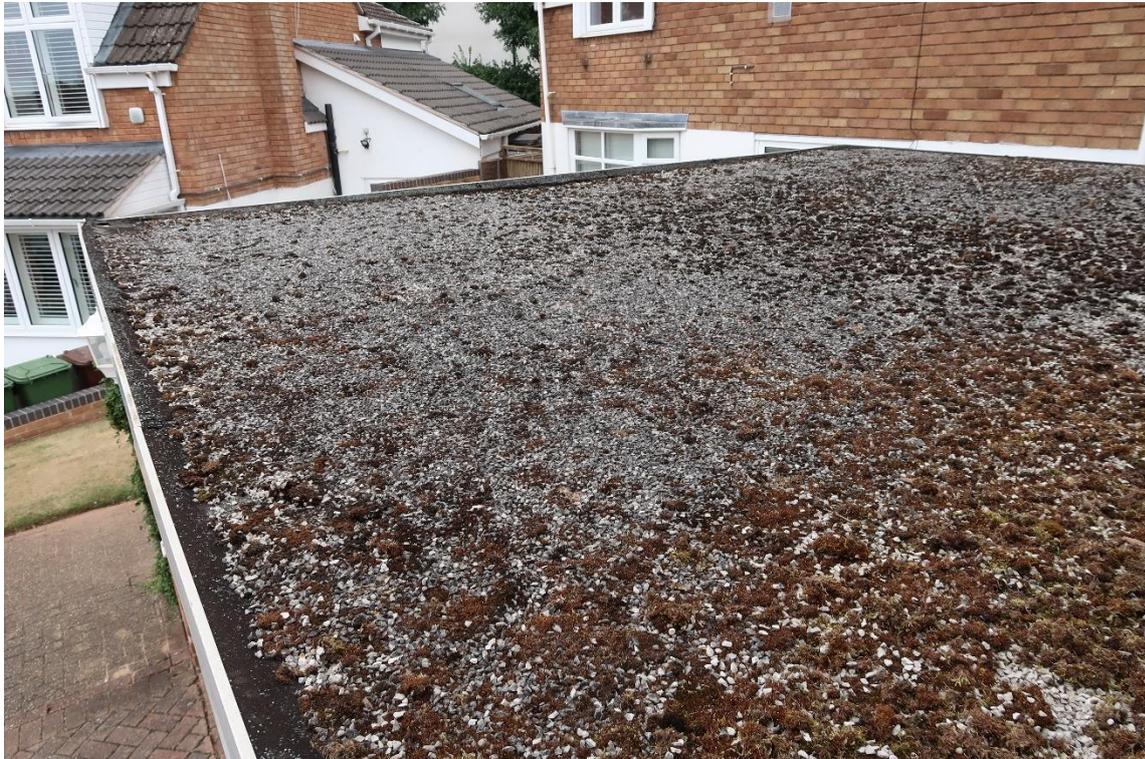
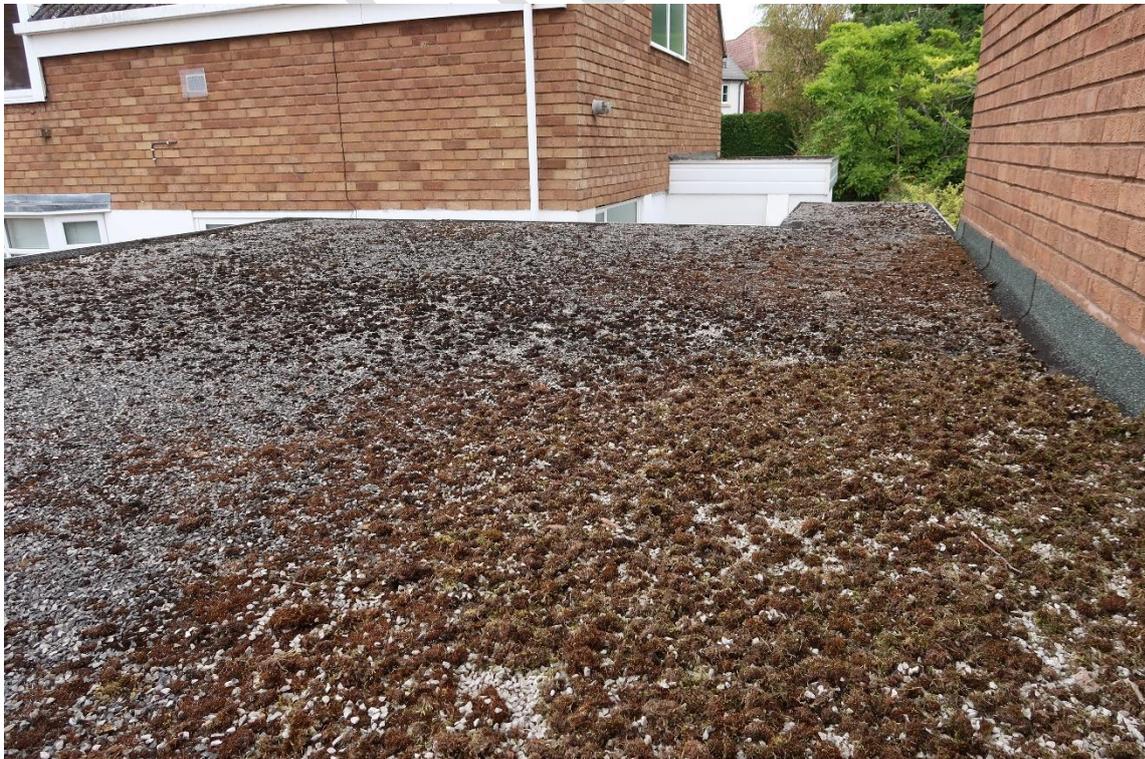
GENERAL VIEW.

3.15 The felt is aged and where it is exposed around the edge upstands, the felt has split and deteriorated. We were surprised that there is not clear evidence of leakage within the garage and store.

3.16 We climbed onto the roof and there is movement in the decking. This could be caused by leakage through the felt.

Condition Rating 3

3.17 We have discussed this with you and recommended immediate renewal including new decking.

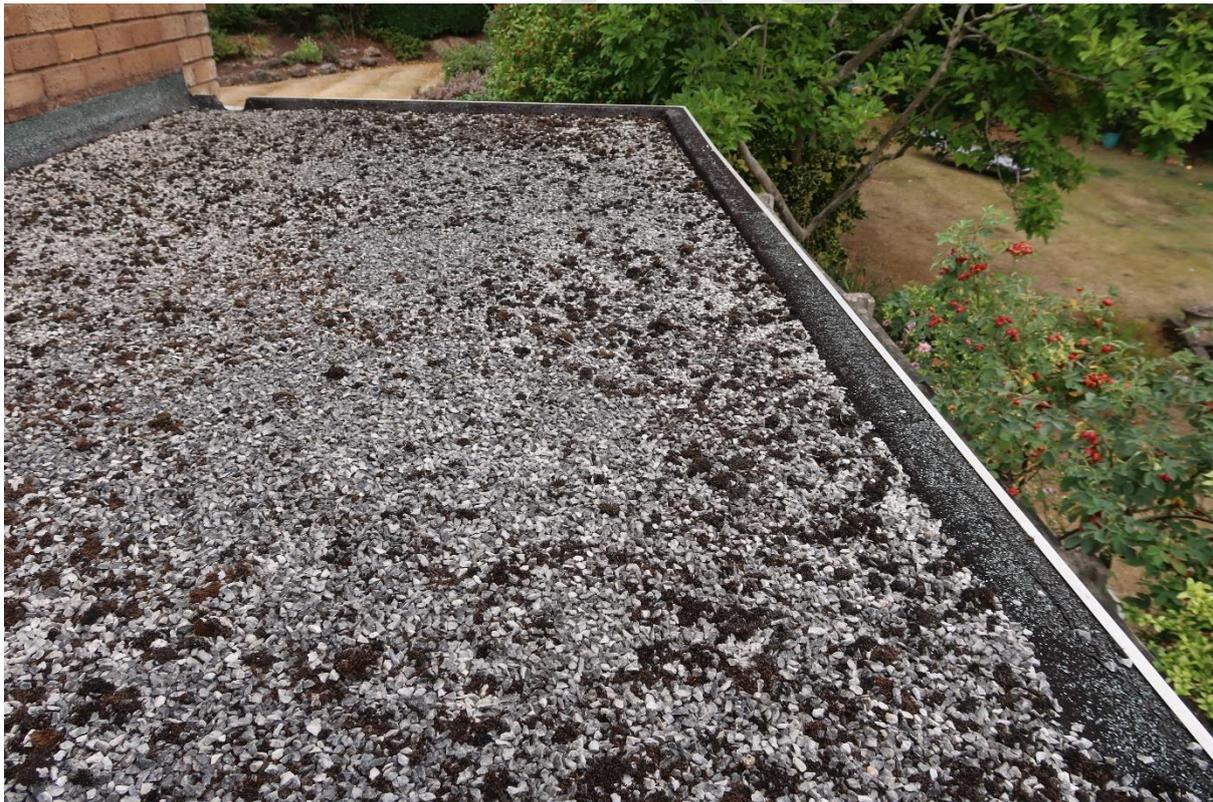
3.21 Again, the felt is aged and where it is exposed around the edge upstands, the felt has split and deteriorated. We were surprised that there is not clear evidence of leakage.

3.22 We climbed onto the roof and there is movement in the decking. This could be caused by leakage through the felt.

**Condition Rating 3**

3.23 We have discussed this with you and recommended immediate renewal including new decking.

3.24 If you wish to extend the lifespan of the new roof, you should consider a long-life material such as EPDM or GRP which should last approximately thirty years. Bitumen felt will only last ten to fifteen years.

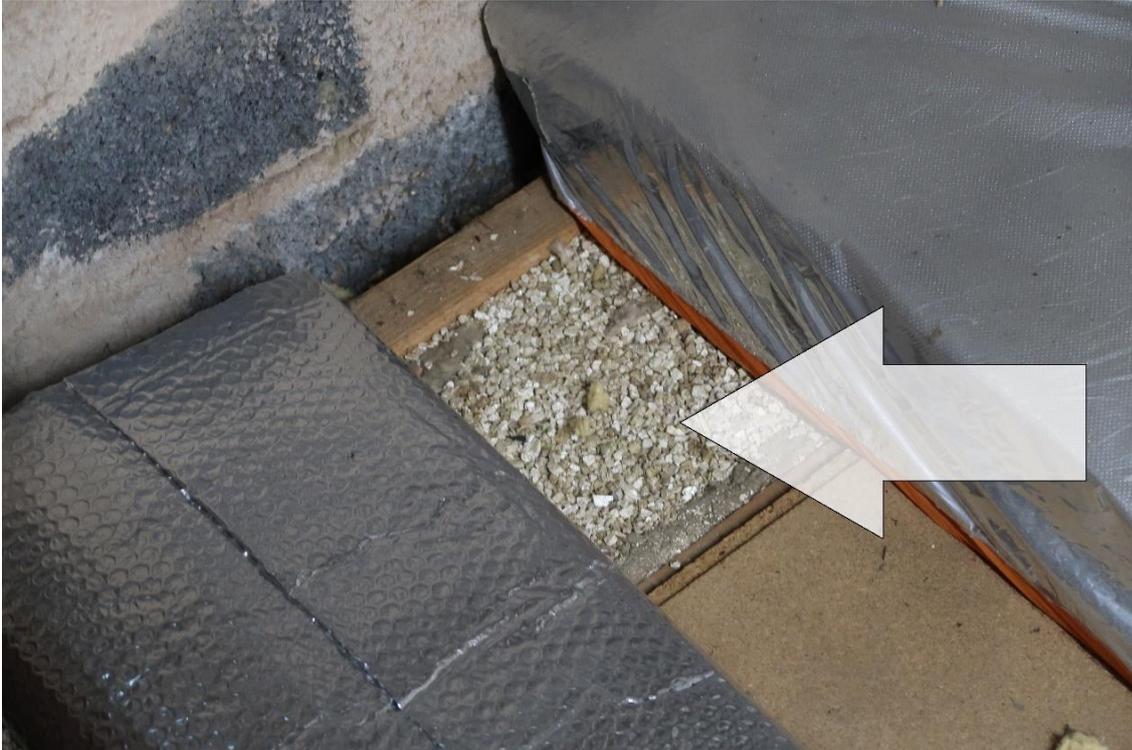
4.03 We noted vermiculite insulation which can contain asbestos. We have advised you to get this asbestos tested with other material within the house. Do not disturb this material until this test has been carried out.

VERMICULITE.

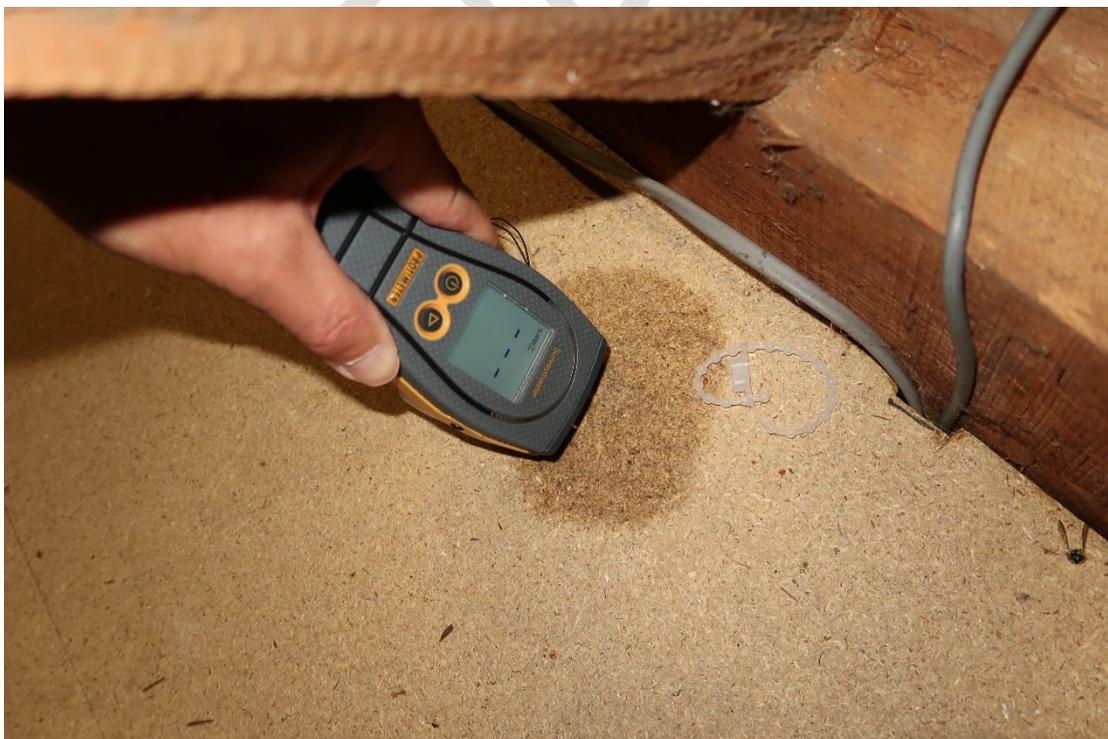
4.11 There are a small number of watermarks on the floorboards. We tested these with a damp meter and they were dry. This could be due to the hot weather as these could be condensation drips in the winter. The insulation should be removed.

TESTING WATER MARKS TO THE FLOOR. THEY WERE DRY.

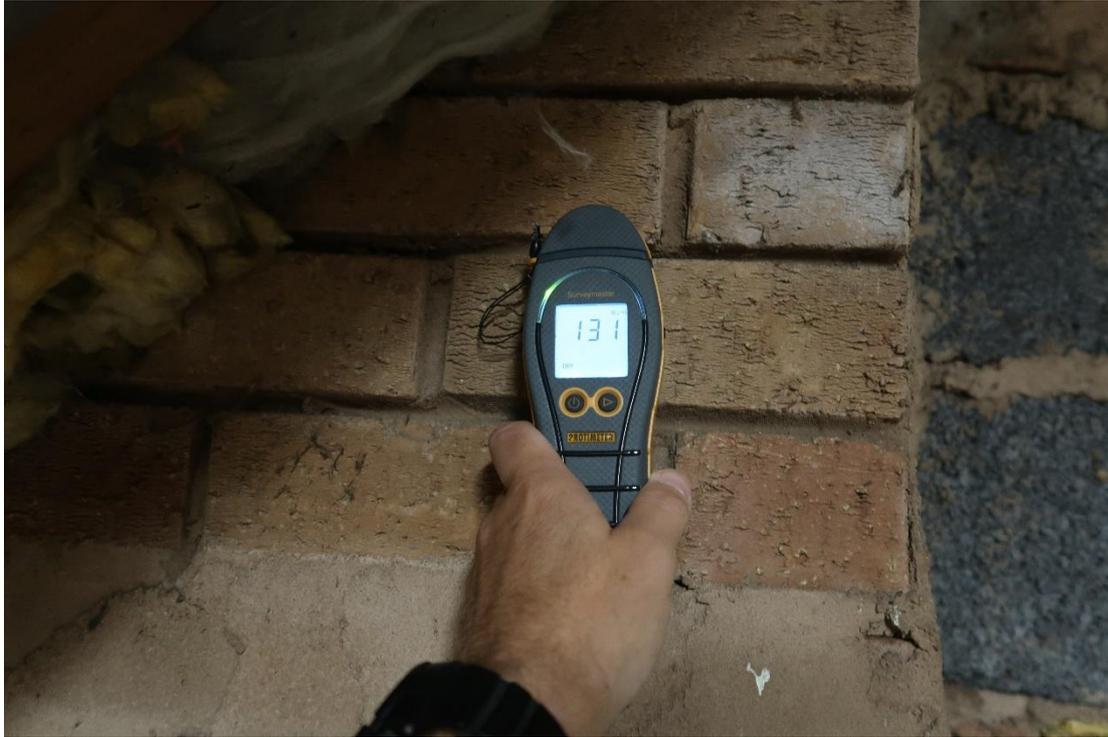
TESTING THE CHIMNEY BRICKWORK.

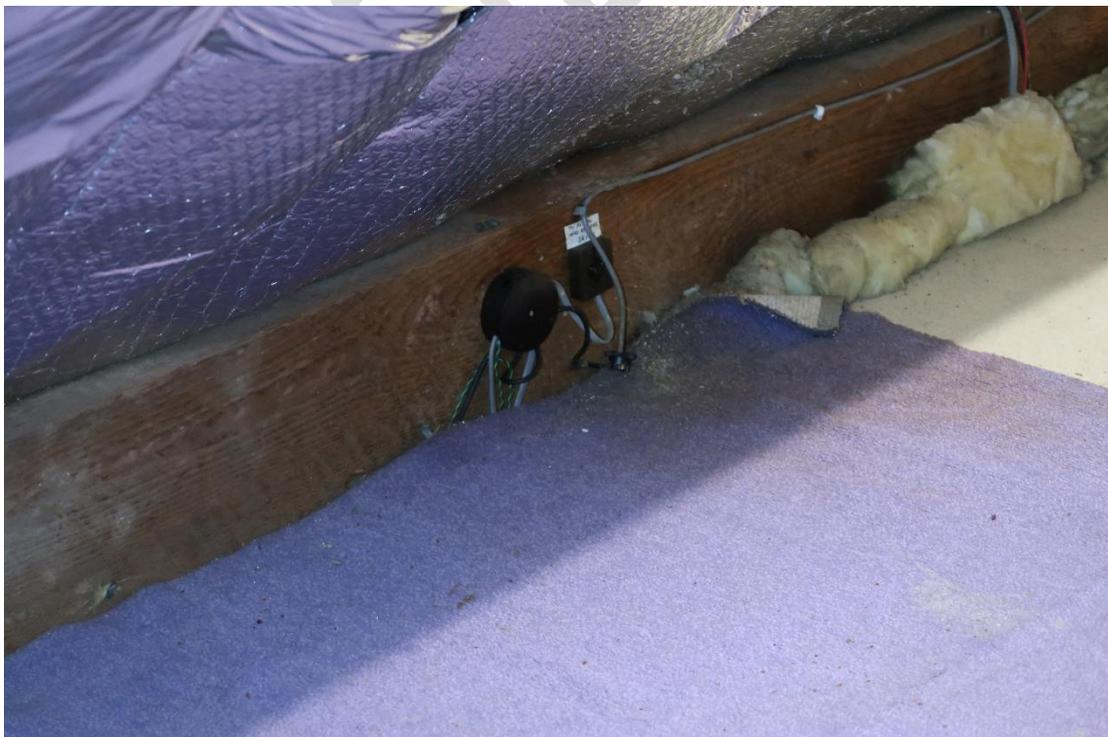
4.12 We could see old electric cables and junction box.

OLD ELECTRICS.

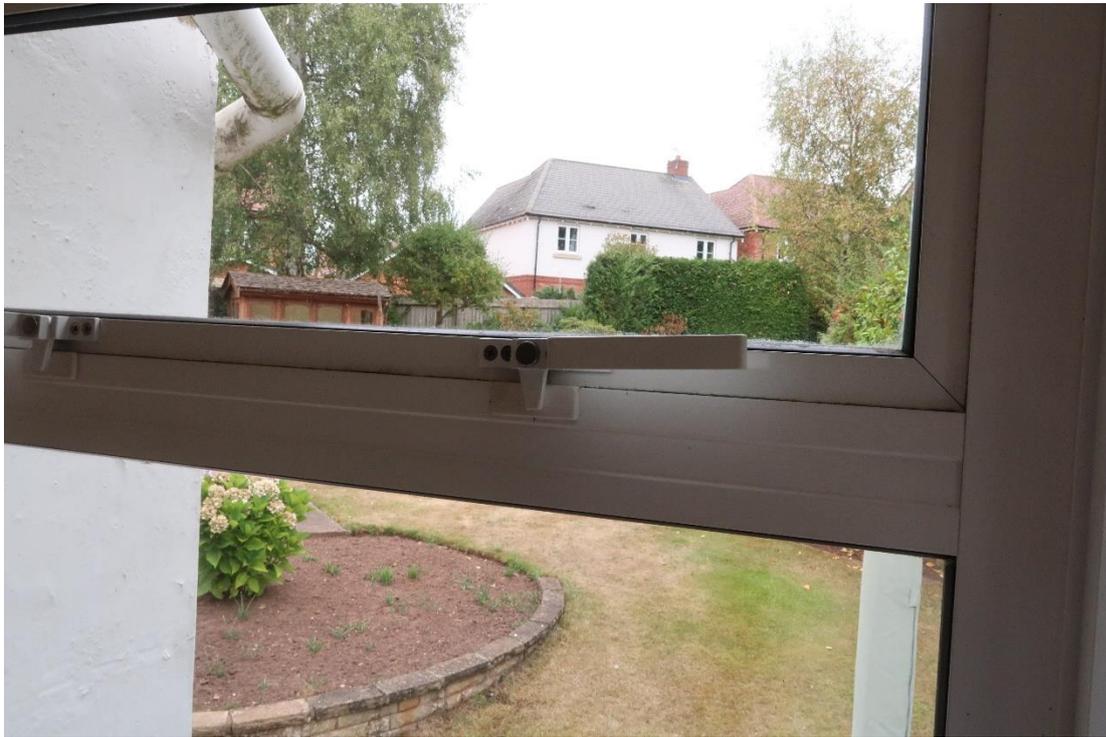
COCKSPUR HANDLE TO UTILITY.

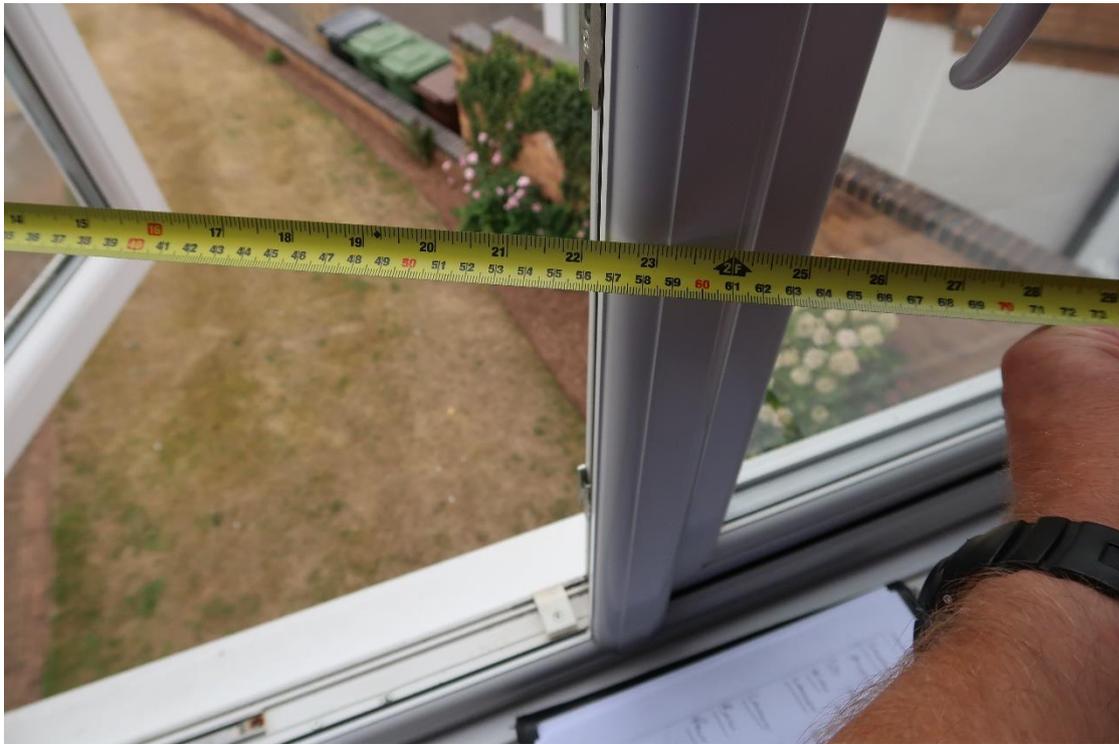
FRONT BEDROOM CASEMENT MEETS FIRE REGULATIONS.

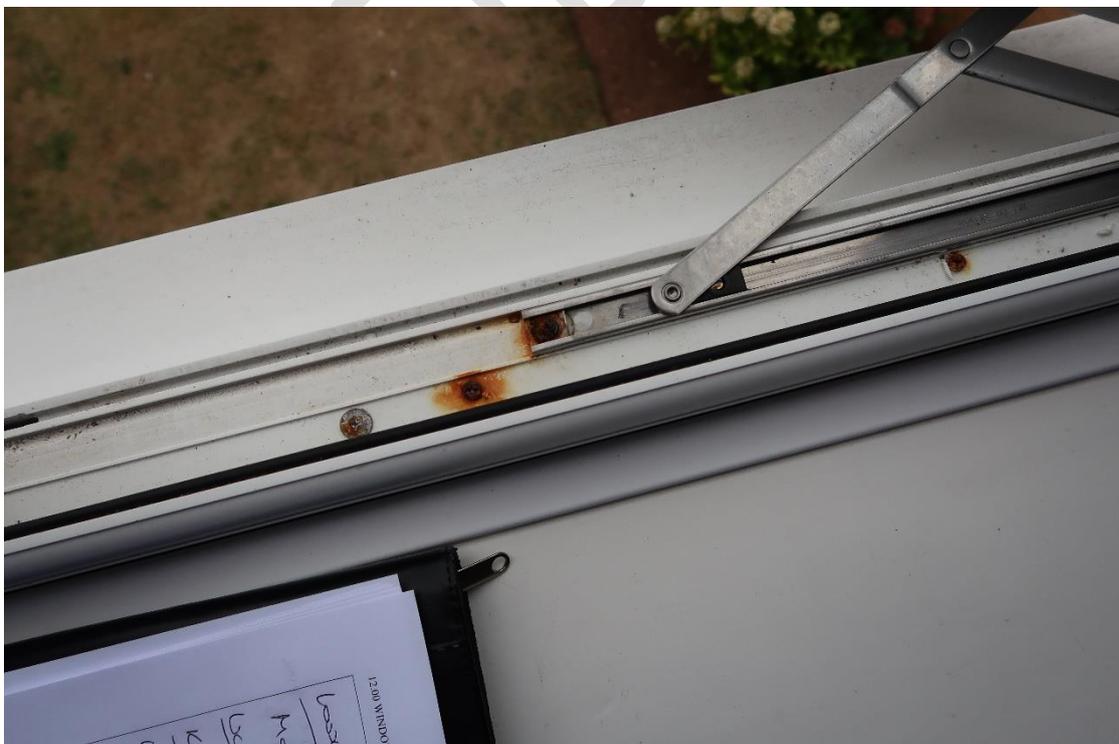
RAINWATER MAY BE GETTING INTO THE FRONT BEDROOM FRAME.

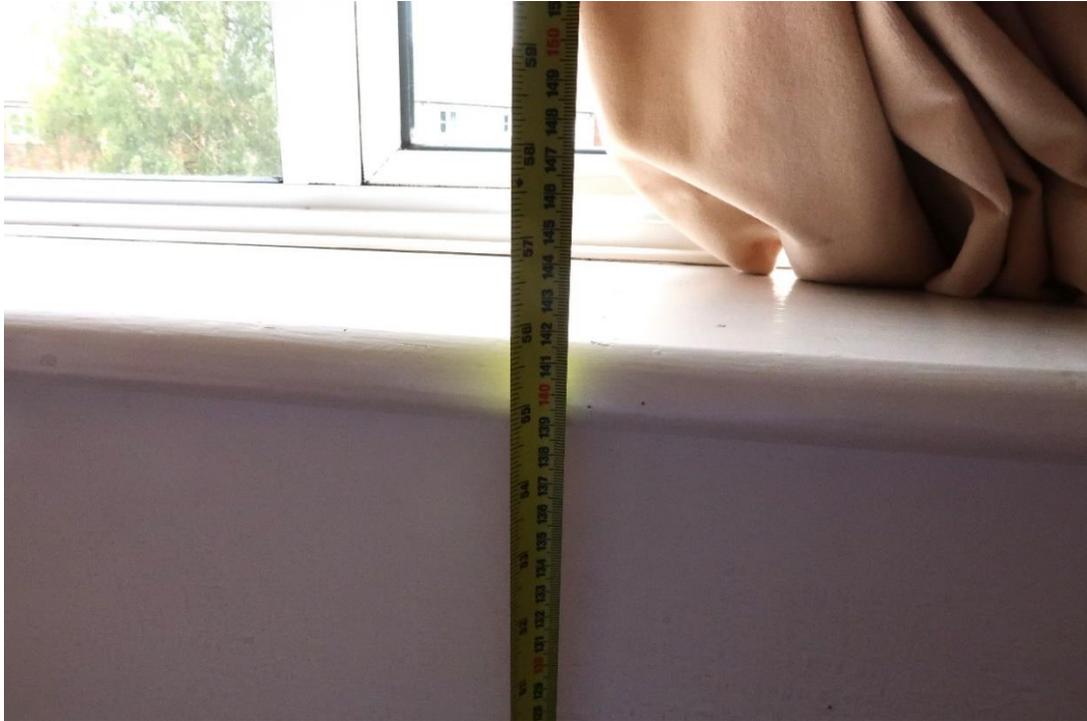
REAR RIGHT HAND BEDROOM: TO COMPLY WITH FIRE ESCAPE REGULATIONS, THE CILL SHOULD NOT BE HIGHER THAN 1100mm.

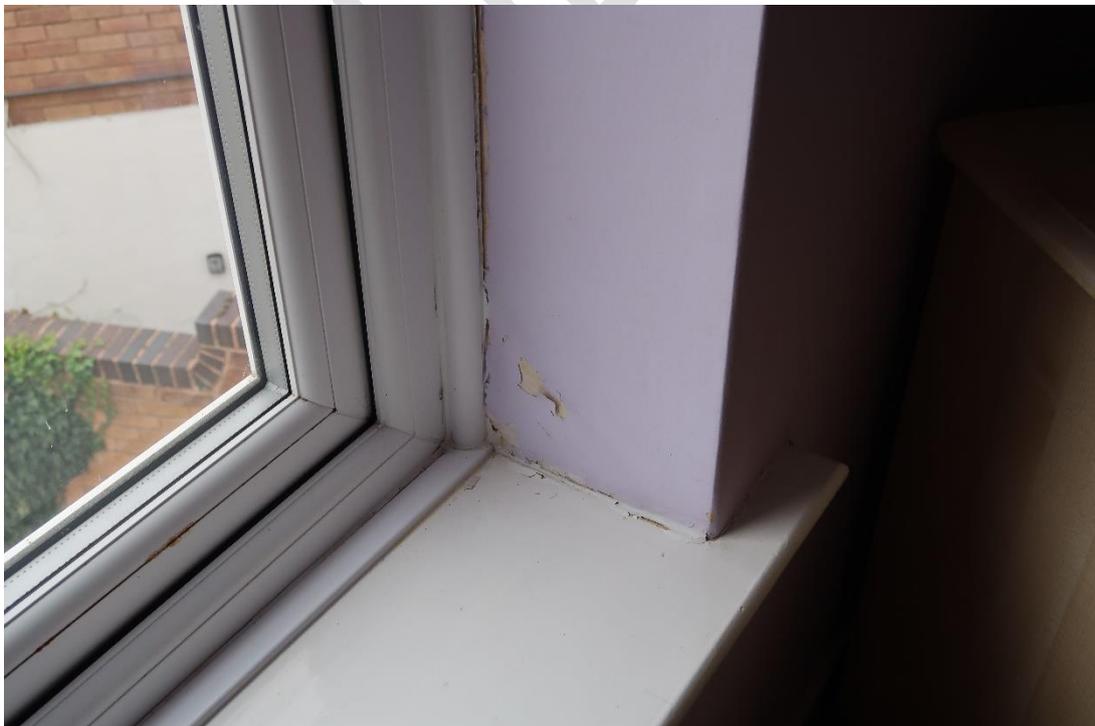
CHECK ALL SILICONE SEALS.

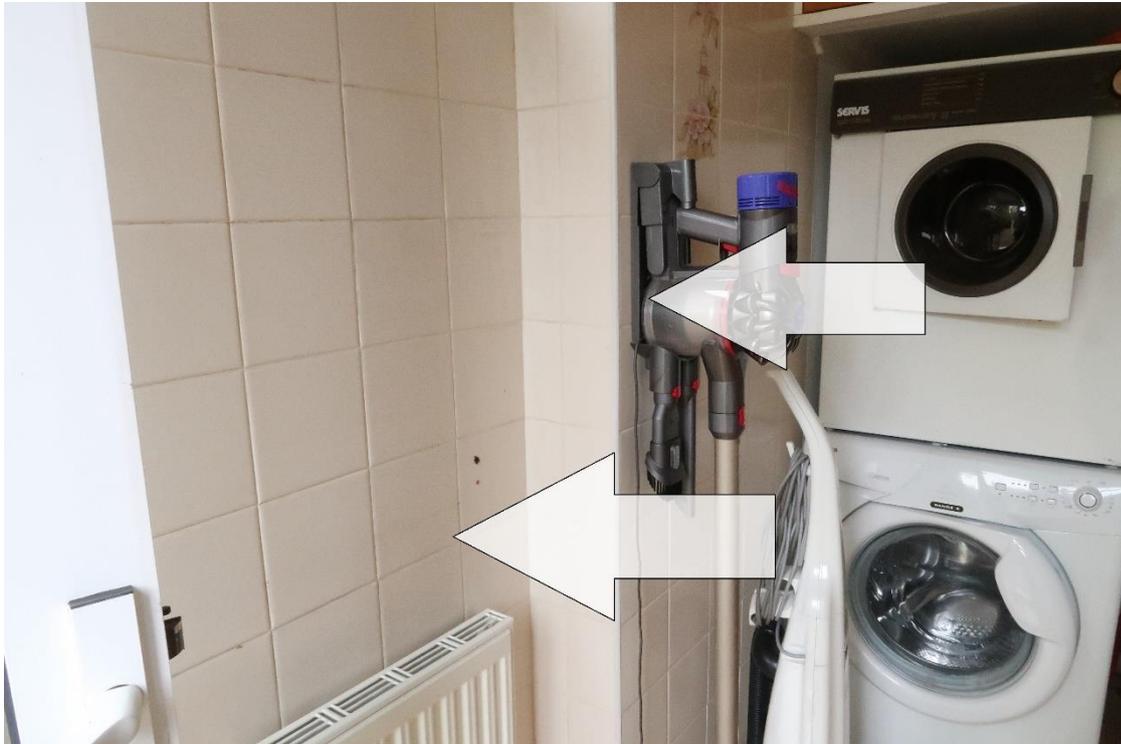
YOU CAN SEE WHERE THE WALL GOES FROM ORIGINAL CAVITY CONSTRUCTION TO A "SINGLE SKIN" EXTENDED SECTION.

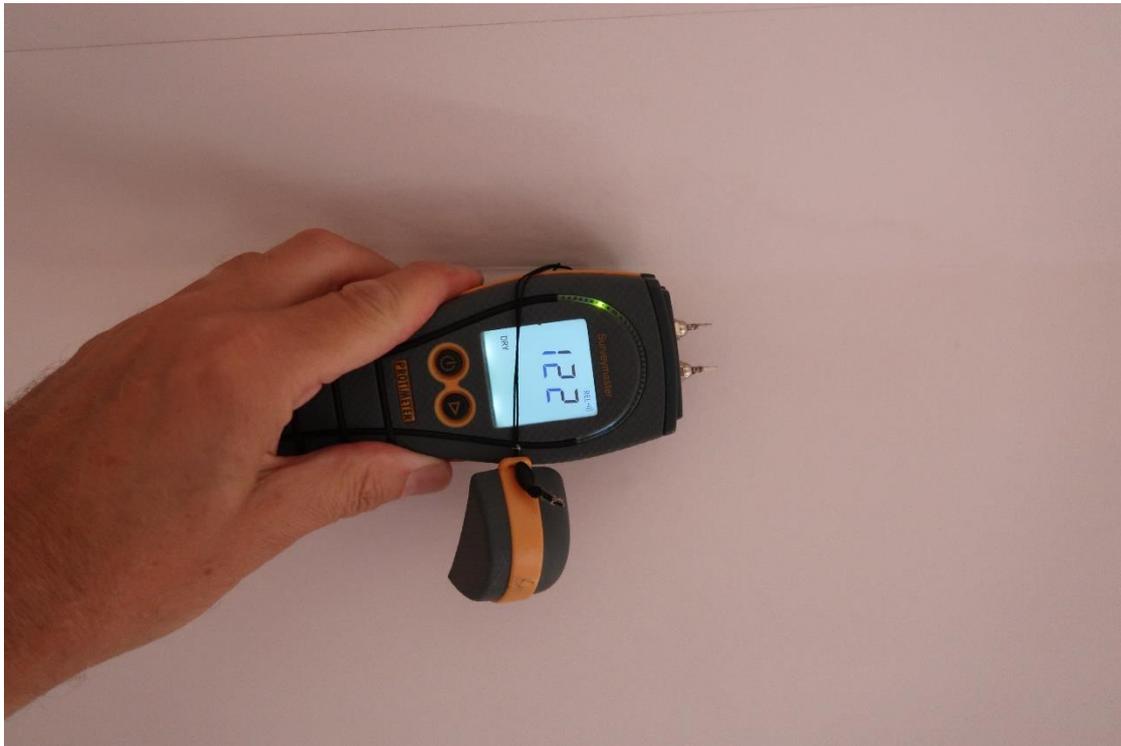
THE MARK IS DRY.

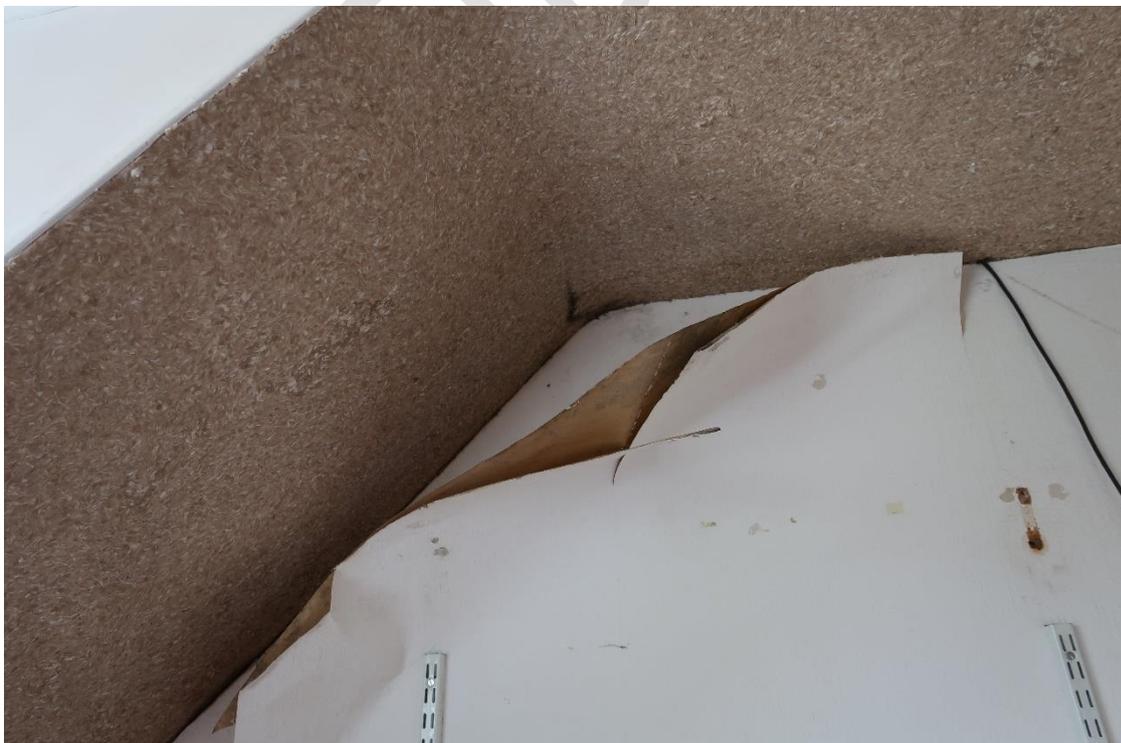
WATER MARK TO THE REAR RIGHT-HAND BEDROOM WALL/CEILING.

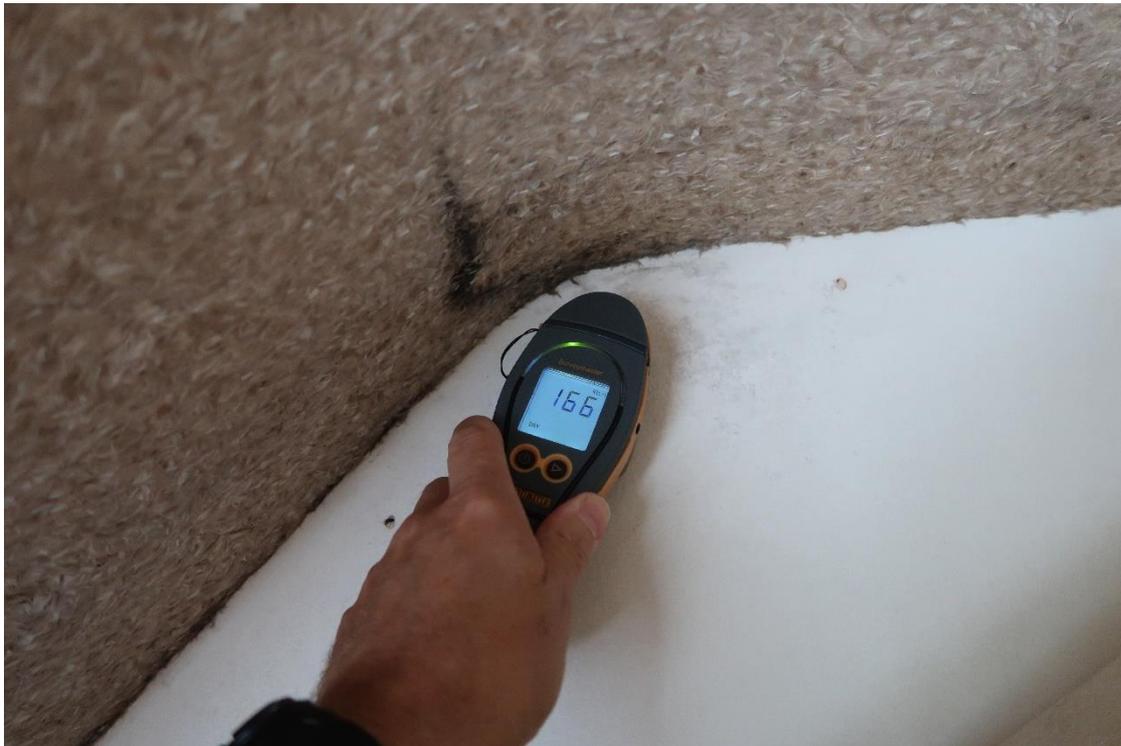
THE MARK IS DRY.

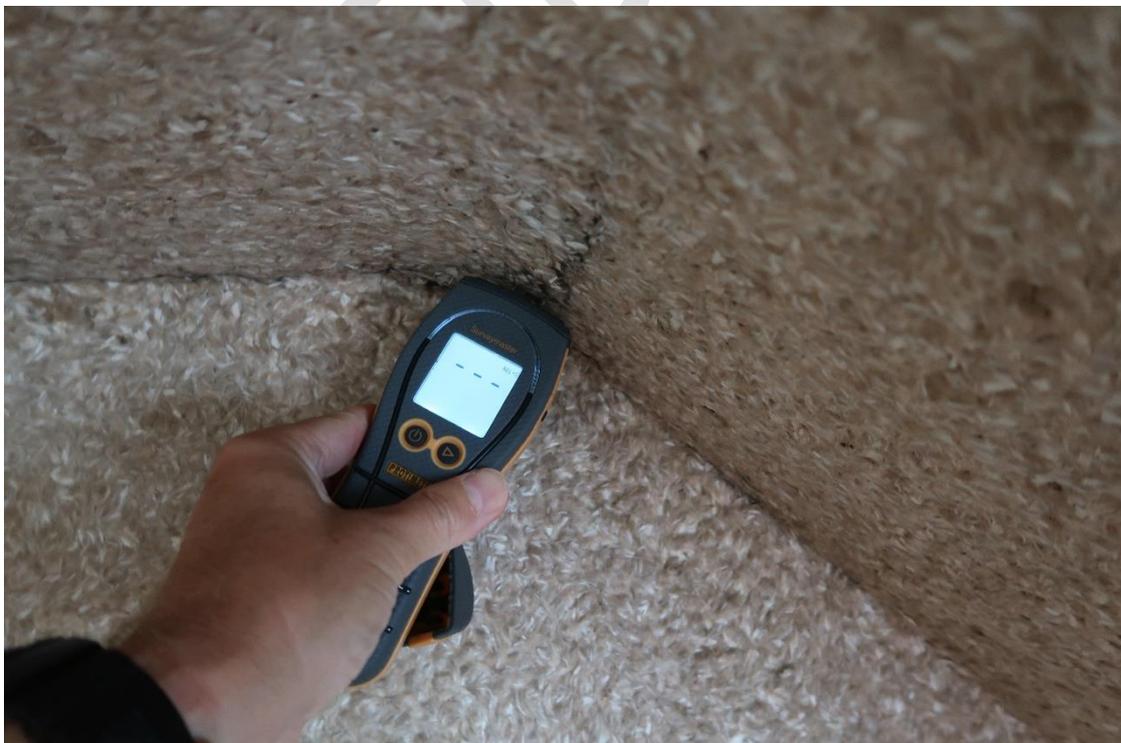
THE MARK IS DRY.

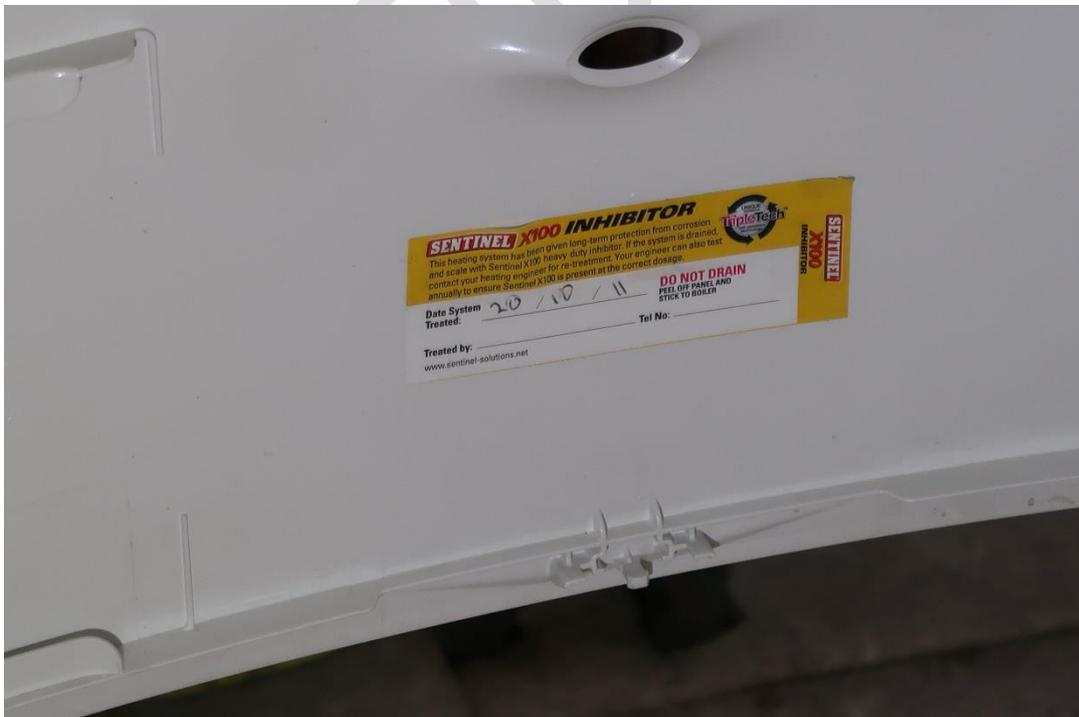
MAGNETIC SYSTEM CLEAN.

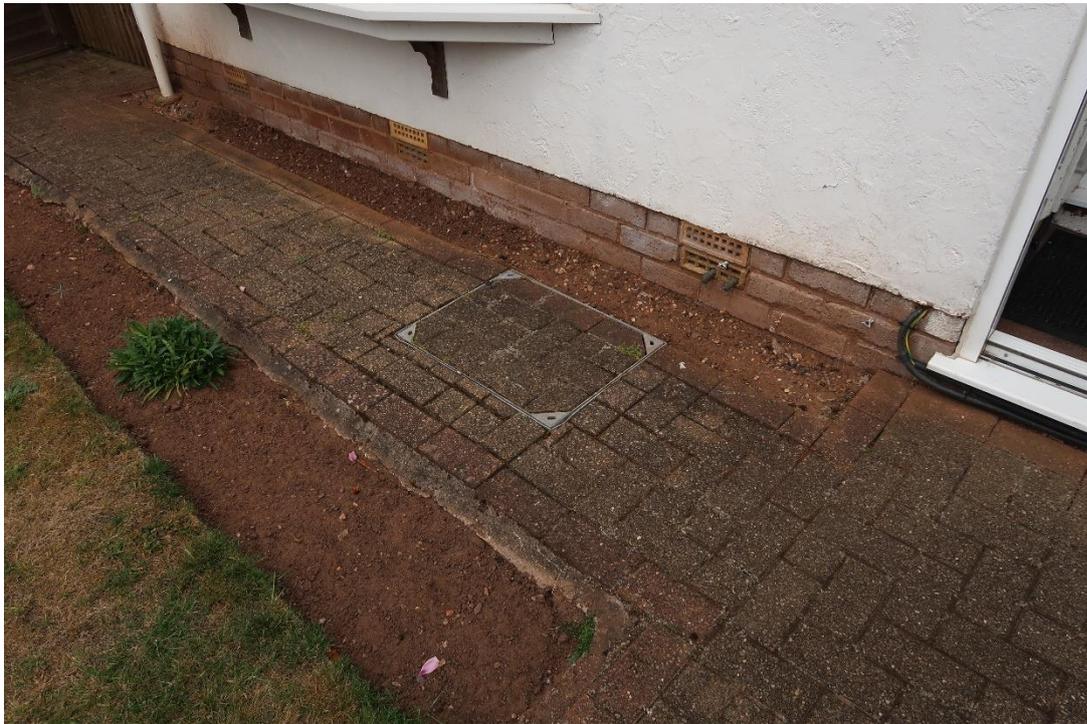
INSPECTION CHAMBER.

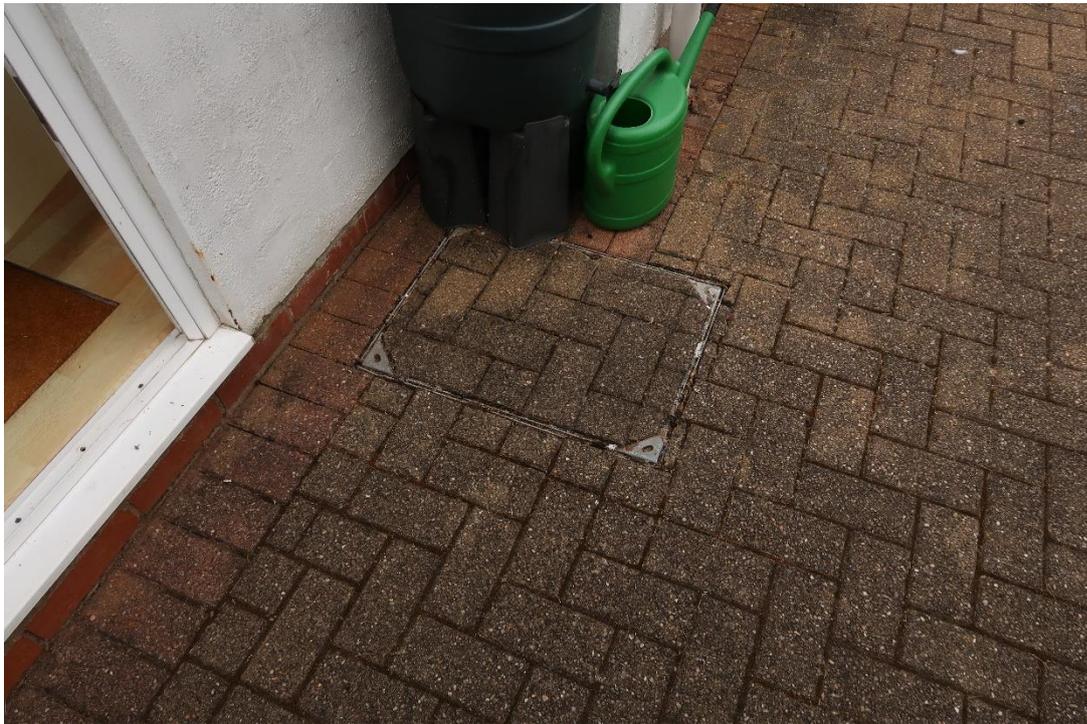
ORIGINAL DRAINAGE GULLEY.

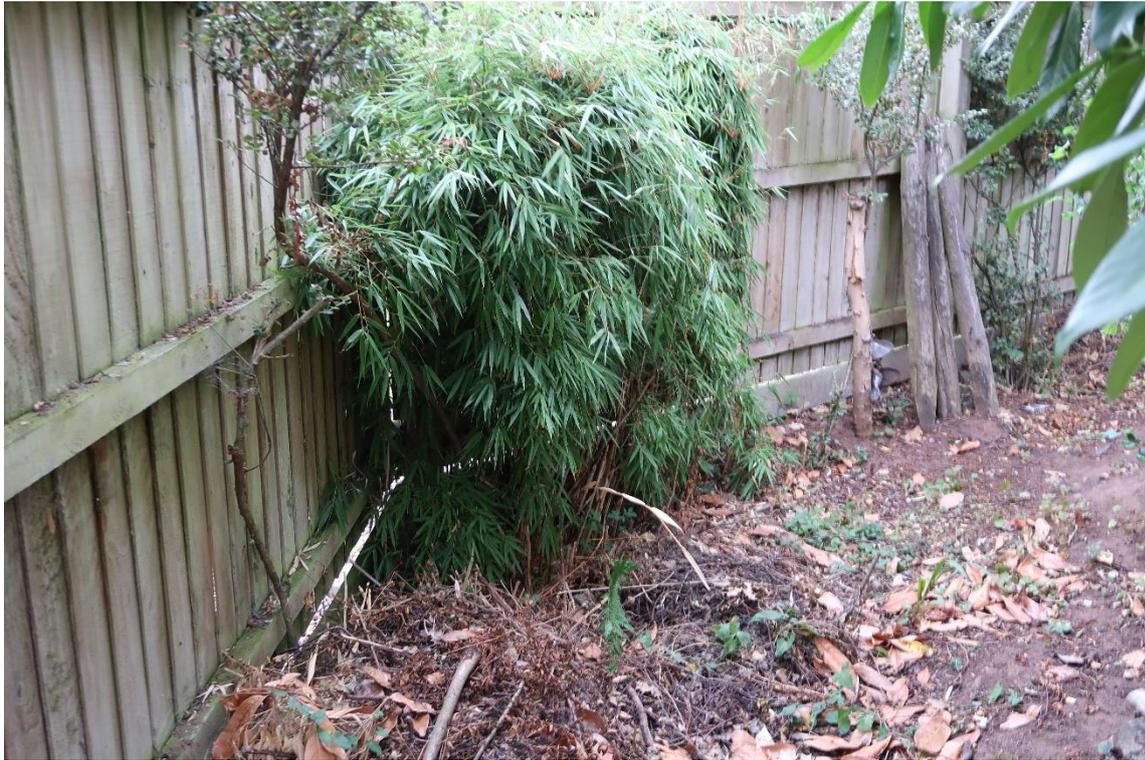
1. There is a crack beneath the side window. We have recommended that the drains are inspected as leaking drains can cause subsidence.
2. To the left-hand side wall of the garage, it looks like raking cracks have been repointed and then painted. The cracks have not clearly reopened and the outside of the wall is covered in planting, so we were unable to inspect the outside face of the wall. We cannot comment further.

RAKING CRACK TO GARAGE.
