BUILDING SURVEY

BUILDING SURVEY FOR *****

*****,
*****,
*****,
Birmingham,
*****.

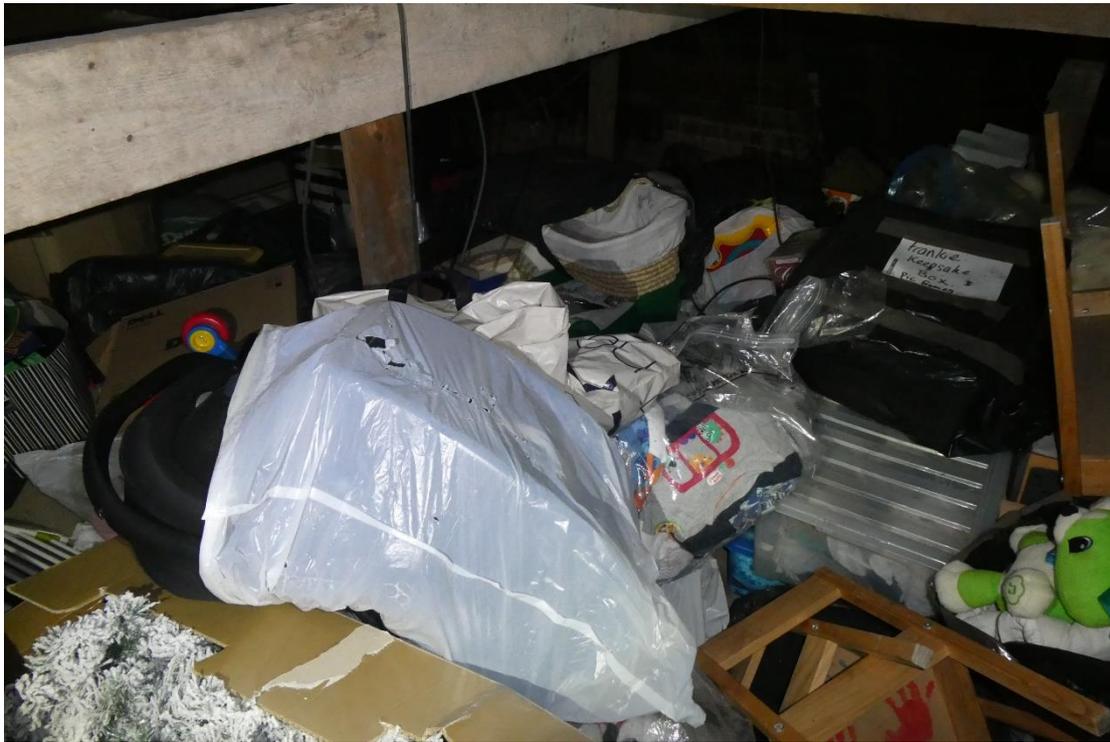
THE BOARDS TO THE ORIGINAL ROOF SPACE ARE COVERED IN STORAGE.

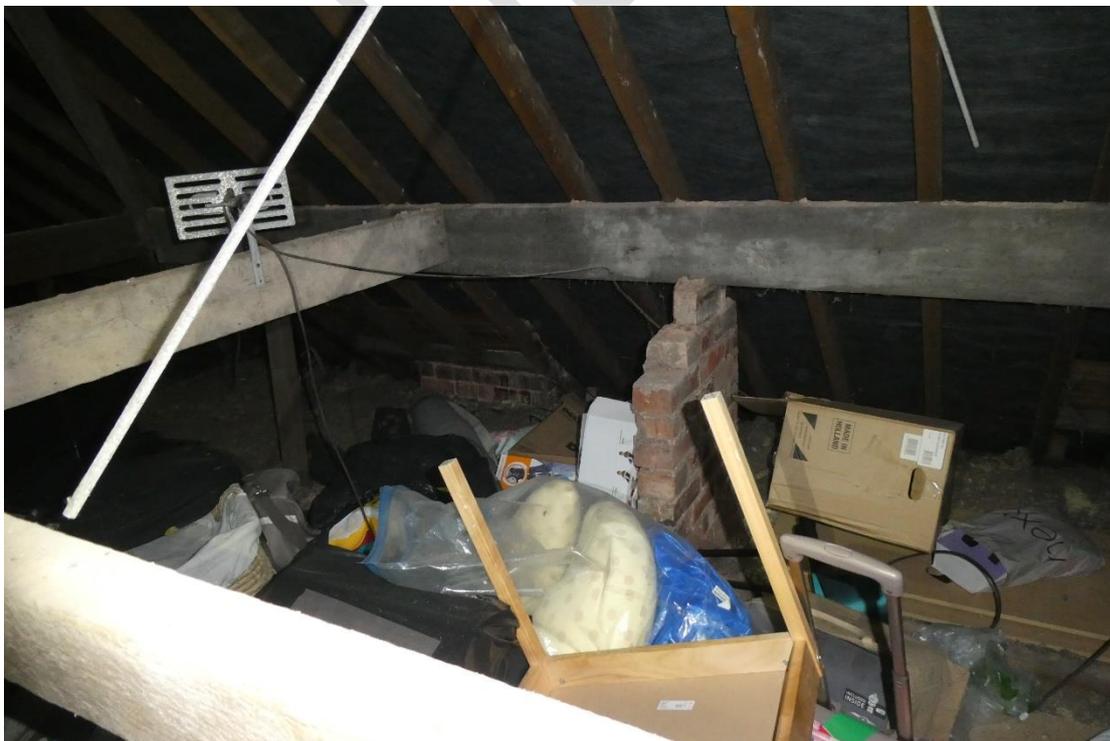
LOOKING TOWARDS THE FRONT LEFT-HAND CORNER OF THE ORIGINAL ROOF SPACE. NOTE BRICK PURLIN SUPPORT WALL.

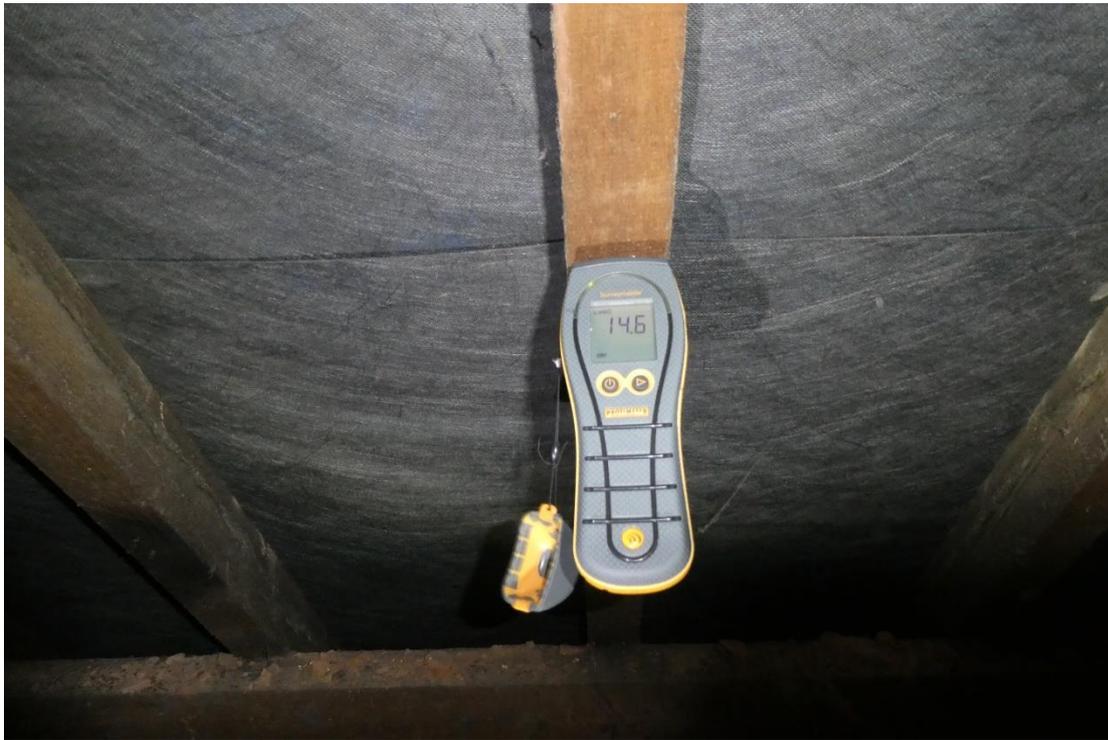
SURFACE MOISTURE CONTENT OF ORIGINAL RAFTER.

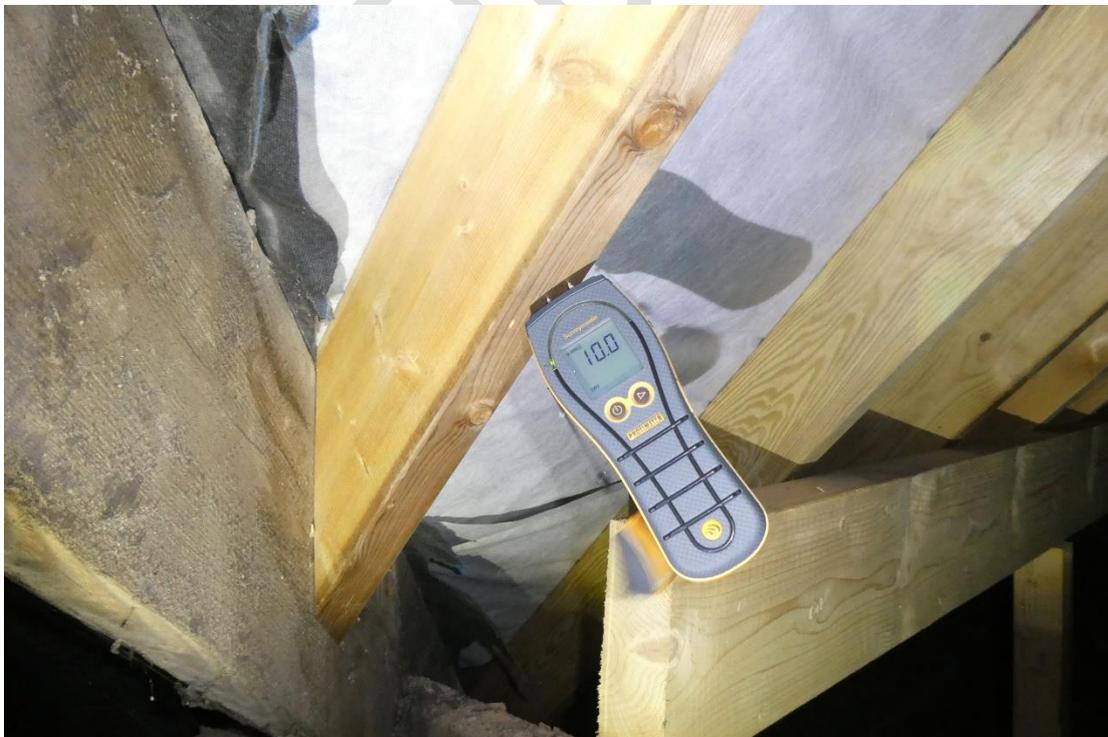
SURFACE MOISTURE CONTENT OF NEW RAFTER.

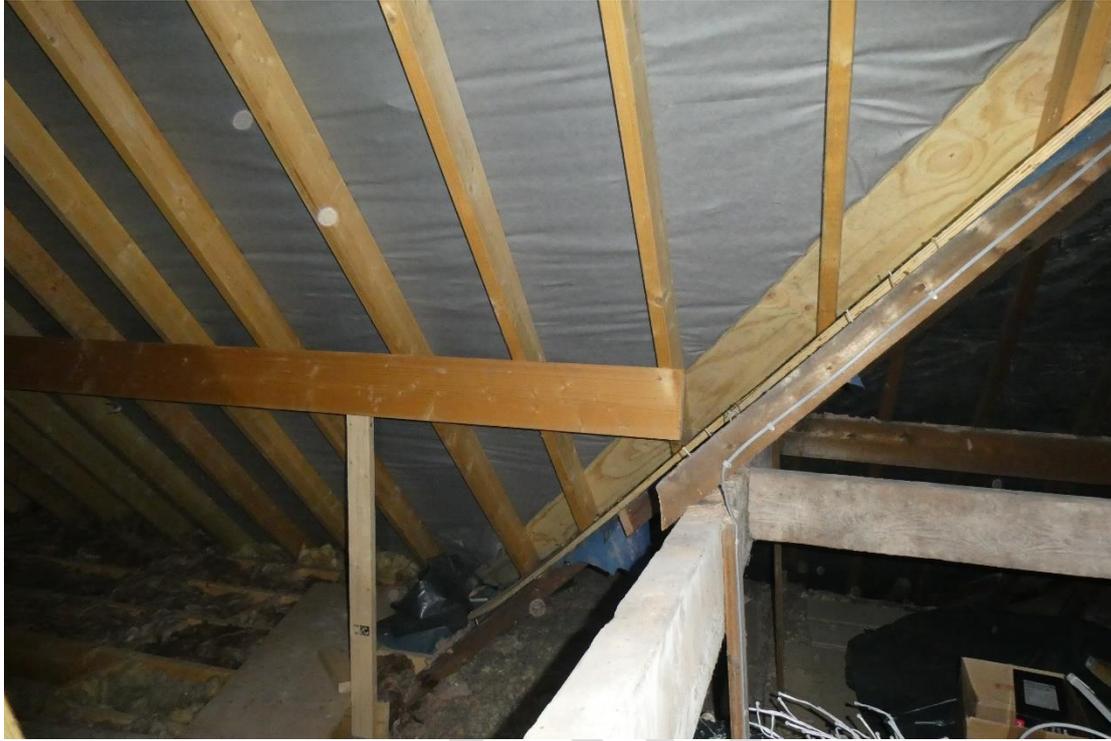
THIS IS THE JUNCTION BETWEEN THE ORIGINAL AND EXTENSION ROOF AREAS.

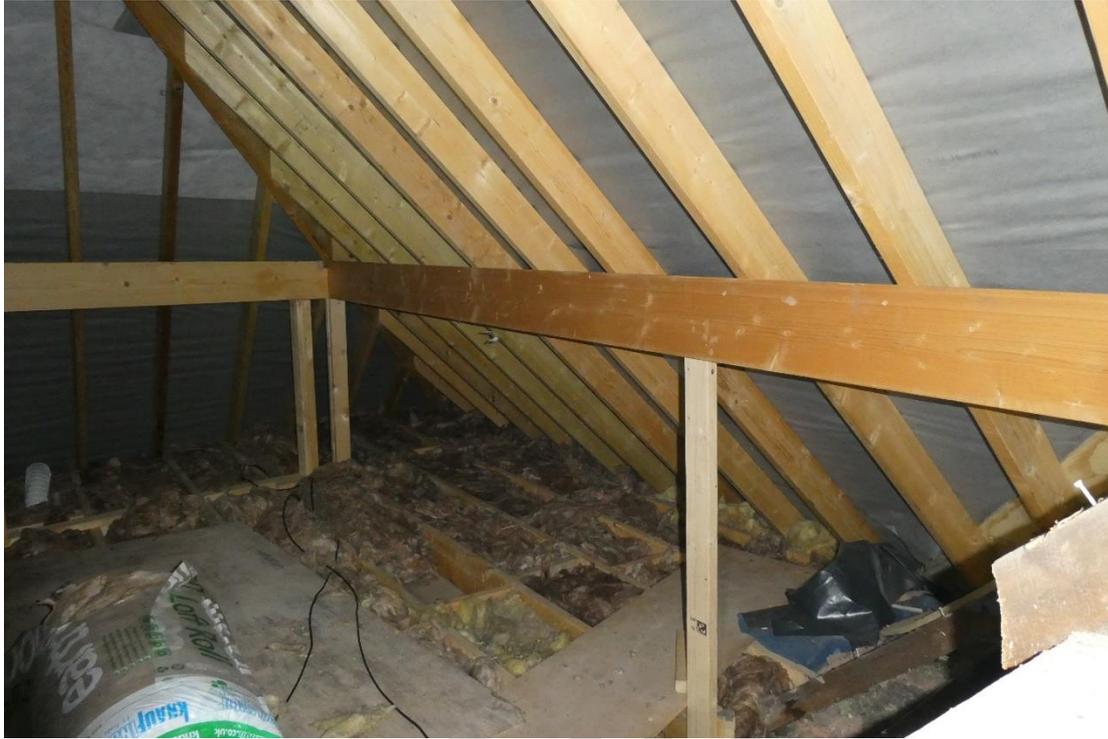
LOOKING ALONG THE FRONT PURLIN.

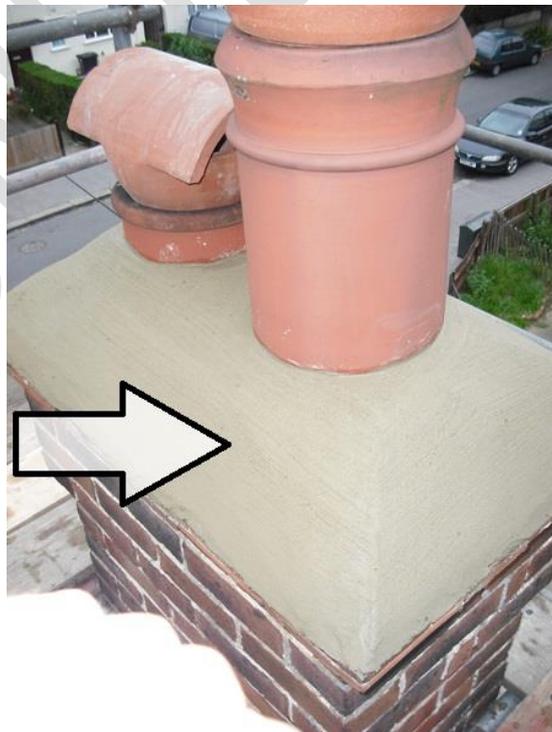
EXAMPLE OF MORTAR FLAUNCHING.

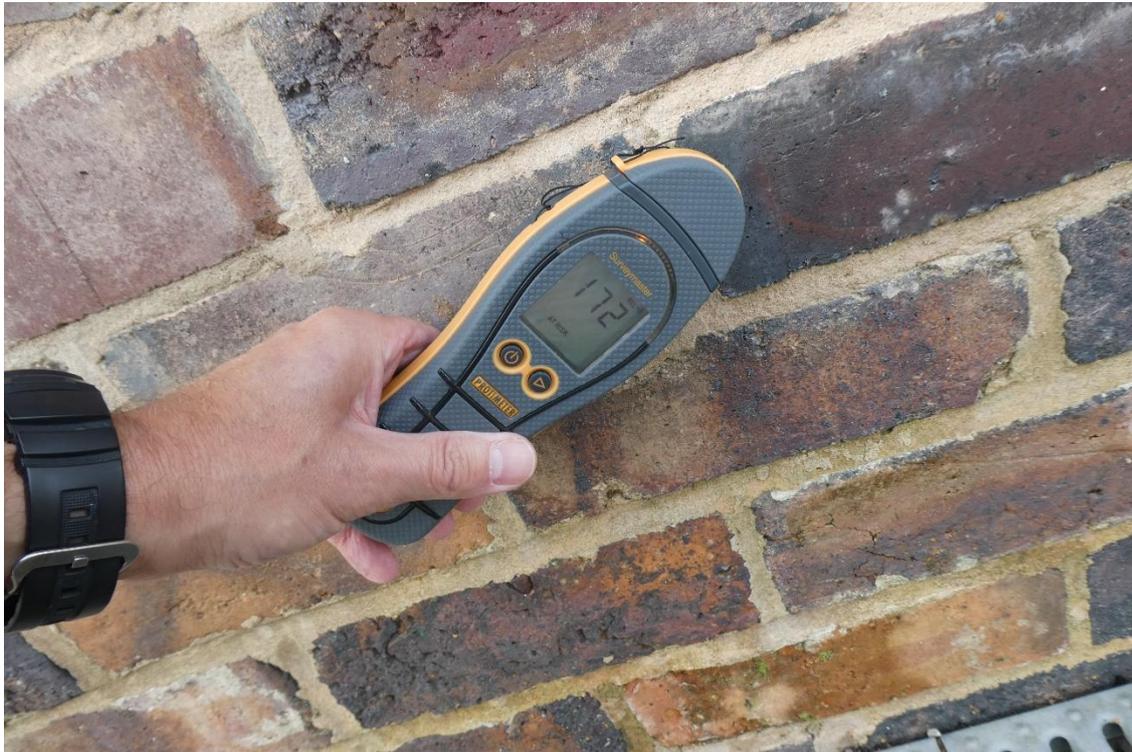
COMPARISON MEASUREMENT TAKEN ABOVE THE DAMP AREA.

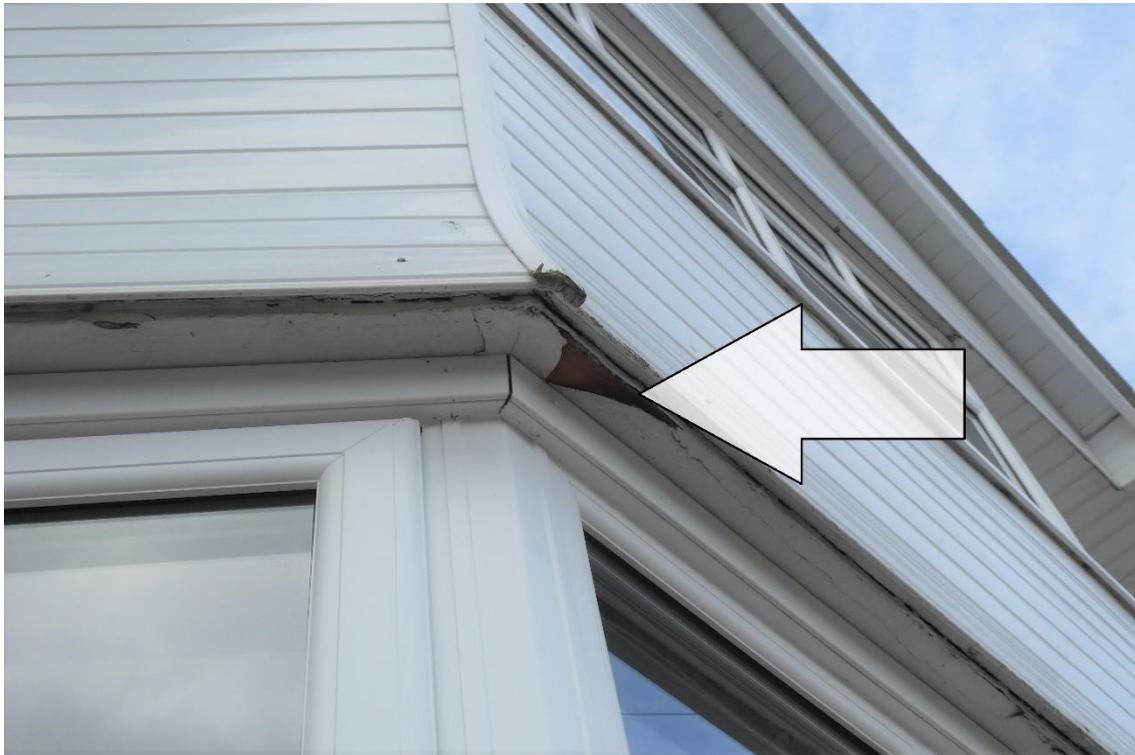
BOARD BENEATH BAY CLADDING.

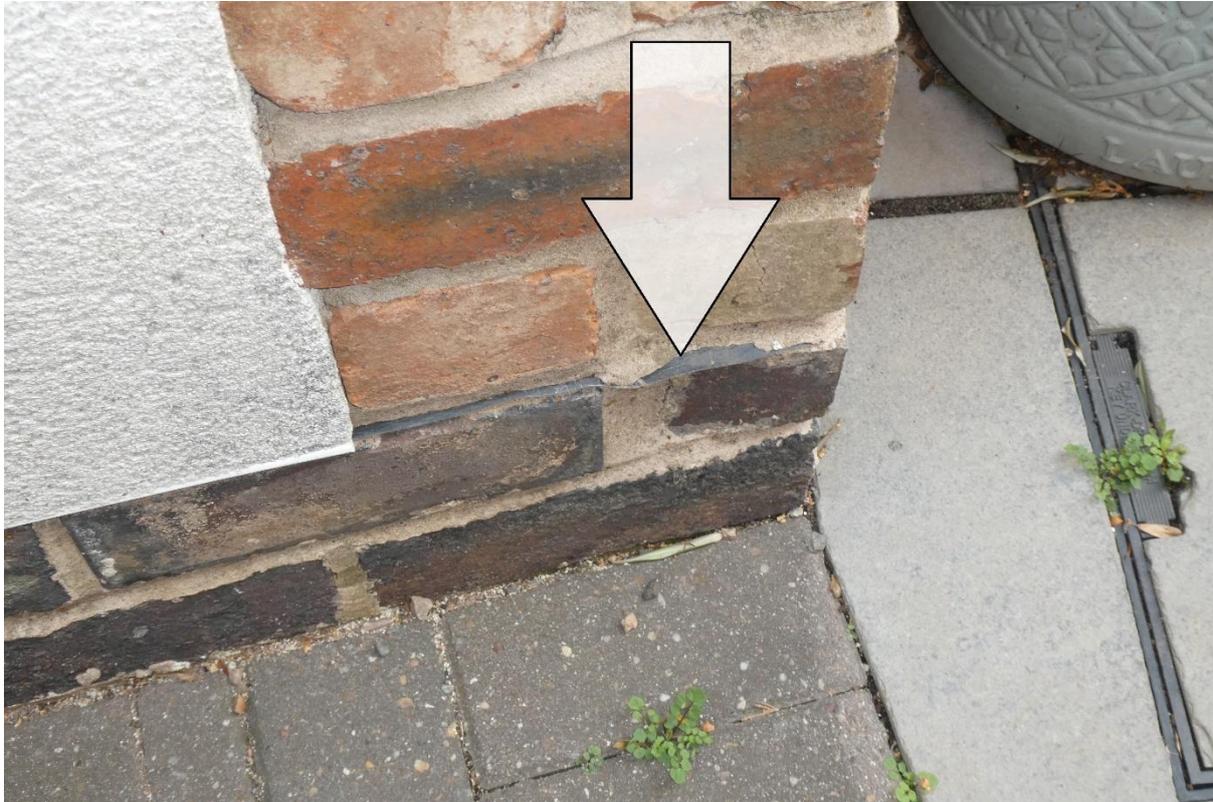
THIS IS THE ONLY SECTION OF DPC THAT WE COULD ACTUALLY SEE. YOU CAN ALSO SEE THE DIFFERENT COLOUR BRICKS BENEATH THE DPC.

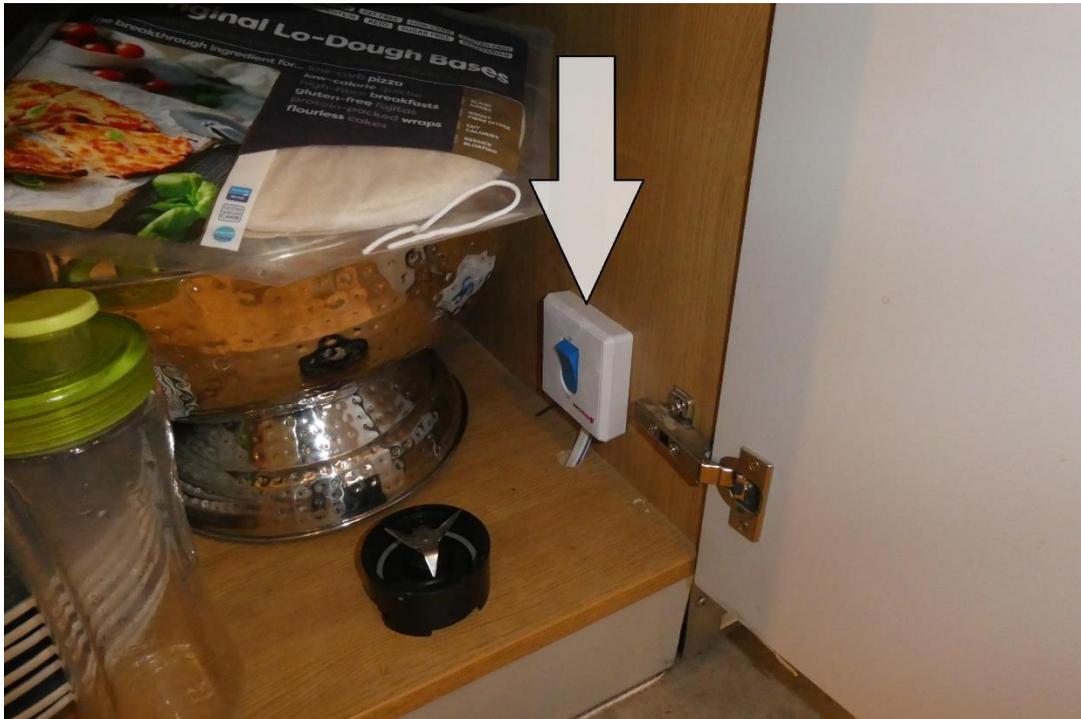
"SURE-STOP" WATER ISOLATOR.

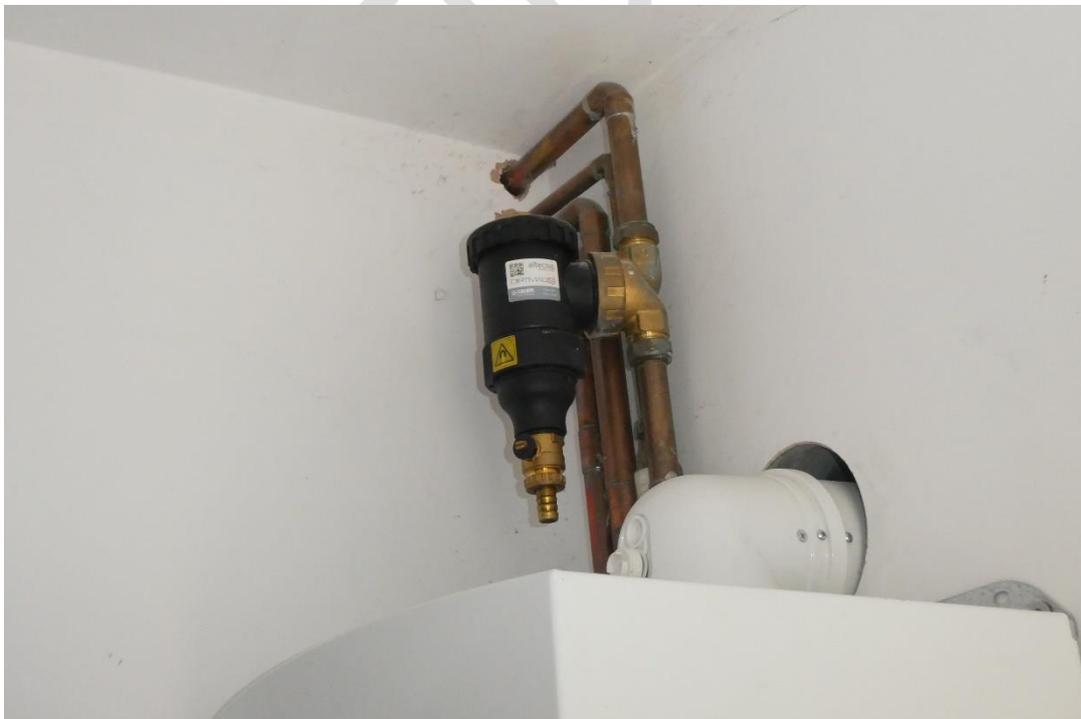
MAGNETIC SYSTEM CLEAN ABOVE THE BOILER.

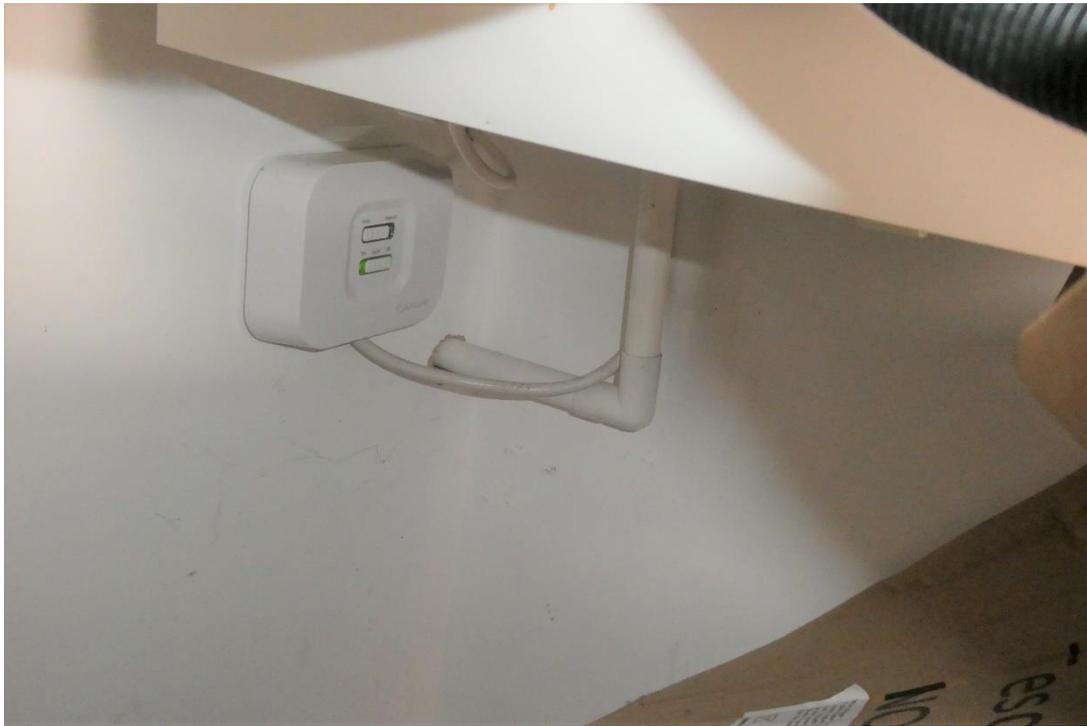
BOILER CONDENSATE PIPE GOING INTO THE UTILITY. YOU CAN ALSO SEE THE THERMOSTAT REMOTE KEY.

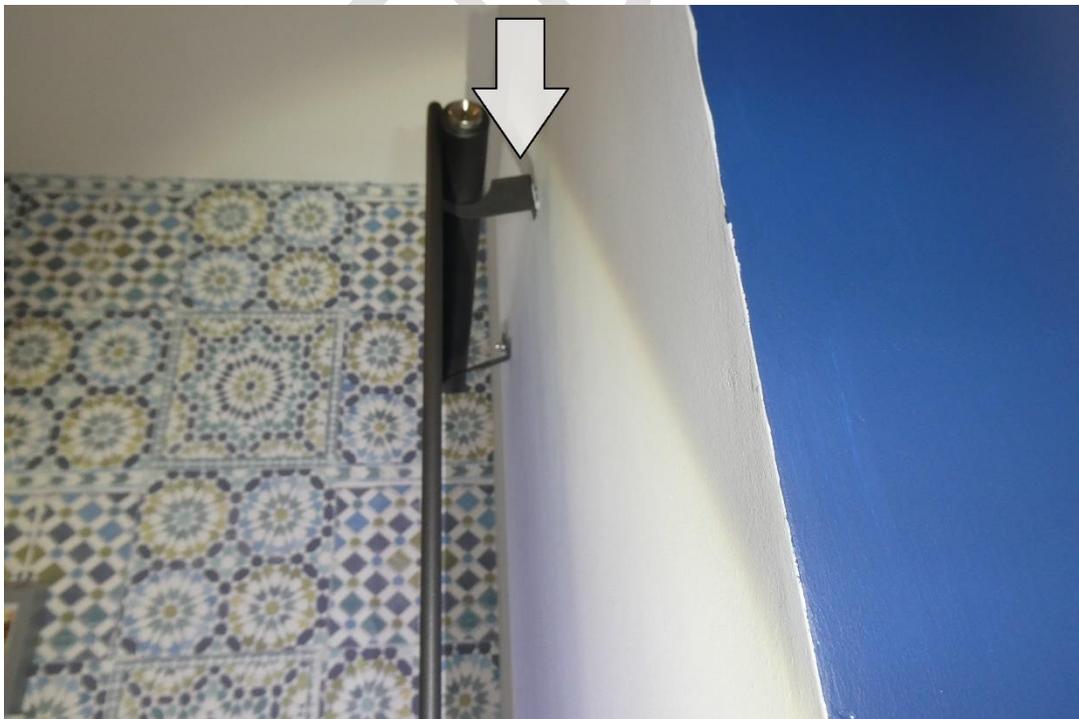
RADIATOR IS NOT FIXED CORRECTLY TO THE WALL.

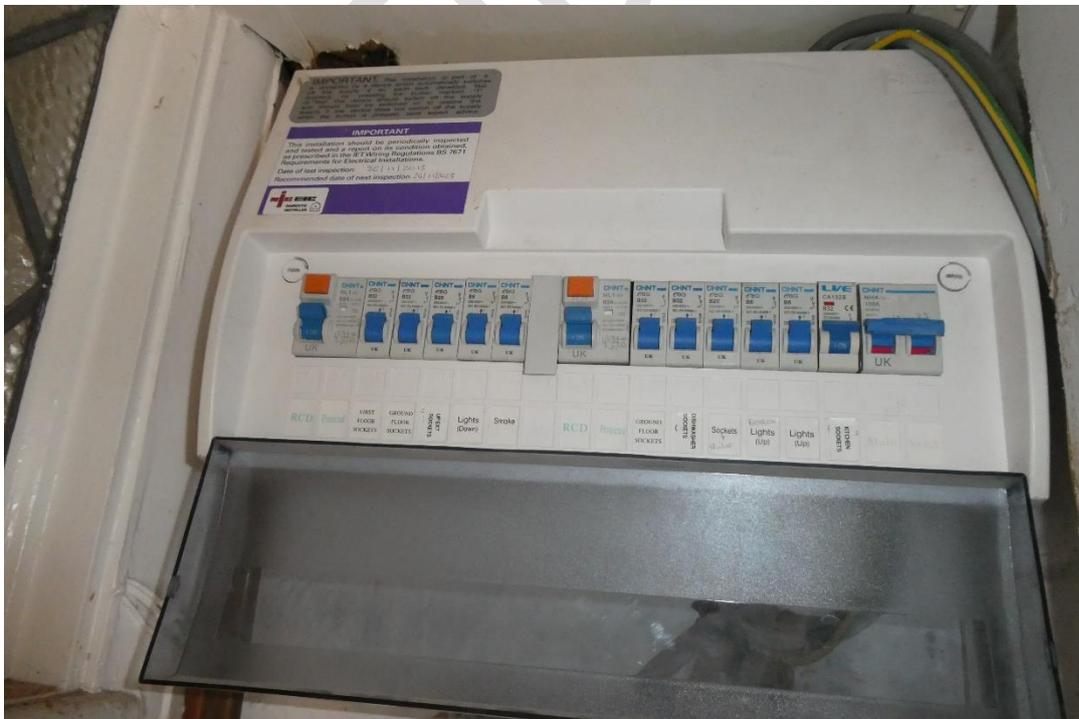
OLDER CONSUMER UNIT.

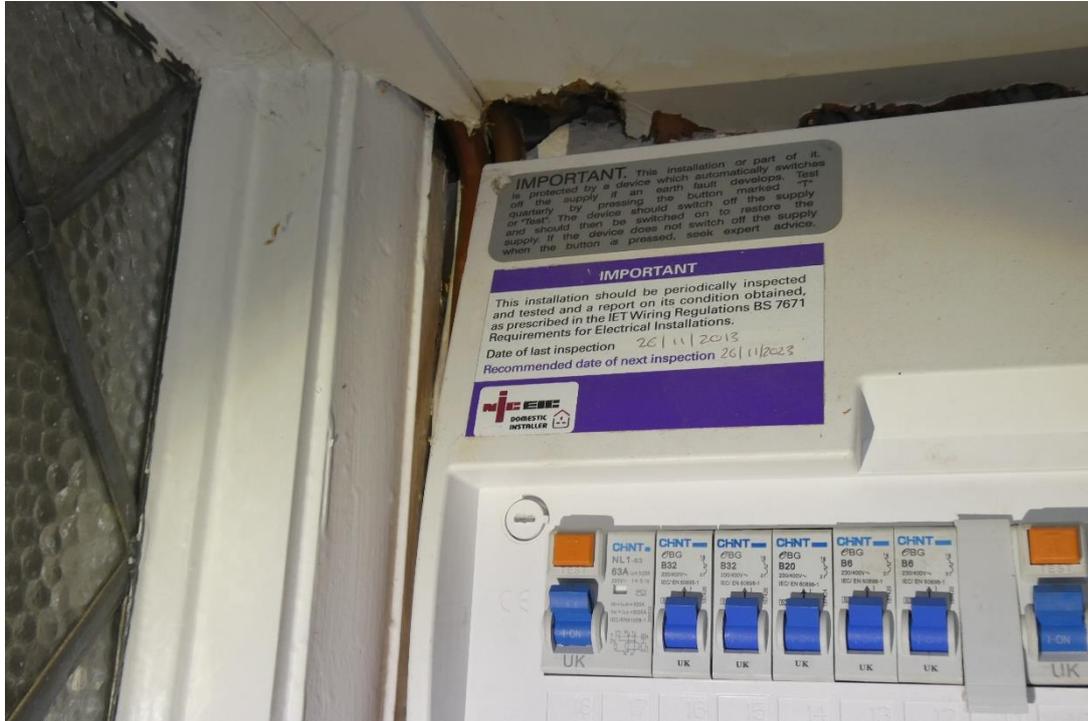
ALTHOUGH THE STICKER STATES "NEXT INSPECTION 2023", THE WHOLE INSTALLATION SHOULD HAVE BEEN CHECKED PRIOR TO EXTENDING IT INTO THE EXTENSION.

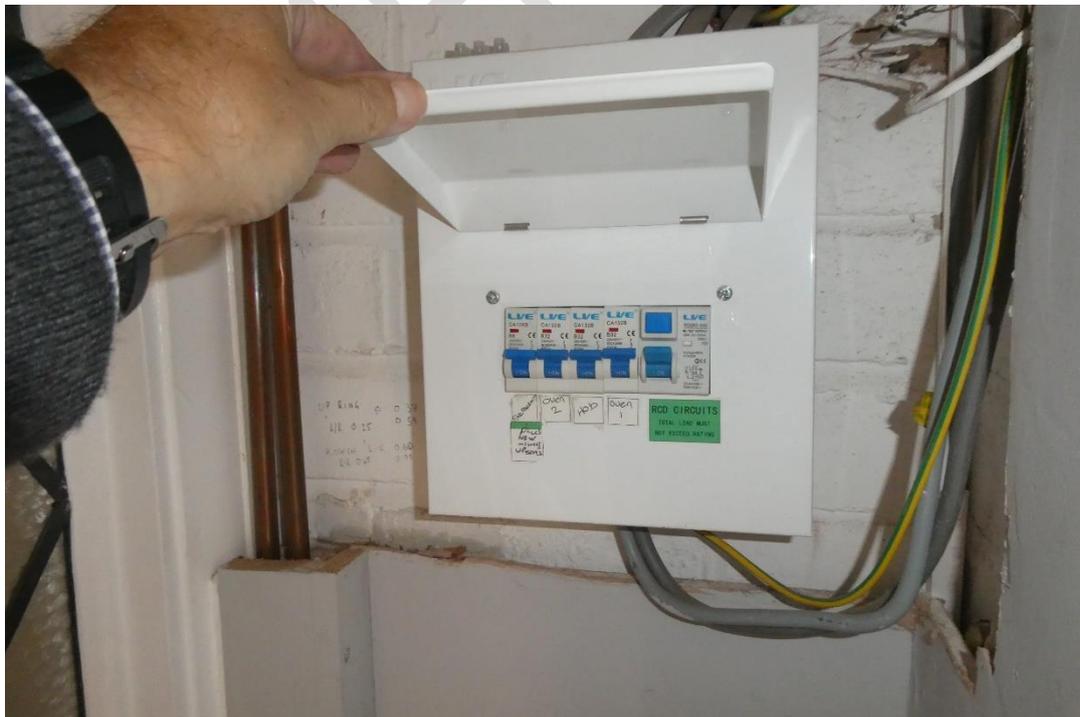
NEW CONSUMER UNIT WHICH ONLY COVERS THE KITCHEN PART OF THE EXTENSION AND SOME LIGHTS UPSTAIRS.
